Profile/Photo Observation Report

Street:	FOXCROFT STREET	Flow Control:	Not Controlled
City:	Hobart, IN	Year Renewed:	
Location:	Yard	Tape/Media #:	
Purpose:	Routine Assessment	Dia/Height:	8"
Use:	Sanitary	Material:	PVC
Drain Area:	NA	Lining:	
Category:	NA		
Comment:

Location Details:		Direction of Survey:	Upstream
US MH:	M-507-068	DS MH:	M-507-069
		Total Length Surveyed (ft):	170.4

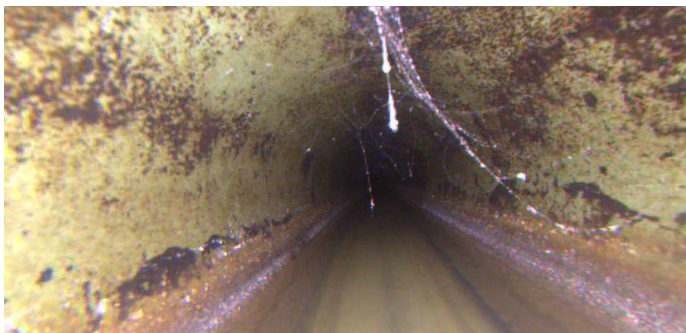
Code: **AMH**
Description: **Manhole**

Distance (ft): **.0**
Structural Grade: **0**
O&M Grade: **0**
Clock Start/From:
Clock To:
1st Value:
2nd Value:
Value Percent:
Continuous Index:
Within 8" of Joint: **NO**
Remarks: **M-507-069**

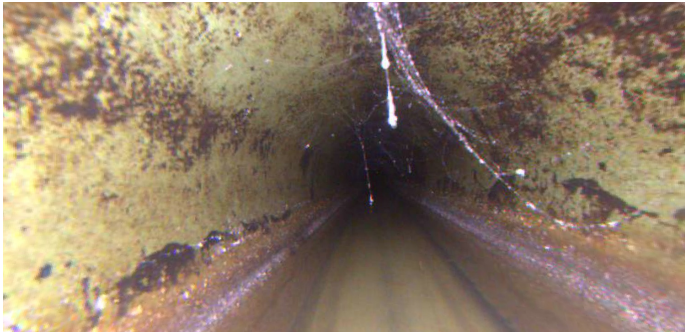
Code: **MWL**
Description: **Water Level**

Distance (ft): **.0**
Structural Grade: **0**
O&M Grade: **0**
Clock Start/From:
Clock To:
1st Value:
2nd Value:
Value Percent: **10.000**
Continuous Index:
Within 8" of Joint: **NO**
Remarks:

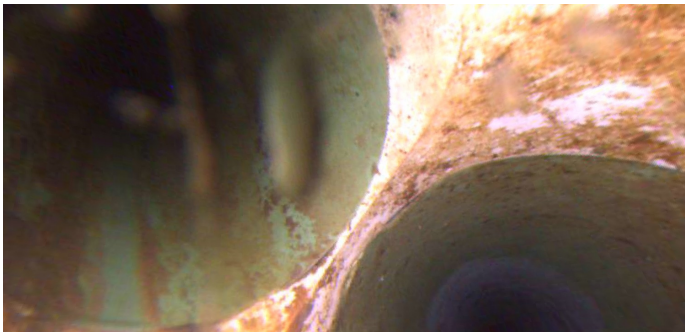
Code: **TF**
Description: **Tap Factory**

Distance (ft): **23.5**
Structural Grade: **0**
O&M Grade: **0**
Clock Start/From: **10**
Clock To:
1st Value: **4.000**
2nd Value:
Value Percent:
Continuous Index:
Within 8" of Joint:
Remarks:

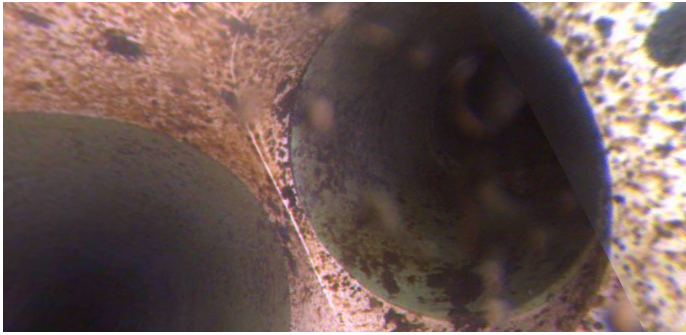
Code: **TF**
Description: **Tap Factory**

Distance (ft): **35.8**
Structural Grade: **0**
O&M Grade: **0**
Clock Start/From: **2**
Clock To:
1st Value: **4.000**
2nd Value:
Value Percent:
Continuous Index:
Within 8" of Joint:
Remarks:

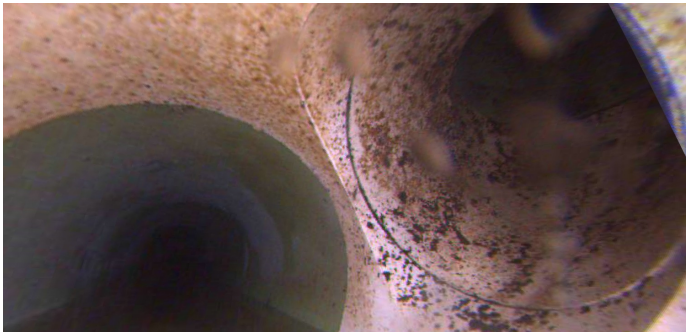
Code: **TF**
Description: **Tap Factory**

Distance (ft): **85.7**
Structural Grade: **0**
O&M Grade: **0**
Clock Start/From: **2**
Clock To:
1st Value: **4.000**
2nd Value:
Value Percent:
Continuous Index:
Within 8" of Joint:
Remarks:

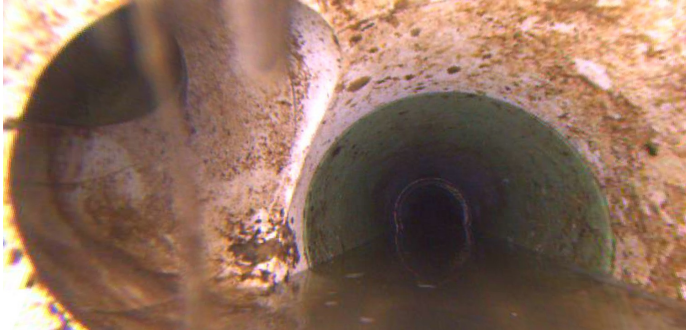
Code: **TF**
Description: **Tap Factory**

Distance (ft): **143.6**
Structural Grade: **0**
O&M Grade: **0**
Clock Start/From: **9**
Clock To:
1st Value: **4.000**
2nd Value:
Value Percent:
Continuous Index:
Within 8" of Joint:
Remarks:

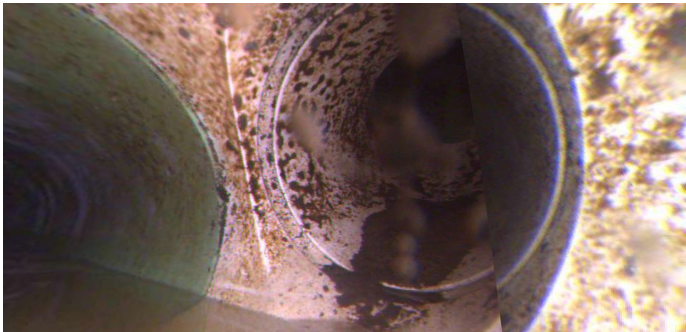
Code: **TF**
Description: **Tap Factory**

Distance (ft): **146.6**
Structural Grade: **0**
O&M Grade: **0**
Clock Start/From: **3**
Clock To:
1st Value: **4.000**
2nd Value:
Value Percent:
Continuous Index:
Within 8" of Joint:
Remarks:

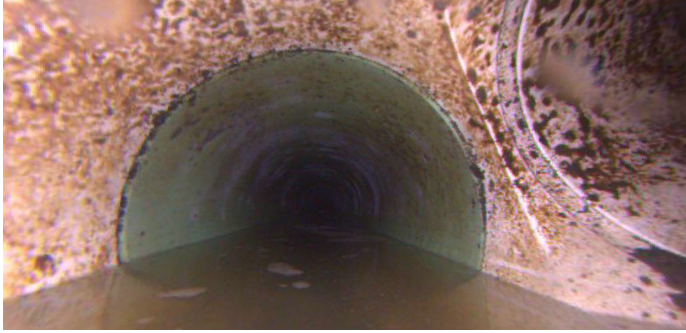
Code:	MWL
Description:	Water Level
Distance (ft):	146.6
Structural Grade:	0
O&M Grade:	0
Clock Start/From:	
Clock To:	
1st Value:	
2nd Value:	
Value Percent:	30.000
Continuous Index:	
Within 8" of Joint:	NO
Remarks:

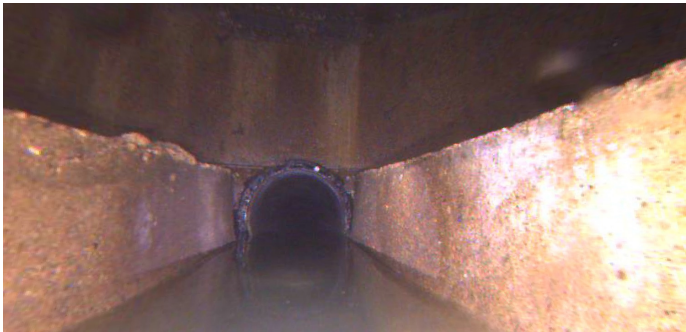
Code:	AMH
Description:	Manhole
Distance (ft):	170.4
Structural Grade:	0
O&M Grade:	0
Clock Start/From:	
Clock To:	
1st Value:	
2nd Value:	
Value Percent:	
Continuous Index:	
Within 8" of Joint:	NO
Remarks:	M-507-068
