## Profile/Photo Observation Report

Date:	<b>10/24/2021</b>	Weather:		Coding:	<b>PACP 6.0</b>
Pipe Length (ft):		Owner:	<b>Hobart, IN</b>	Pre Clean:	<b>Not Known</b>
P.O.#:	<b>997_1</b>	Surveyor:	<b>M. Pielacha</b>	PSR:	<b>M-507-069_M-507-069A</b>
Customer:	<b>Hobart, IN</b>	Clean Date:		Shape:	<b>C</b>

Street:	<b>Off Csokasy Lane</b>	Flow Control:	
City:	<b>Hobart, IN</b>	Year Renewed:	
Location:	<b>Sidewalk</b>	Tape/Media #:	<b>997</b>
Purpose:	<b>Routine Assessment</b>	Dia/Height:	<b>8"</b>
Use:	<b>Sanitary</b>	Material:	<b>PVC</b>
Drain Area:		Lining:

US MH: **M-507-069** DS MH: **M-507-069A** Total Length Surveyed (ft): **120.6**

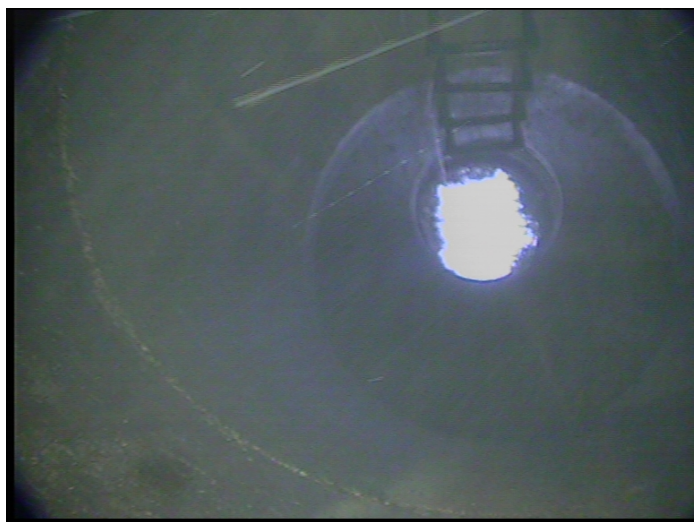
Code: **AMH**  
 Description: **Manhole**

Distance (ft): **.0**  
 Structural Grade: **0**  
 O&M Grade: **0**  
 Clock Start/From:  
 Clock To:  
 1st Value:  
 2nd Value:  
 Value Percent:  
 Continuous Index:  
 Within 8" of Joint: **NO**  
 Remarks: **M-507-069**

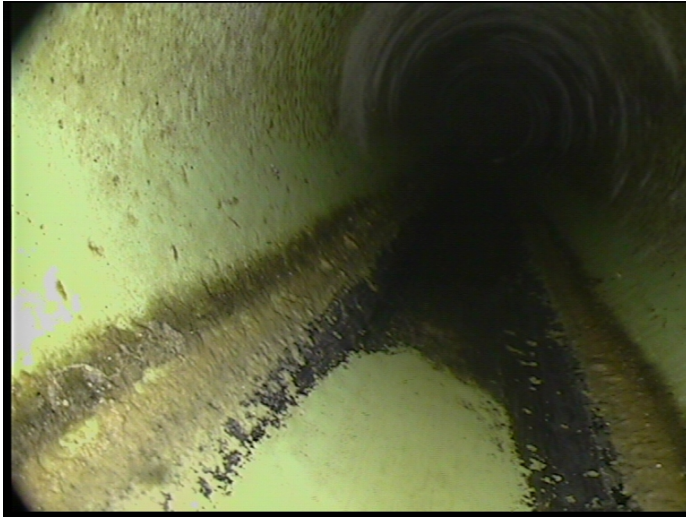
Code:	<b>MWL</b>
Description:	<b>Water Level</b>
Distance (ft):	<b>.0</b>
Structural Grade:	<b>0</b>
O&M Grade:	<b>0</b>
Clock Start/From:	
Clock To:	
1st Value:	
2nd Value:	
Value Percent:	<b>5.000</b>
Continuous Index:	
Within 8" of Joint:	<b>NO</b>
Remarks:

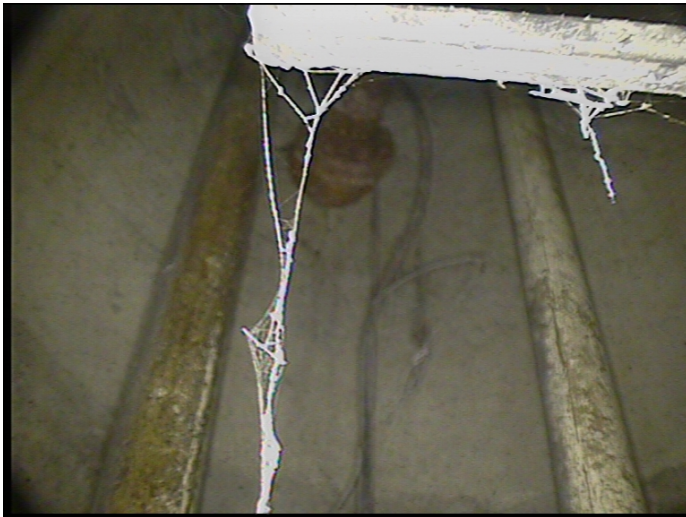
Code:	<b>AWW</b>
Description:	<b>Wet Well</b>
Distance (ft):	<b>120.6</b>
Structural Grade:	<b>0</b>
O&M Grade:	<b>0</b>
Clock Start/From:	
Clock To:	
1st Value:	
2nd Value:	
Value Percent:	
Continuous Index:	
Within 8" of Joint:	<b>NO</b>
Remarks:	<b>M-507-069A</b>
