Profile/Photo Observation Report

Street:	Off Csokasy Lane	Flow Control:	
City:	Hobart, IN	Year Renewed:	
Location:	Sidewalk	Tape/Media #:	998
Purpose:	Routine Assessment	Dia/Height:	8"
Use:	Sanitary	Material:	PVC
Drain Area:		Lining:	
Category:	NA		
Comment:

Location Details:		Direction of Survey:	Upstream
US MH:	M-507-69	DS MH:	M-507-70
		Total Length Surveyed (ft):	205.1

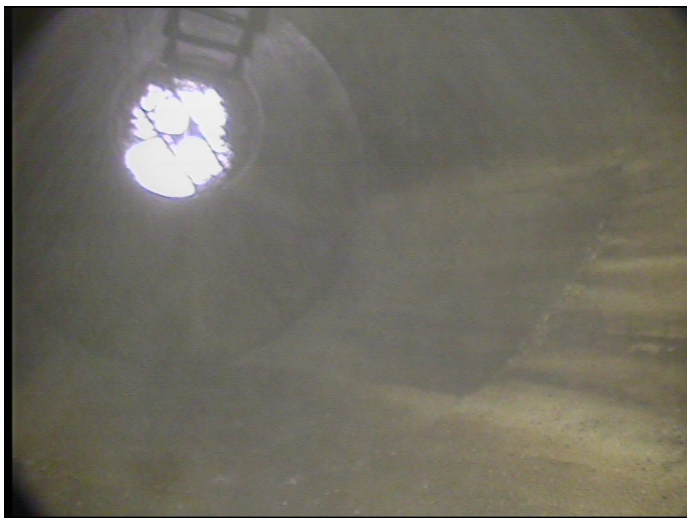
The diagram illustrates a vertical manhole section. On the left, a vertical gray cylinder represents the manhole. At the top, a circle is labeled **M-507-70**. At the bottom, a circle is labeled **M-507-69**. A red arrow on the left side points downwards, labeled **Camera Direction**. A table of observations is positioned to the right of the manhole, with lines connecting specific observation points to the manhole wall. The table has five columns: **Position**, **Code**, **Observation**, **Video (sec)**, and **Grade**.

Position	Code	Observation	Video (sec)	Grade
.0	AMH	Manhole	0	NA
.0	MWL	Water Level	86	NA
25.1	TF	Tap Factory	149	NA
80.1	TF	Tap Factory	217	NA
128.6	TFC	Tap Factory Capped	281	NA
169.9	TB	Tap Break-in	337	NA
171.7	TB	Tap Break-in	358	NA
176.2	TFC	Tap Factory Capped	374	NA
205.1	AMH	Manhole	428	NA

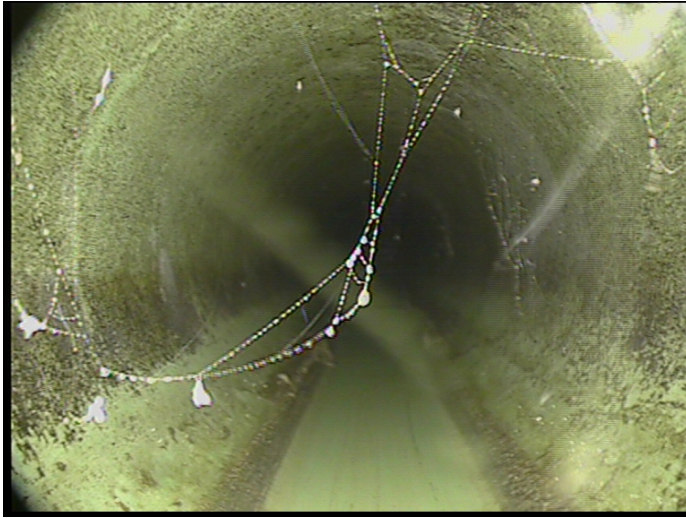
Code:	MWL
Description:	Water Level
Distance (ft):	.0
Structural Grade:	0
O&M Grade:	0
Clock Start/From:	
Clock To:	
1st Value:	
2nd Value:	
Value Percent:	5.000
Continuous Index:	
Within 8" of Joint:	NO
Remarks:

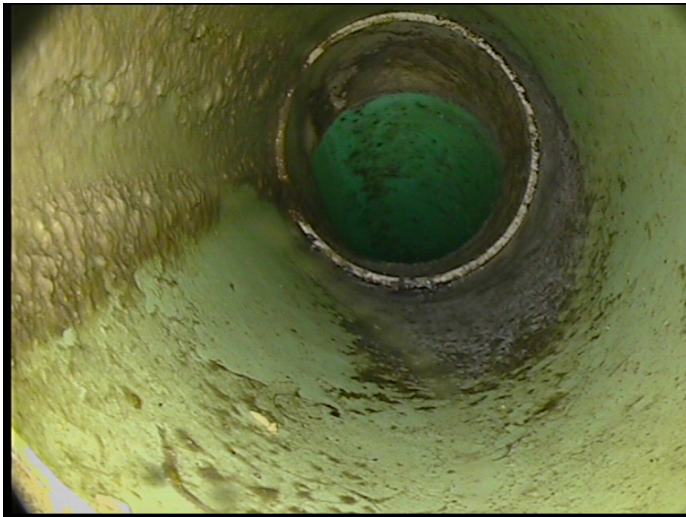
Code:	TF
Description:	Tap Factory
Distance (ft):	25.1
Structural Grade:	0
O&M Grade:	0
Clock Start/From:	10
Clock To:	
1st Value:	4.000
2nd Value:	
Value Percent:	
Continuous Index:	
Within 8" of Joint:	NO
Remarks:

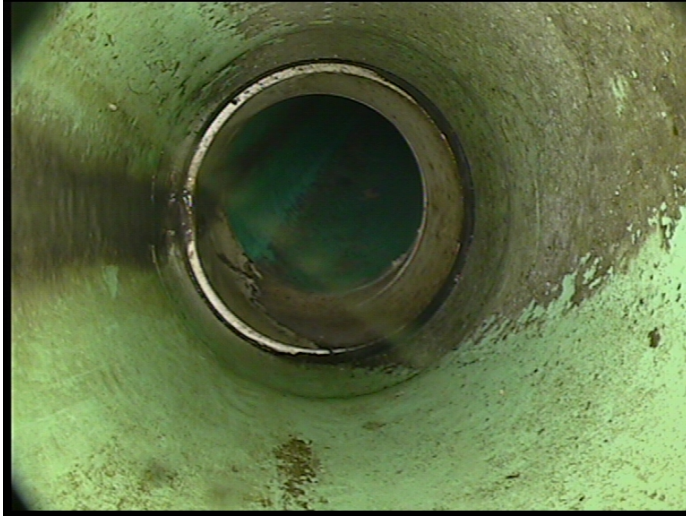
Code: **TF**
Description: **Tap Factory**

Distance (ft): **80.1**
Structural Grade: **0**
O&M Grade: **0**
Clock Start/From: **9**
Clock To:
1st Value: **4.000**
2nd Value:
Value Percent:
Continuous Index:
Within 8" of Joint: **NO**
Remarks:

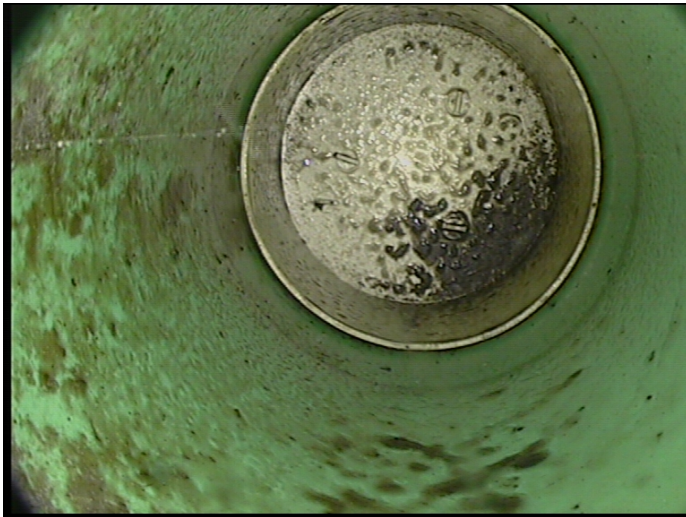
Code: **TFC**
Description: **Tap Factory Capped**

Distance (ft): **128.6**
Structural Grade: **0**
O&M Grade: **0**
Clock Start/From: **9**
Clock To:
1st Value: **4.000**
2nd Value:
Value Percent:
Continuous Index:
Within 8" of Joint: **NO**
Remarks:

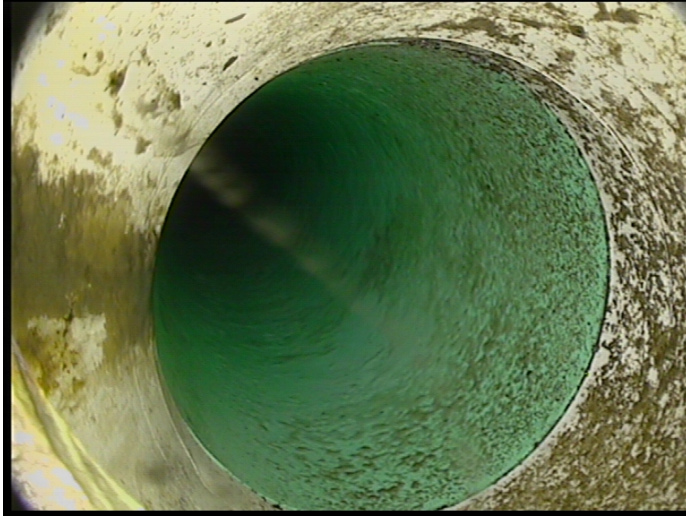
Code: **TB**
Description: **Tap Break-in**

Distance (ft): **169.9**
Structural Grade: **0**
O&M Grade: **0**
Clock Start/From: **9**
Clock To:
1st Value: **4.000**
2nd Value:
Value Percent:
Continuous Index:
Within 8" of Joint: **NO**
Remarks:

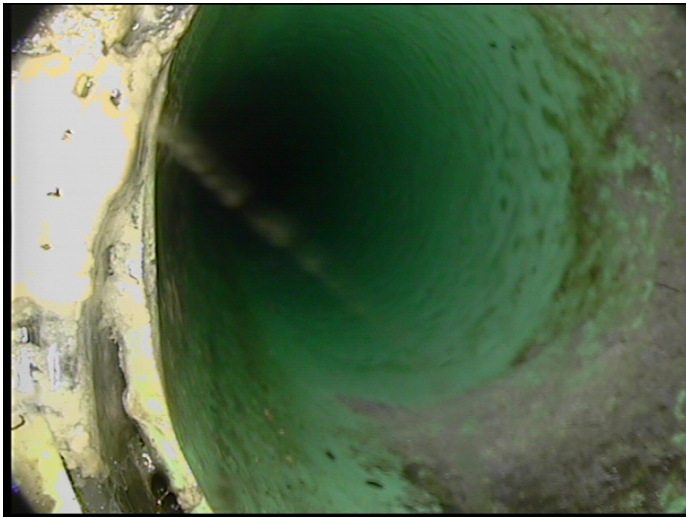
Code: **TB**
Description: **Tap Break-in**

Distance (ft): **171.7**
Structural Grade: **0**
O&M Grade: **0**
Clock Start/From: **9**
Clock To:
1st Value: **4.000**
2nd Value:
Value Percent:
Continuous Index:
Within 8" of Joint: **NO**
Remarks:

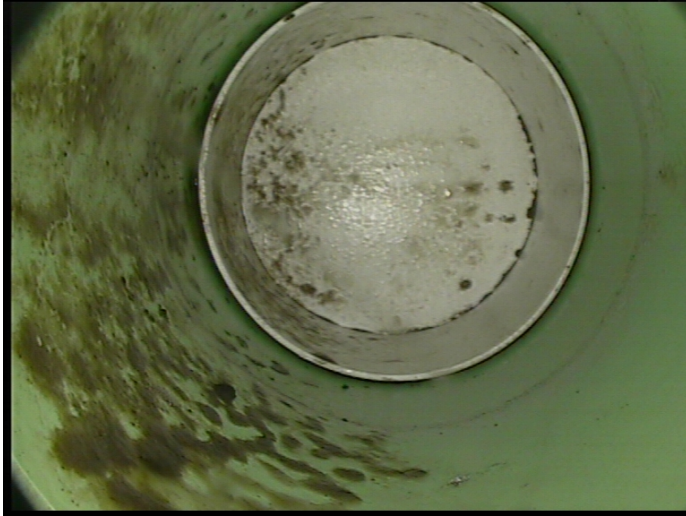
Code: **TFC**
Description: **Tap Factory Capped**

Distance (ft): **176.2**
Structural Grade: **0**
O&M Grade: **0**
Clock Start/From: **9**
Clock To:
1st Value: **4.000**
2nd Value:
Value Percent:
Continuous Index:
Within 8" of Joint: **NO**
Remarks:

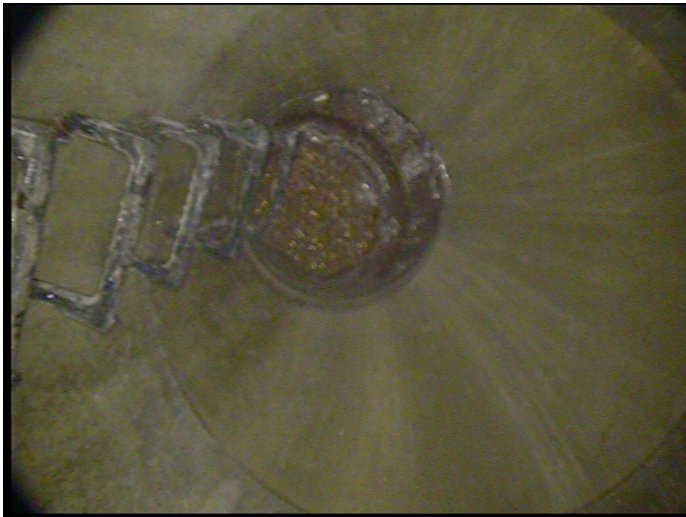
Code: **AMH**
Description: **Manhole**

Distance (ft): **205.1**
Structural Grade: **0**
O&M Grade: **0**
Clock Start/From:
Clock To:
1st Value:
2nd Value:
Value Percent:
Continuous Index:
Within 8" of Joint: **NO**
Remarks: **M-507-69**
