Profile/Photo Observation Report

Street:	CSOKASY CT	Flow Control:	Not Controlled
City:	Hobart, IN	Year Renewed:	
Location:	Yard	Tape/Media #:	
Purpose:	Routine Assessment	Dia/Height:	8"
Use:	Sanitary	Material:	VCP
Drain Area:	NA	Lining:	
Category:	NA		
Comment:

Location Details:		Direction of Survey:	Upstream
US MH:	M-507-070	DS MH:	M-507-073
		Total Length Surveyed (ft):	247.8

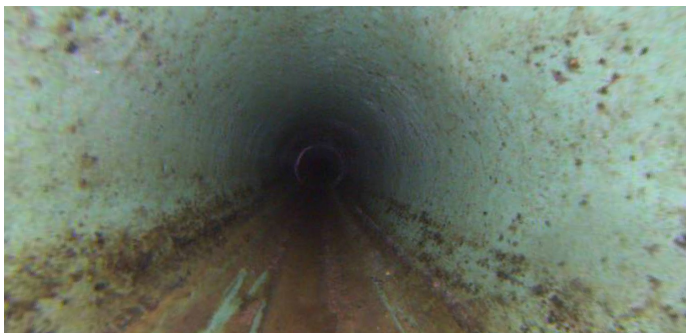
Code: **AMH**
Description: **Manhole**

Distance (ft): **.0**
Structural Grade: **0**
O&M Grade: **0**
Clock Start/From:
Clock To:
1st Value:
2nd Value:
Value Percent:
Continuous Index:
Within 8" of Joint: **NO**
Remarks: **M-507-073**

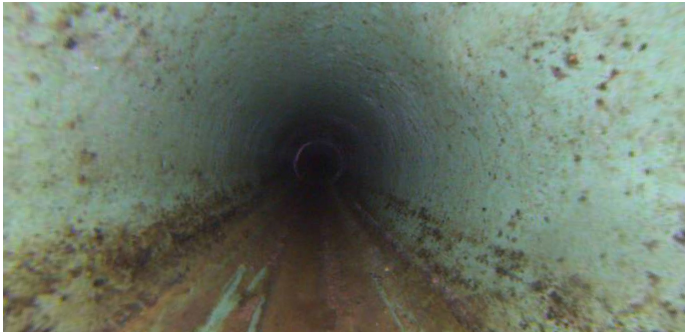
Code:	MWL
Description:	Water Level

Distance (ft):	.0
Structural Grade:	0
O&M Grade:	0
Clock Start/From:	
Clock To:	
1st Value:	
2nd Value:	
Value Percent:	5.000
Continuous Index:	
Within 8" of Joint:	NO
Remarks:

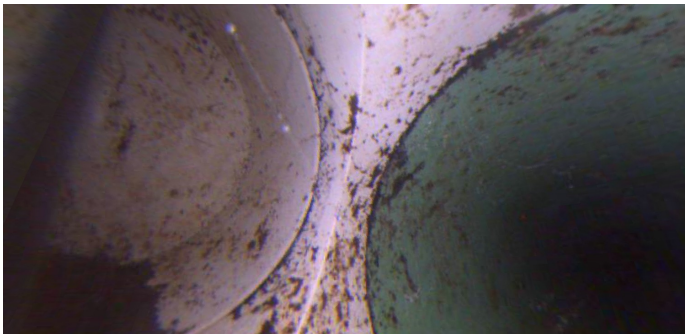
Code:	TFC
Description:	Tap Factory Capped

Distance (ft):	4.8
Structural Grade:	0
O&M Grade:	0
Clock Start/From:	9
Clock To:	
1st Value:	4.000
2nd Value:	
Value Percent:	
Continuous Index:	
Within 8" of Joint:	
Remarks:

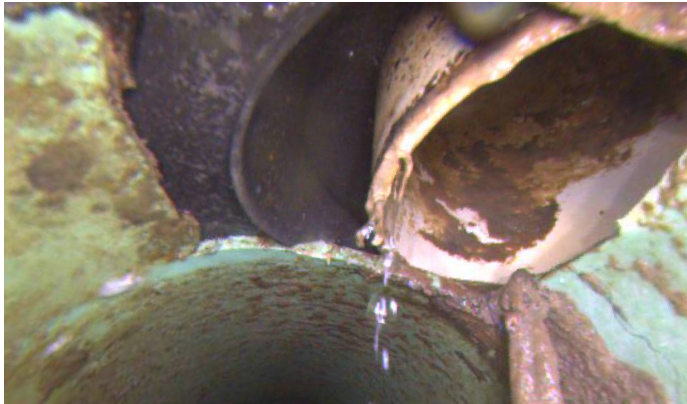
Code: **TBD**
Description: **Tap Break-in Defective**

Distance (ft): **24.4**
Structural Grade: **0**
O&M Grade: **3**
Clock Start/From: **12**
Clock To:
1st Value: **4.000**
2nd Value:
Value Percent:
Continuous Index:
Within 8" of Joint:
Remarks: **offset from connection**

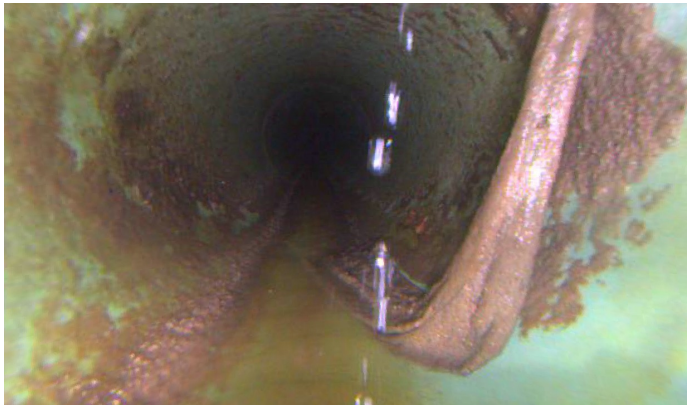
Code: **DAR**
Description: **Deposits Attached Ragging**

Distance (ft): **24.4**
Structural Grade: **0**
O&M Grade: **2**
Clock Start/From: **1**
Clock To:
1st Value:
2nd Value:
Value Percent: **10.000**
Continuous Index:
Within 8" of Joint: **NO**
Remarks:

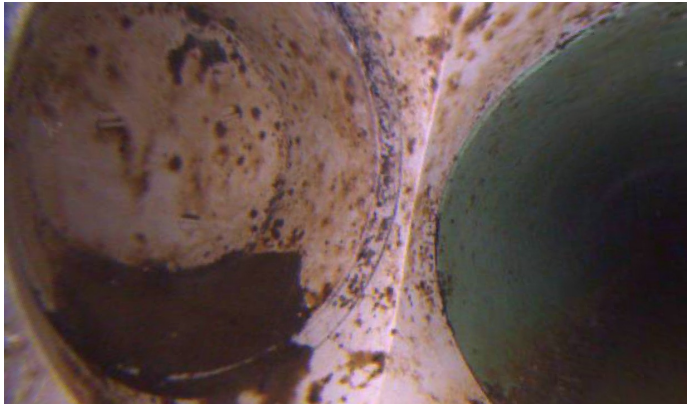
Code: **TFC**
Description: **Tap Factory Capped**

Distance (ft): **39.4**
Structural Grade: **0**
O&M Grade: **0**
Clock Start/From: **9**
Clock To:
1st Value: **4.000**
2nd Value:
Value Percent:
Continuous Index:
Within 8" of Joint:
Remarks:

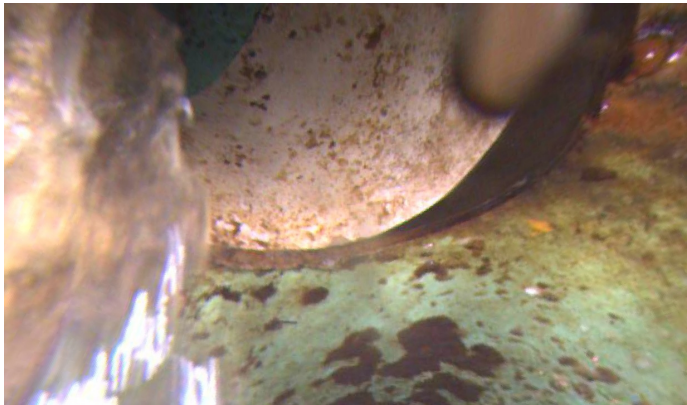
Code: **TBA**
Description: **Tap Break-in Active**

Distance (ft): **48.9**
Structural Grade: **0**
O&M Grade: **0**
Clock Start/From: **12**
Clock To:
1st Value: **4.000**
2nd Value:
Value Percent:
Continuous Index:
Within 8" of Joint:
Remarks:

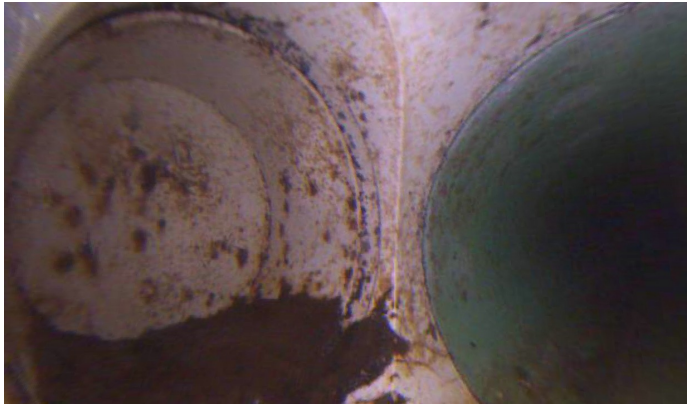
Code: **TFC**
Description: **Tap Factory Capped**

Distance (ft): **68.7**
Structural Grade: **0**
O&M Grade: **0**
Clock Start/From: **9**
Clock To:
1st Value: **4.000**
2nd Value:
Value Percent:
Continuous Index:
Within 8" of Joint:
Remarks:

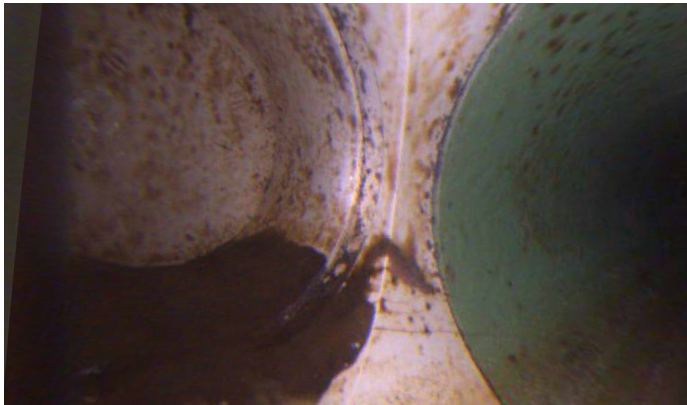
Code: **TFC**
Description: **Tap Factory Capped**

Distance (ft): **104.5**
Structural Grade: **0**
O&M Grade: **0**
Clock Start/From: **9**
Clock To:
1st Value: **4.000**
2nd Value:
Value Percent:
Continuous Index:
Within 8" of Joint:
Remarks:

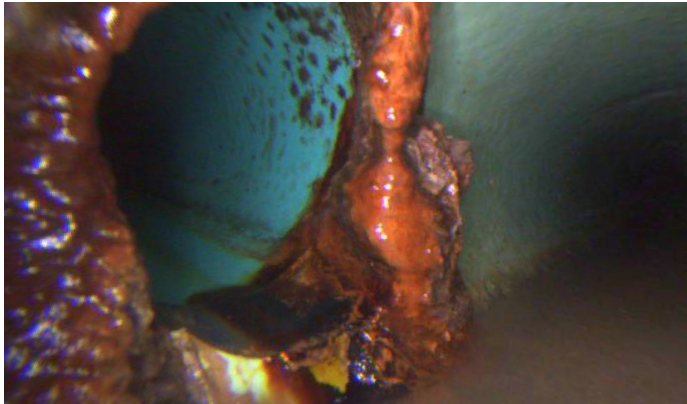
Code: **TBD**
Description: **Tap Break-in Defective**

Distance (ft): **117.6**
Structural Grade: **0**
O&M Grade: **3**
Clock Start/From: **9**
Clock To:
1st Value: **4.000**
2nd Value:
Value Percent:
Continuous Index:
Within 8" of Joint:
Remarks: **dae**

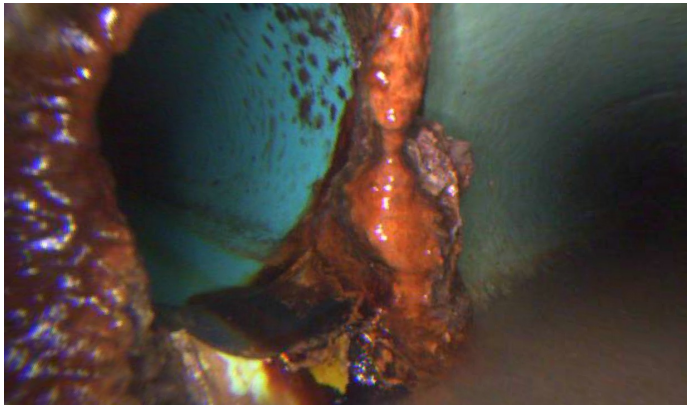
Code: **DAE**
Description: **Deposits Attached Encrustation**

Distance (ft): **117.6**
Structural Grade: **0**
O&M Grade: **2**
Clock Start/From: **8**
Clock To: **10**
1st Value:
2nd Value:
Value Percent: **5.000**
Continuous Index:
Within 8" of Joint: **NO**
Remarks:

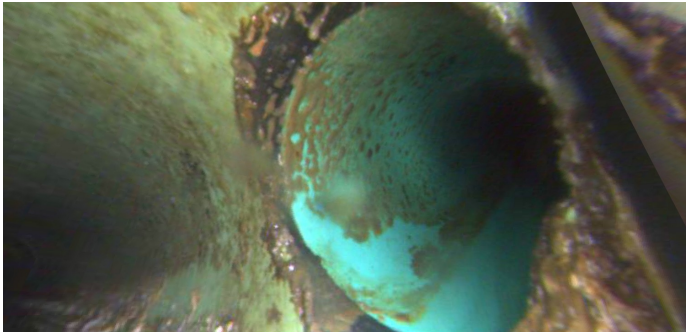
Code: **TB**
Description: **Tap Break-in**

Distance (ft): **135.2**
Structural Grade: **0**
O&M Grade: **0**
Clock Start/From: **10**
Clock To:
1st Value: **4.000**
2nd Value:
Value Percent:
Continuous Index:
Within 8" of Joint:
Remarks:

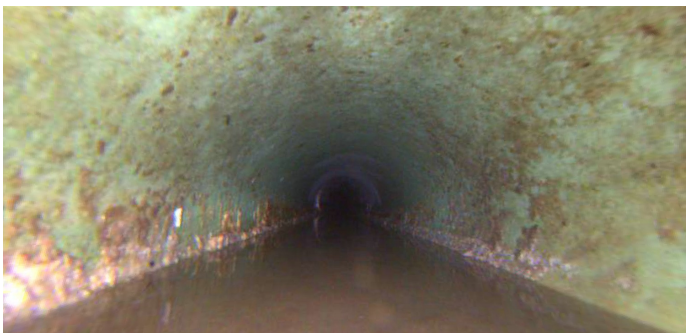
Code: **MWL**
Description: **Water Level**

Distance (ft): **135.2**
Structural Grade: **0**
O&M Grade: **0**
Clock Start/From:
Clock To:
1st Value:
2nd Value:
Value Percent: **30.000**
Continuous Index:
Within 8" of Joint: **NO**
Remarks:

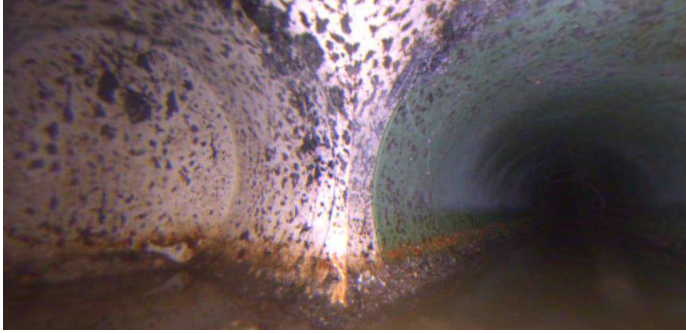
Code: **TFC**
Description: **Tap Factory Capped**

Distance (ft): **138.8**
Structural Grade: **0**
O&M Grade: **0**
Clock Start/From: **9**
Clock To:
1st Value: **4.000**
2nd Value:
Value Percent:
Continuous Index:
Within 8" of Joint:
Remarks:

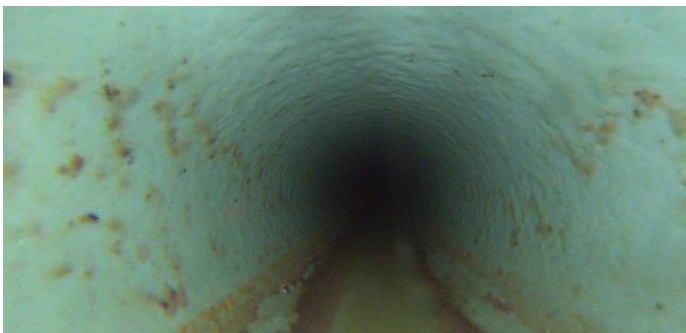
Code: **MWL**
Description: **Water Level**

Distance (ft): **147.7**
Structural Grade: **0**
O&M Grade: **0**
Clock Start/From:
Clock To:
1st Value:
2nd Value:
Value Percent: **5.000**
Continuous Index:
Within 8" of Joint: **NO**
Remarks:

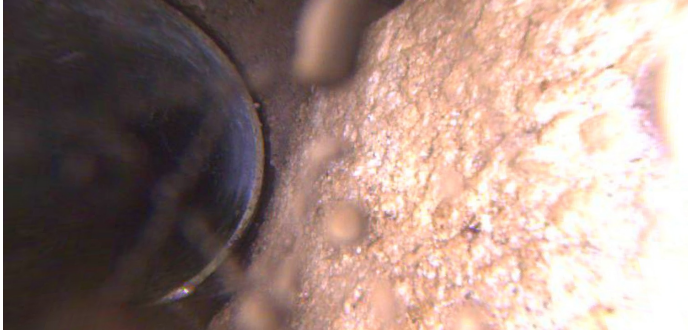
Code:	AMH
Description:	Manhole
Distance (ft):	247.8
Structural Grade:	0
O&M Grade:	0
Clock Start/From:	
Clock To:	
1st Value:	
2nd Value:	
Value Percent:	
Continuous Index:	
Within 8" of Joint:	NO
Remarks:	M-507-070
