## Profile/Photo Observation Report

Street:	<b>FOXCROFT STREET</b>	Flow Control:	<b>Not Controlled</b>
City:	<b>Hobart, IN</b>	Year Renewed:	
Location:	<b>Yard</b>	Tape/Media #:	
Purpose:	<b>Routine Assessment</b>	Dia/Height:	<b>8"</b>
Use:	<b>Sanitary</b>	Material:	<b>VCP</b>
Drain Area:	<b>NA</b>	Lining:	
Category:	<b>NA</b>		
Comment:

Location Details:		Direction of Survey:	<b>Upstream</b>
US MH:	<b>M-507-070</b>	DS MH:	<b>M-507-073</b>
		Total Length Surveyed (ft):	<b>247.8</b>

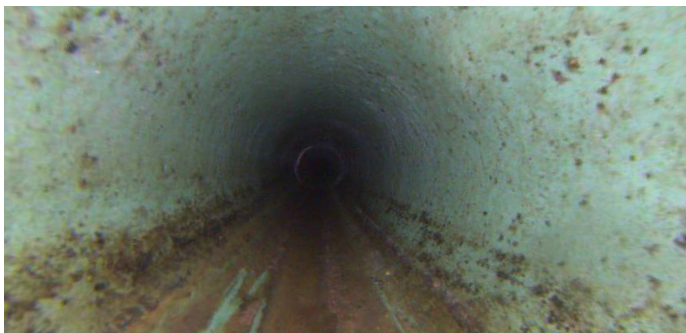
Code: **AMH**  
Description: **Manhole**

Distance (ft): **.0**  
Structural Grade: **0**  
O&M Grade: **0**  
Clock Start/From:  
Clock To:  
1st Value:  
2nd Value:  
Value Percent:  
Continuous Index:  
Within 8" of Joint: **NO**  
Remarks: **M-507-073**

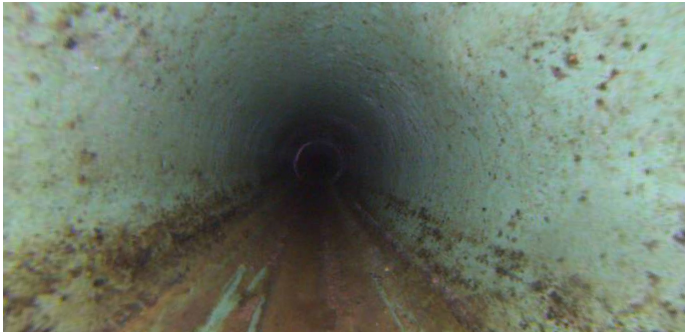
Code:	<b>MWL</b>
Description:	<b>Water Level</b>

Distance (ft):	<b>.0</b>
Structural Grade:	<b>0</b>
O&M Grade:	<b>0</b>
Clock Start/From:	
Clock To:	
1st Value:	
2nd Value:	
Value Percent:	<b>5.000</b>
Continuous Index:	
Within 8" of Joint:	<b>NO</b>
Remarks:

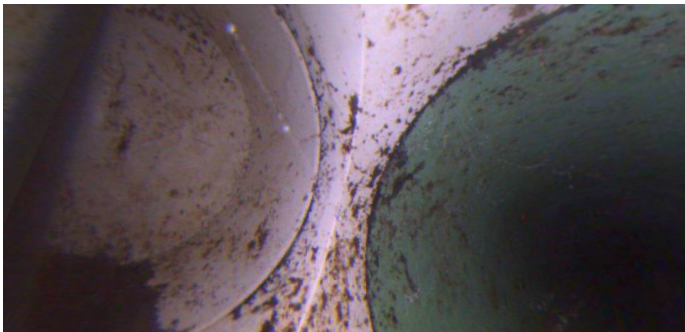
Code:	<b>TFC</b>
Description:	<b>Tap Factory Capped</b>

Distance (ft):	<b>4.8</b>
Structural Grade:	<b>0</b>
O&M Grade:	<b>0</b>
Clock Start/From:	<b>9</b>
Clock To:	
1st Value:	<b>4.000</b>
2nd Value:	
Value Percent:	
Continuous Index:	
Within 8" of Joint:	
Remarks:

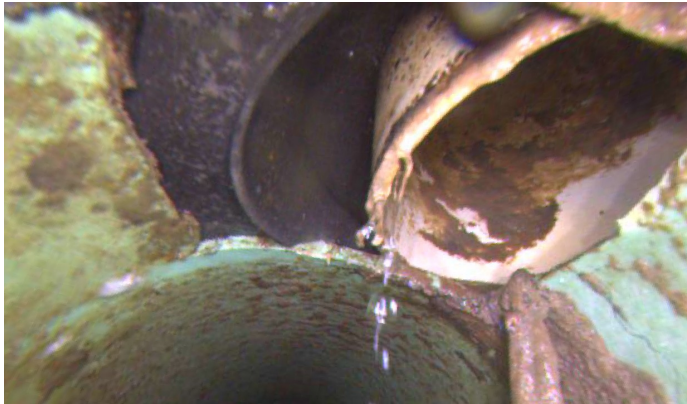
Code: **TBD**  
Description: **Tap Break-in Defective**

Distance (ft): **24.4**  
Structural Grade: **0**  
O&M Grade: **3**  
Clock Start/From: **12**  
Clock To:  
1st Value: **4.000**  
2nd Value:  
Value Percent:  
Continuous Index:  
Within 8" of Joint:  
Remarks: **offset from connection**

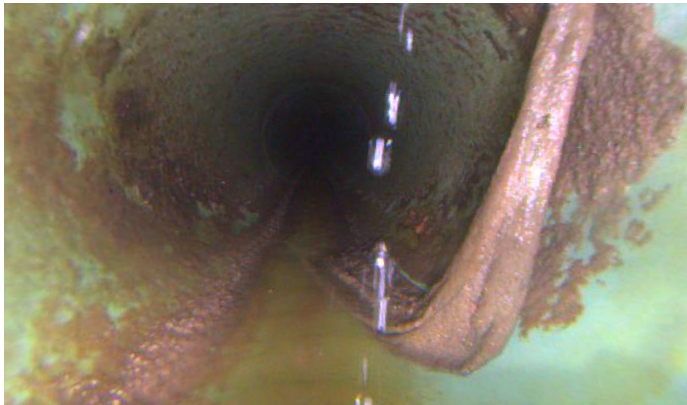
Code: **DAR**  
Description: **Deposits Attached Ragging**

Distance (ft): **24.4**  
Structural Grade: **0**  
O&M Grade: **2**  
Clock Start/From: **1**  
Clock To:  
1st Value:  
2nd Value:  
Value Percent: **10.000**  
Continuous Index:  
Within 8" of Joint: **NO**  
Remarks:

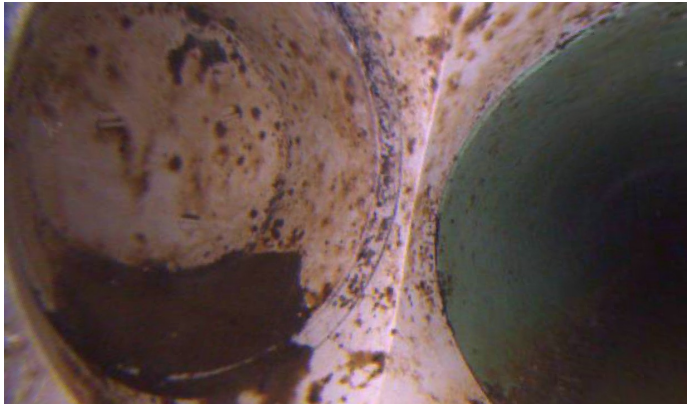
Code: **TFC**  
Description: **Tap Factory Capped**

Distance (ft): **39.4**  
Structural Grade: **0**  
O&M Grade: **0**  
Clock Start/From: **9**  
Clock To:  
1st Value: **4.000**  
2nd Value:  
Value Percent:  
Continuous Index:  
Within 8" of Joint:  
Remarks:

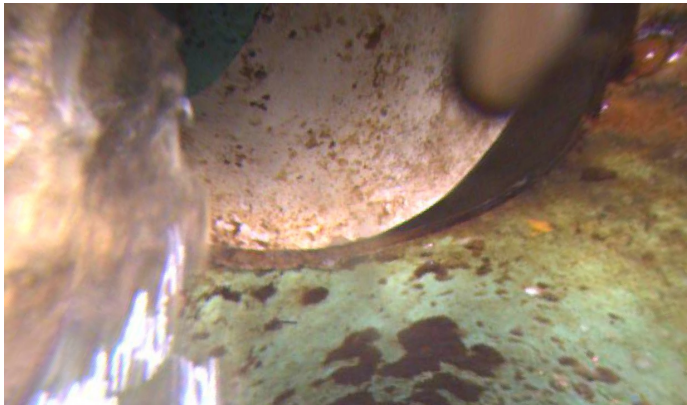
Code: **TBA**  
Description: **Tap Break-in Active**

Distance (ft): **48.9**  
Structural Grade: **0**  
O&M Grade: **0**  
Clock Start/From: **12**  
Clock To:  
1st Value: **4.000**  
2nd Value:  
Value Percent:  
Continuous Index:  
Within 8" of Joint:  
Remarks:

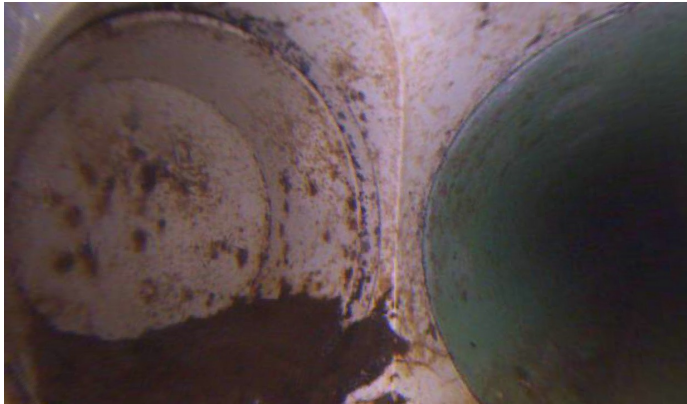
Code: **TFC**  
Description: **Tap Factory Capped**

Distance (ft): **68.7**  
Structural Grade: **0**  
O&M Grade: **0**  
Clock Start/From: **9**  
Clock To:  
1st Value: **4.000**  
2nd Value:  
Value Percent:  
Continuous Index:  
Within 8" of Joint:  
Remarks:

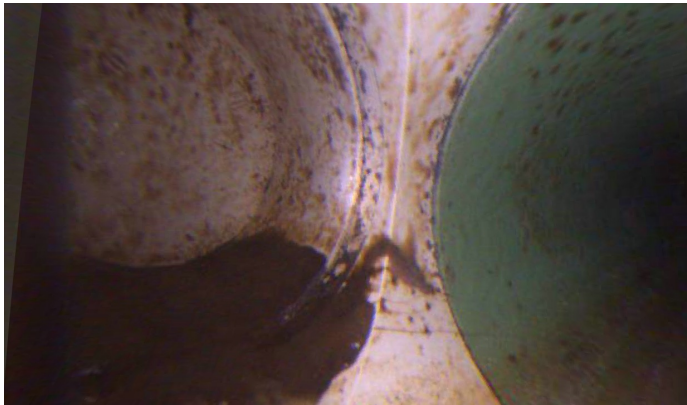
Code: **TFC**  
Description: **Tap Factory Capped**

Distance (ft): **104.5**  
Structural Grade: **0**  
O&M Grade: **0**  
Clock Start/From: **9**  
Clock To:  
1st Value: **4.000**  
2nd Value:  
Value Percent:  
Continuous Index:  
Within 8" of Joint:  
Remarks:

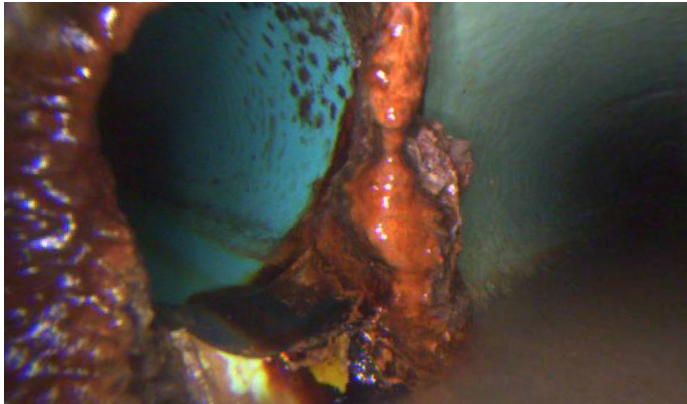
Code:	<b>TBD</b>
Description:	<b>Tap Break-in Defective</b>
Distance (ft):	<b>117.6</b>
Structural Grade:	<b>0</b>
O&M Grade:	<b>3</b>
Clock Start/From:	<b>9</b>
Clock To:	
1st Value:	<b>4.000</b>
2nd Value:	
Value Percent:	
Continuous Index:	
Within 8" of Joint:	
Remarks:	<b>dae</b>

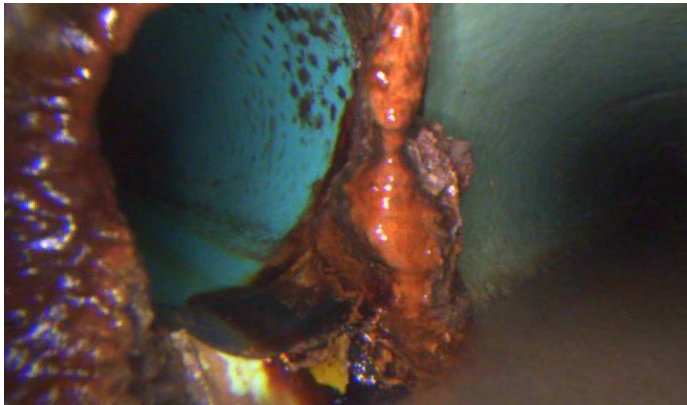
Code:	<b>DAE</b>
Description:	<b>Deposits Attached Encrustation</b>
Distance (ft):	<b>117.6</b>
Structural Grade:	<b>0</b>
O&M Grade:	<b>2</b>
Clock Start/From:	<b>8</b>
Clock To:	<b>10</b>
1st Value:	
2nd Value:	
Value Percent:	<b>5.000</b>
Continuous Index:	
Within 8" of Joint:	<b>NO</b>
Remarks:

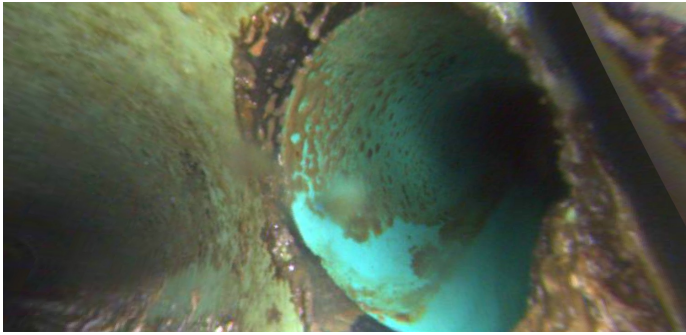
Code: **TB**  
Description: **Tap Break-in**

Distance (ft): **135.2**  
Structural Grade: **0**  
O&M Grade: **0**  
Clock Start/From: **10**  
Clock To:  
1st Value: **4.000**  
2nd Value:  
Value Percent:  
Continuous Index:  
Within 8" of Joint:  
Remarks:

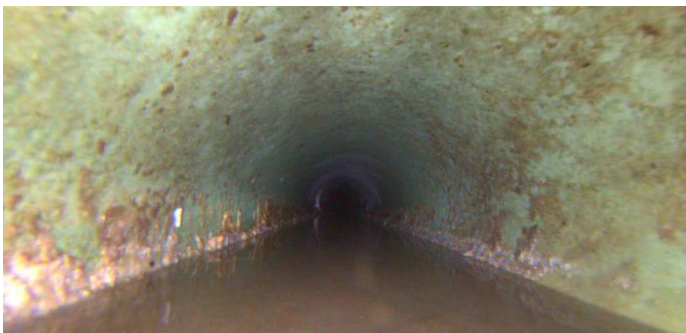
Code: **MWL**  
Description: **Water Level**

Distance (ft): **135.2**  
Structural Grade: **0**  
O&M Grade: **0**  
Clock Start/From:  
Clock To:  
1st Value:  
2nd Value:  
Value Percent: **30.000**  
Continuous Index:  
Within 8" of Joint: **NO**  
Remarks:

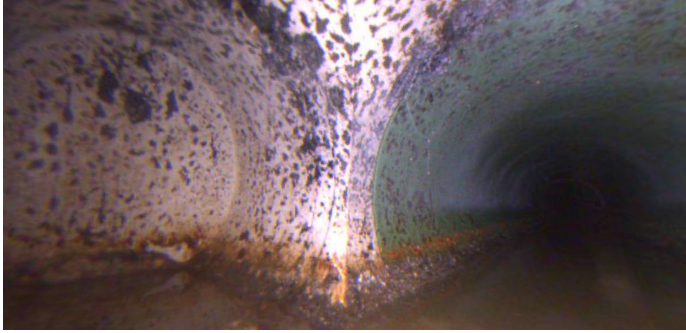
Code: **TFC**  
Description: **Tap Factory Capped**

Distance (ft): **138.8**  
Structural Grade: **0**  
O&M Grade: **0**  
Clock Start/From: **9**  
Clock To:  
1st Value: **4.000**  
2nd Value:  
Value Percent:  
Continuous Index:  
Within 8" of Joint:  
Remarks:

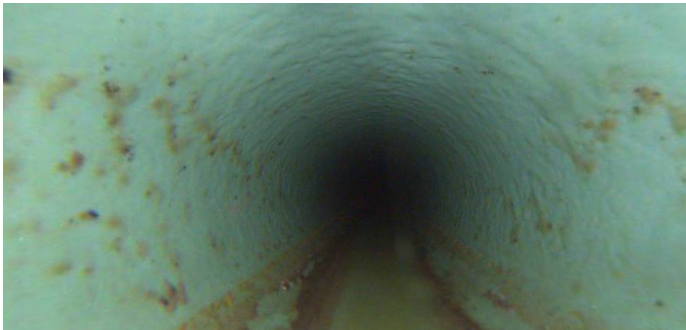
Code: **MWL**  
Description: **Water Level**

Distance (ft): **147.7**  
Structural Grade: **0**  
O&M Grade: **0**  
Clock Start/From:  
Clock To:  
1st Value:  
2nd Value:  
Value Percent: **5.000**  
Continuous Index:  
Within 8" of Joint: **NO**  
Remarks:

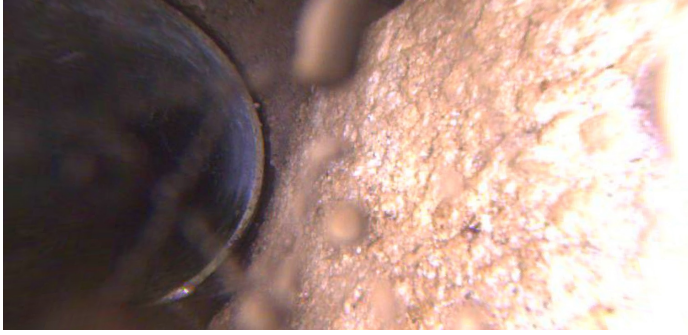
Code:	AMH
Description:	Manhole
Distance (ft):	247.8
Structural Grade:	0
O&M Grade:	0
Clock Start/From:	
Clock To:	
1st Value:	
2nd Value:	
Value Percent:	
Continuous Index:	
Within 8" of Joint:	NO
Remarks:	M-507-070
