## Profile/Photo Observation Report

Street:	<b>FOXCROFT STREET</b>	Flow Control:	<b>Not Controlled</b>
City:	<b>Hobart, IN</b>	Year Renewed:	
Location:	<b>Yard</b>	Tape/Media #:	
Purpose:	<b>Routine Assessment</b>	Dia/Height:	<b>8"</b>
Use:	<b>Sanitary</b>	Material:	<b>PVC</b>
Drain Area:	<b>NA</b>	Lining:	
Category:	<b>NA</b>		
Comment:

Location Details:		Direction of Survey:	<b>Upstream</b>
US MH:	<b>M-507-071</b>	DS MH:	<b>M-507-072</b>
		Total Length Surveyed (ft):	<b>157.5</b>

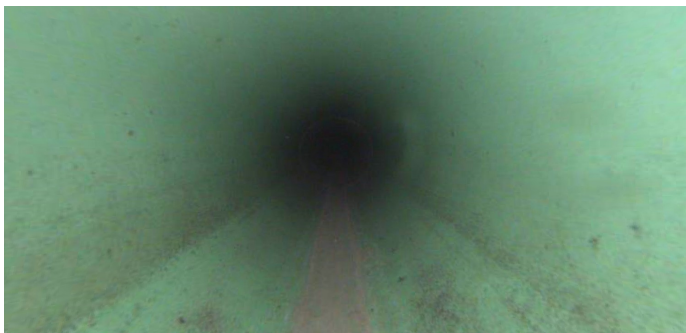
Code: **AMH**  
Description: **Manhole**

Distance (ft): **.0**  
Structural Grade: **0**  
O&M Grade: **0**  
Clock Start/From:  
Clock To:  
1st Value:  
2nd Value:  
Value Percent:  
Continuous Index:  
Within 8" of Joint: **NO**  
Remarks: **M-507-072**

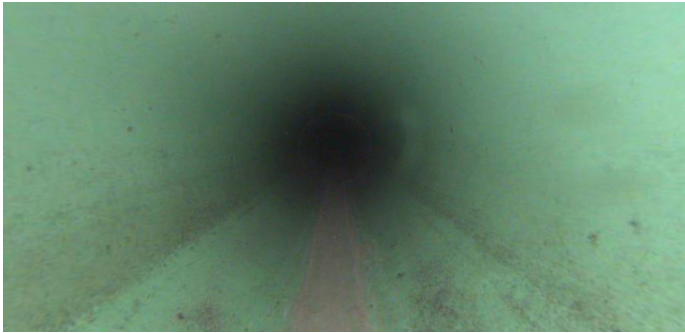
Code:	<b>MWL</b>
Description:	<b>Water Level</b>

Distance (ft):	<b>.0</b>
Structural Grade:	<b>0</b>
O&M Grade:	<b>0</b>
Clock Start/From:	
Clock To:	
1st Value:	
2nd Value:	
Value Percent:	<b>5.000</b>
Continuous Index:	
Within 8" of Joint:	<b>NO</b>
Remarks:

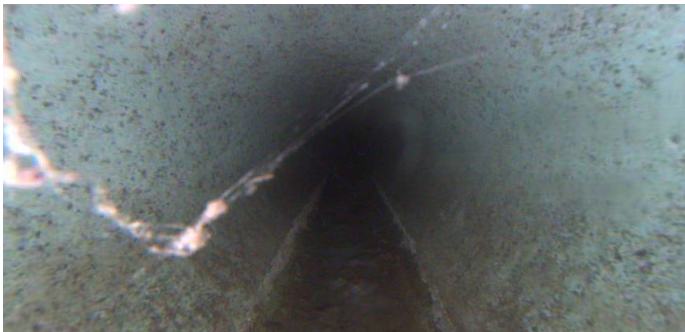
Code:	<b>DSF</b>
Description:	<b>Deposits Settled Fine</b>

Distance (ft):	<b>22.3</b>
Structural Grade:	<b>0</b>
O&M Grade:	<b>2</b>
Clock Start/From:	<b>6</b>
Clock To:	
1st Value:	
2nd Value:	
Value Percent:	<b>5.000</b>
Continuous Index:	<b>S01</b>
Within 8" of Joint:	<b>NO</b>
Remarks:

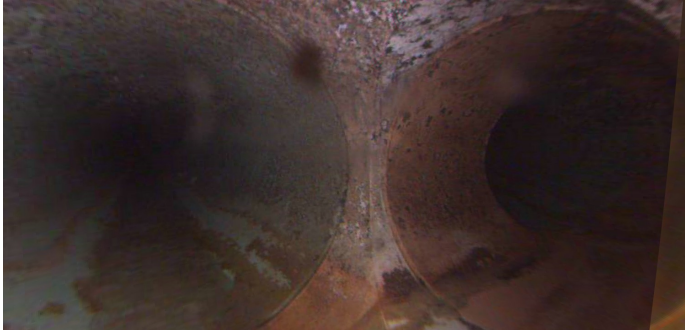
Code: **TFA**  
Description: **Tap Factory Active**

Distance (ft): **29.5**  
Structural Grade: **0**  
O&M Grade: **0**  
Clock Start/From: **3**  
Clock To:  
1st Value: **4.000**  
2nd Value:  
Value Percent:  
Continuous Index:  
Within 8" of Joint:  
Remarks:

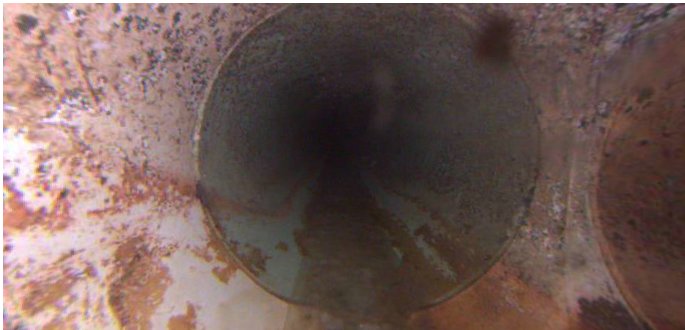
Code: **DSF**  
Description: **Deposits Settled Fine**

Distance (ft): **29.5**  
Structural Grade: **0**  
O&M Grade: **2**  
Clock Start/From: **6**  
Clock To:  
1st Value:  
2nd Value:  
Value Percent: **5.000**  
Continuous Index: **F01**  
Within 8" of Joint: **NO**  
Remarks:

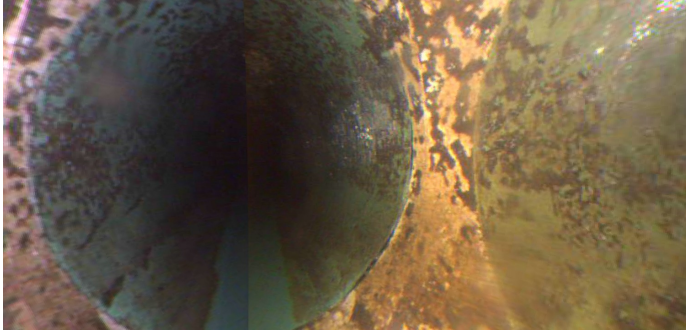
Code: **TF**  
Description: **Tap Factory**

Distance (ft): **65.9**  
Structural Grade: **0**  
O&M Grade: **0**  
Clock Start/From: **3**  
Clock To:  
1st Value: **4.000**  
2nd Value:  
Value Percent:  
Continuous Index:  
Within 8" of Joint:  
Remarks:

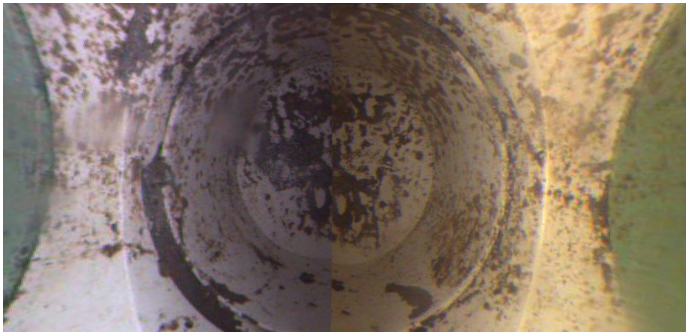
Code: **TFC**  
Description: **Tap Factory Capped**

Distance (ft): **94.5**  
Structural Grade: **0**  
O&M Grade: **0**  
Clock Start/From: **3**  
Clock To:  
1st Value: **4.000**  
2nd Value:  
Value Percent:  
Continuous Index:  
Within 8" of Joint:  
Remarks:

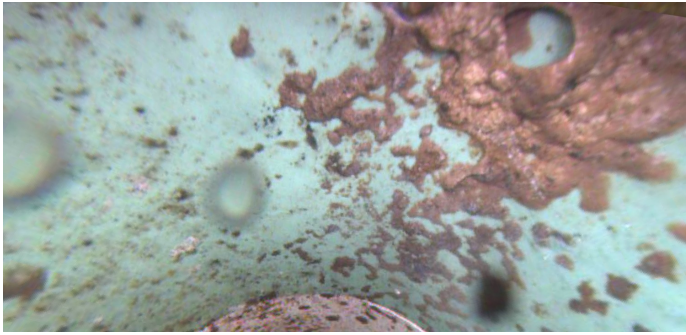
Code: **DAGS**  
Description: **Deposits Attached Grease**

Distance (ft): **128.7**  
Structural Grade: **0**  
O&M Grade: **2**  
Clock Start/From: **12**  
Clock To: **1**  
1st Value:  
2nd Value:  
Value Percent: **5.000**  
Continuous Index:  
Within 8" of Joint: **NO**  
Remarks:

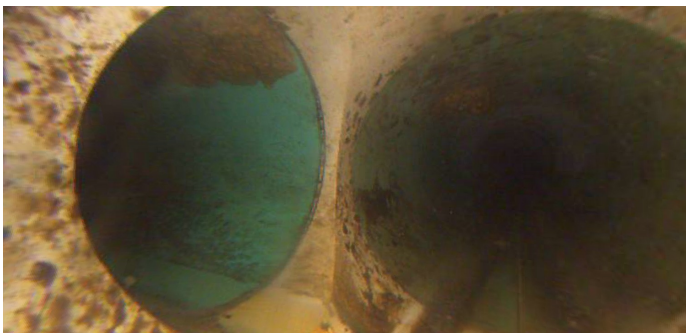
Code: **TF**  
Description: **Tap Factory**

Distance (ft): **130.0**  
Structural Grade: **0**  
O&M Grade: **0**  
Clock Start/From: **3**  
Clock To:  
1st Value: **4.000**  
2nd Value:  
Value Percent:  
Continuous Index:  
Within 8" of Joint:  
Remarks:

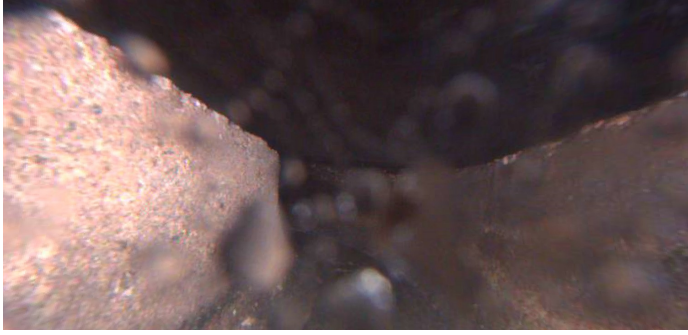
Code:	AMH
Description:	Manhole
Distance (ft):	157.5
Structural Grade:	0
O&M Grade:	0
Clock Start/From:	
Clock To:	
1st Value:	
2nd Value:	
Value Percent:	
Continuous Index:	
Within 8" of Joint:	NO
Remarks:	M-507-071
