Profile/Photo Observation Report

Date:	04/02/2018	Weather:		Coding:	PACP 6.0
Pipe Length (ft):	184.0	Owner:	NA	Pre Clean:	No Pre-Cleaning
P.O.#:		Surveyor:	Jen Costello	PSR:	P-507-072-073
Customer:		Clean Date:	01/01/1900	Shape:	C

Street:	FOXCROFT STREET	Flow Control:	Not Controlled
City:	Hobart, IN	Year Renewed:	
Location:	Yard	Tape/Media #:	
Purpose:	Routine Assessment	Dia/Height:	8"
Use:	Sanitary	Material:	PVC
Drain Area:	NA	Lining:	
Category:	NA		
Comment:	False P_C, MH_F.

Location Details:		Direction of Survey:	Upstream
US MH:	M-507-072	DS MH:	M-507-073
		Total Length Surveyed (ft):	180.3

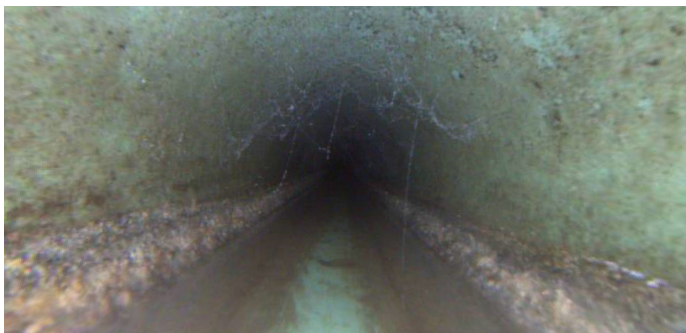
Code: **AMH**
Description: **Manhole**

Distance (ft): **.0**
Structural Grade: **0**
O&M Grade: **0**
Clock Start/From:
Clock To:
1st Value:
2nd Value:
Value Percent:
Continuous Index:
Within 8" of Joint: **NO**
Remarks: **M-507-073**

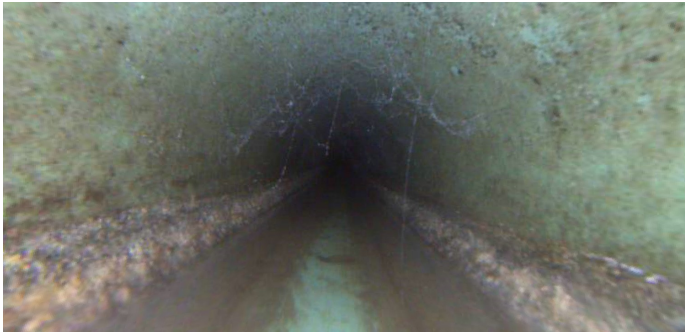
Code: **MWL**
Description: **Water Level**

Distance (ft): **.0**
Structural Grade: **0**
O&M Grade: **0**
Clock Start/From:
Clock To:
1st Value:
2nd Value:
Value Percent: **5.000**
Continuous Index:
Within 8" of Joint: **NO**
Remarks:

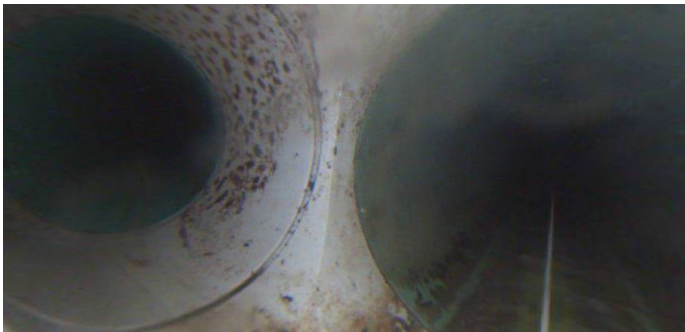
Code: **TF**
Description: **Tap Factory**

Distance (ft): **15.9**
Structural Grade: **0**
O&M Grade: **0**
Clock Start/From: **3**
Clock To:
1st Value: **4.000**
2nd Value:
Value Percent:
Continuous Index:
Within 8" of Joint:
Remarks:

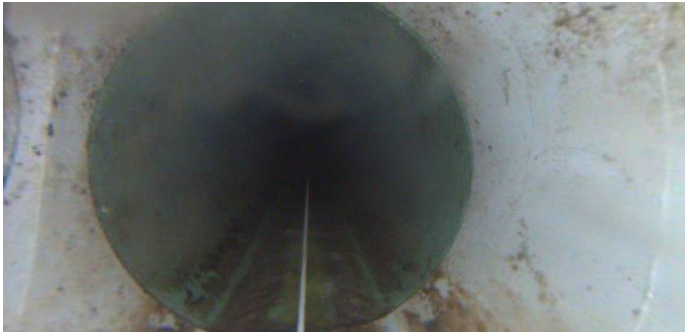
Code: **MGO**
Description: **General Observation**

Distance (ft): **15.9**
Structural Grade: **0**
O&M Grade: **0**
Clock Start/From:
Clock To:
1st Value:
2nd Value:
Value Percent:
Continuous Index:
Within 8" of Joint: **NO**
Remarks: **rear camera**

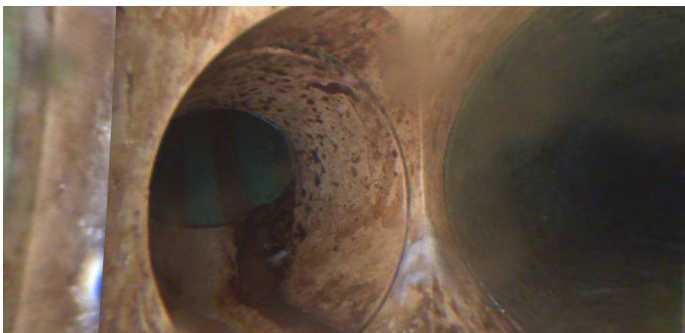
Code: **TFA**
Description: **Tap Factory Active**

Distance (ft): **47.3**
Structural Grade: **0**
O&M Grade: **0**
Clock Start/From: **3**
Clock To:
1st Value: **4.000**
2nd Value:
Value Percent:
Continuous Index:
Within 8" of Joint:
Remarks:

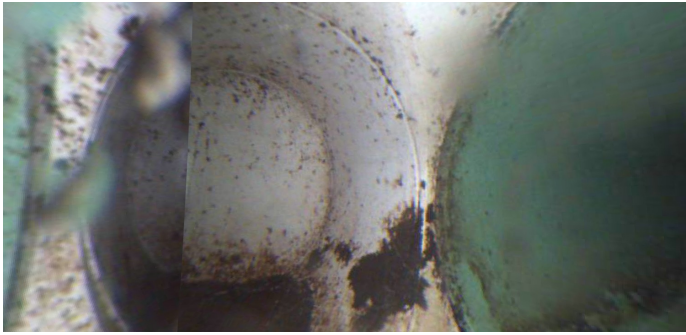
Code: **TFC**
Description: **Tap Factory Capped**

Distance (ft): **85.9**
Structural Grade: **0**
O&M Grade: **0**
Clock Start/From: **3**
Clock To:
1st Value: **4.000**
2nd Value:
Value Percent:
Continuous Index:
Within 8" of Joint:
Remarks:

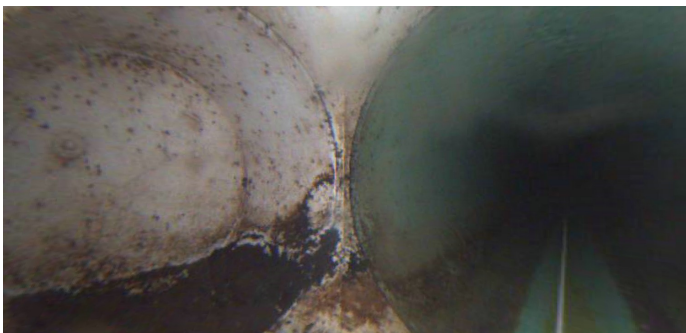
Code: **TFC**
Description: **Tap Factory Capped**

Distance (ft): **112.1**
Structural Grade: **0**
O&M Grade: **0**
Clock Start/From: **3**
Clock To:
1st Value: **4.000**
2nd Value:
Value Percent:
Continuous Index:
Within 8" of Joint:
Remarks:

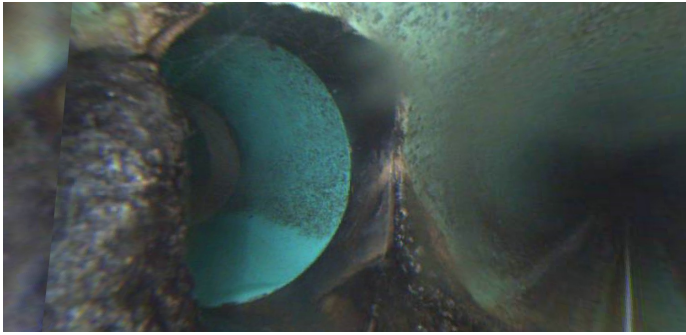
Code: **TBD**
Description: **Tap Break-in Defective**

Distance (ft): **136.7**
Structural Grade: **0**
O&M Grade: **3**
Clock Start/From: **3**
Clock To:
1st Value: **4.000**
2nd Value:
Value Percent:
Continuous Index:
Within 8" of Joint:
Remarks: **dae**

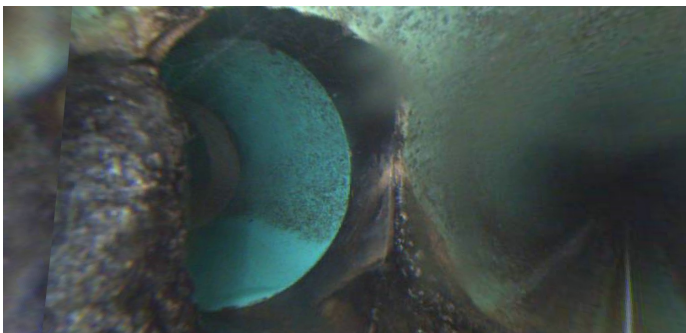
Code: **DAE**
Description: **Deposits Attached Encrustation**

Distance (ft): **136.7**
Structural Grade: **0**
O&M Grade: **2**
Clock Start/From: **2**
Clock To: **4**
1st Value:
2nd Value:
Value Percent: **10.000**
Continuous Index:
Within 8" of Joint: **NO**
Remarks:

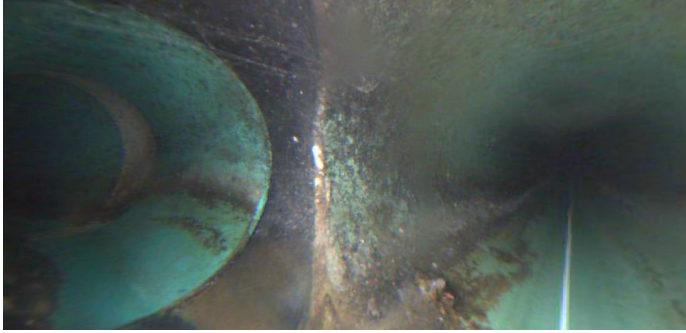
Code: **TB**
Description: **Tap Break-in**

Distance (ft): **143.4**
Structural Grade: **0**
O&M Grade: **0**
Clock Start/From: **3**
Clock To:
1st Value: **4.000**
2nd Value:
Value Percent:
Continuous Index:
Within 8" of Joint: **NO**
Remarks:

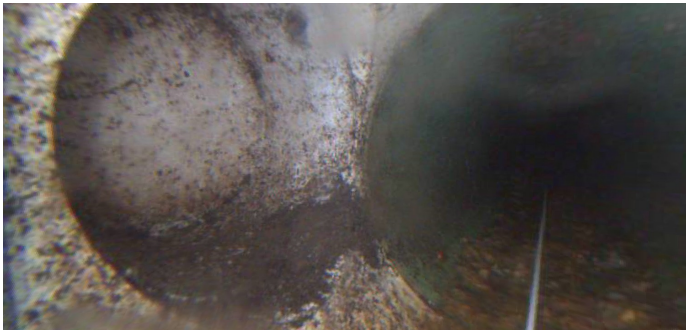
Code: **TFC**
Description: **Tap Factory Capped**

Distance (ft): **147.2**
Structural Grade: **0**
O&M Grade: **0**
Clock Start/From: **3**
Clock To:
1st Value: **4.000**
2nd Value:
Value Percent:
Continuous Index:
Within 8" of Joint:
Remarks:

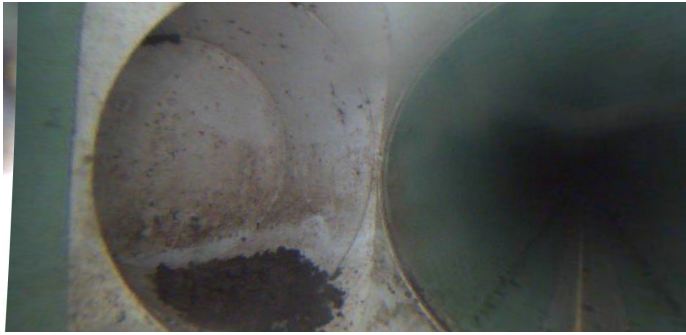
Code: **TFC**
Description: **Tap Factory Capped**

Distance (ft): **174.5**
Structural Grade: **0**
O&M Grade: **0**
Clock Start/From: **3**
Clock To:
1st Value: **4.000**
2nd Value:
Value Percent:
Continuous Index:
Within 8" of Joint:
Remarks:

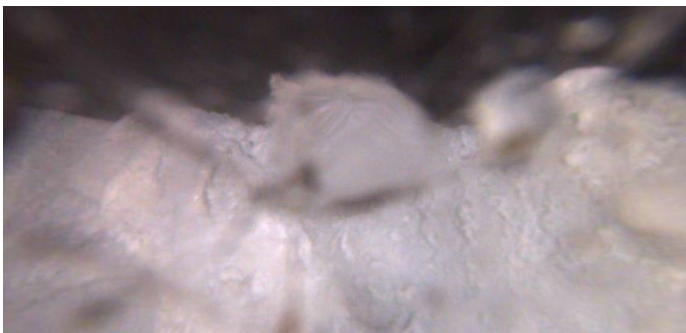
Code: **AMH**
Description: **Manhole**

Distance (ft): **180.3**
Structural Grade: **0**
O&M Grade: **0**
Clock Start/From:
Clock To:
1st Value:
2nd Value:
Value Percent:
Continuous Index:
Within 8" of Joint: **NO**
Remarks: **M-507-072**
