## Profile/Photo Observation Report

Street:	<b>FOXCROFT STREET</b>	Flow Control:	<b>Not Controlled</b>
City:	<b>Hobart, IN</b>	Year Renewed:	
Location:	<b>Yard</b>	Tape/Media #:	
Purpose:	<b>Routine Assessment</b>	Dia/Height:	<b>8"</b>
Use:	<b>Sanitary</b>	Material:	<b>VCP</b>
Drain Area:	<b>NA</b>	Lining:	
Category:	<b>NA</b>		
Comment:

Location Details:		Direction of Survey:	<b>Downstream</b>
US MH:	<b>M-507-074</b>	DS MH:	<b>M-507-075</b>
		Total Length Surveyed (ft):	<b>15.4</b>

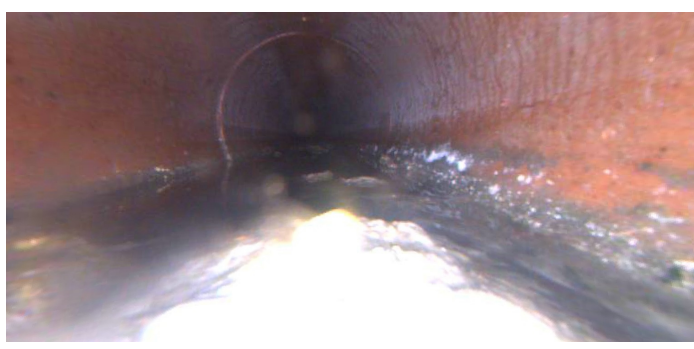
Code: **AMH**  
Description: **Manhole**

Distance (ft): **.0**  
Structural Grade: **0**  
O&M Grade: **0**  
Clock Start/From:  
Clock To:  
1st Value:  
2nd Value:  
Value Percent:  
Continuous Index:  
Within 8" of Joint: **NO**  
Remarks: **M-507-074**

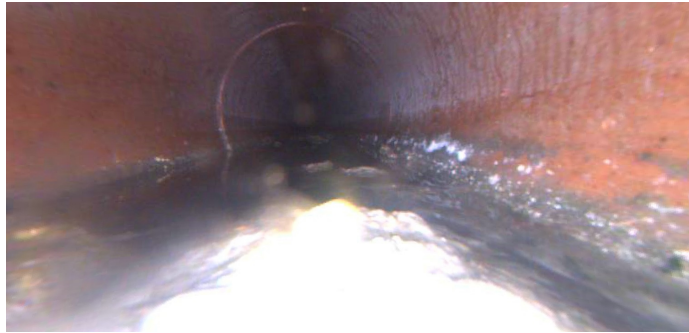
Code: **MWL**  
Description: **Water Level**

Distance (ft): **.0**  
Structural Grade: **0**  
O&M Grade: **0**  
Clock Start/From:  
Clock To:  
1st Value:  
2nd Value:  
Value Percent: **20.000**  
Continuous Index:  
Within 8" of Joint: **NO**  
Remarks:

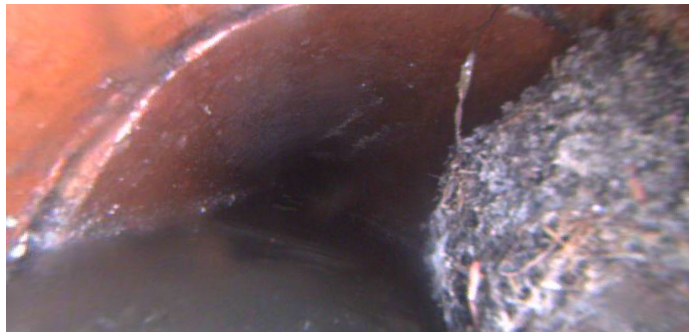
Code: **RMJ**  
Description: **Roots Medium Joint**

Distance (ft): **14.2**  
Structural Grade: **0**  
O&M Grade: **3**  
Clock Start/From: **12**  
Clock To: **4**  
1st Value:  
2nd Value:  
Value Percent: **40.000**  
Continuous Index:  
Within 8" of Joint: **YES**  
Remarks:

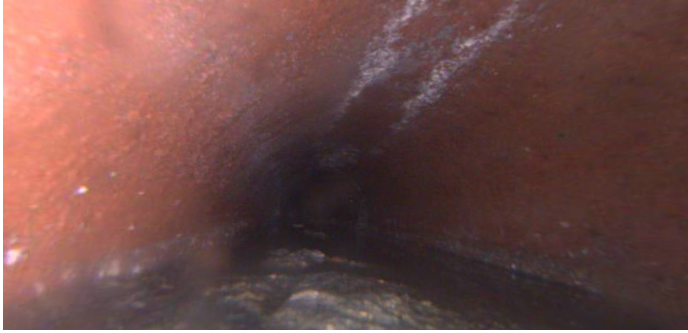
Code:	<b>MSA</b>
Description:	<b>Abandoned Survey</b>
Distance (ft):	<b>15.4</b>
Structural Grade:	<b>0</b>
O&M Grade:	<b>0</b>
Clock Start/From:	
Clock To:	
1st Value:	
2nd Value:	
Value Percent:	
Continuous Index:	
Within 8" of Joint:	<b>NO</b>
Remarks:	<b>ROOTS</b>
