Profile/Ph	oto Observation	Report			RedZone R 0 B 0 T I C S
Date: Pipe Length (ft P.O.#: Customer:	04/12/2018): 40.2	Weather: Owner: Surveyor: Clean Date:	NA Jen Costello 01/01/1900	Coding: Pre Clea PSR: Shape:	
Street:	FOXCROFT STREET		Flow Control:		trolled
City:	Hobart, IN		Year Renewed:		
Location:	Yard		Tape/Media #:		
Purpose:	Routine Assessment	t	Dia/Height:	12"	
Use:	Sanitary		Material:	VCP	
Drain Area:	NA		Lining:		
Category:	NA				
Comment:					
Location Detai	ls:		Direction of Surv	vey: Downst	ream
US MH:	M-507-074	DS MH:	M-507-085	Total Length Surve	yed (ft): 12.0
D&M Index:	2.00	O&M Quick:	210	00 O&M Ratin	ıg: 2.00
Structural Index:	0.00		iick: 000	00 Structural F	Rating: 0.00
Overall Index:	2.00	Overall Quick		00 Overall Rat	ing: 2.00

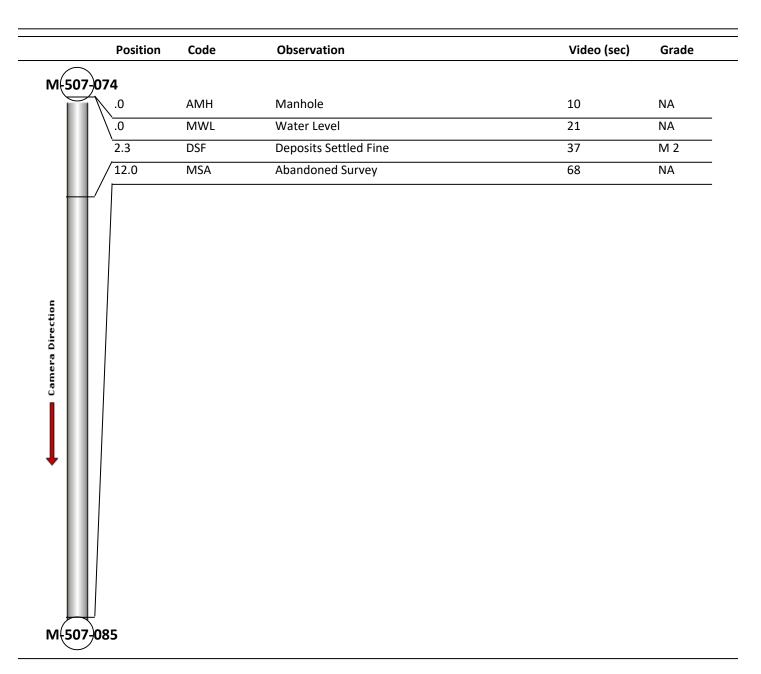
Code: Description:	AMH Manhole
Distance (ft):	.0
Structural Grade:	0
O&M Grade:	0
Clock Start/From:	
Clock To:	
1st Value:	
2nd Value:	
Value Percent:	
Continuous Index:	
Within 8" of Joint:	NO
Remarks:	M-507-074

Code: MWL Description: Water Level

Distance (ft):	.0
Structural Grade:	0
O&M Grade:	0
Clock Start/From:	
Clock To:	
1st Value:	
2nd Value:	
Value Percent:	10.000
Continuous Index:	
Within 8" of Joint:	NO
Remarks:

Code:	DSF
Description:	Deposits Settled Fine

Distance (ft):	2.3
Structural Grade:	0
O&M Grade:	2
Clock Start/From:	4
Clock To:	6
1st Value:	
2nd Value:	
Value Percent:	10.000
Continuous Index:	
Within 8" of Joint:	NO
Remarks:

Code: Description: MSA Abandoned Survey

Distance (ft):	12.0	
Structural Grade:	0	
O&M Grade:	0	
Clock Start/From:		
Clock To:		
1st Value:		
2nd Value:		
Value Percent:		
Continuous Index:		
Within 8" of Joint:	NO	
Remarks:	roots
