## Profile/Photo Observation Report

Date:	12/05/2024	Weather:		Coding:	PACP 7.0
Pipe Length (ft):	40.0	Owner:	City of Hobart	Pre Clean:	Heavy Cleaning
P.O.#:	YES502259	Surveyor:	S. Bucklin	PSR:	P-507-074-085
Customer:	City of Hobart	Clean Date:	09/07/2024	Shape:	C

Street:	Colorado Street	Flow Control:	Not Controlled
City:	Hobart, IN	Year Renewed:	
Location:	Local rural streets with light traffic, t	Tape/Media #:	
Purpose:	Sewer System Evaluation Survey (SS	Dia/Height:	10"
Use:	Sanitary Sewage Pipe	Material:	VCP
Drain Area:		Lining:	None
Category:	NA		
Comment:			
Location Details:		Direction of Survey:	Downstream
US MH:	M-507-074	DS MH:	M-507-085
		Total Length Surveyed (ft):	35.6

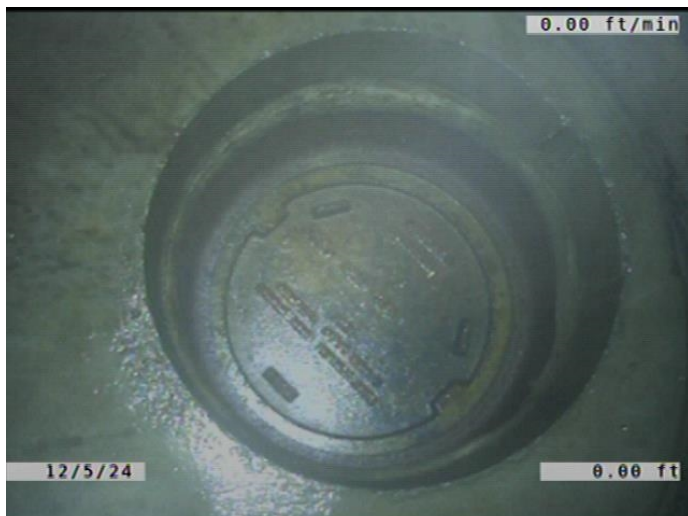
Code: **AMH**  
Description: **Manhole**

Distance (ft): **.0**  
Structural Grade: **0**  
O&M Grade: **0**  
Clock Start/From:  
Clock To:  
1st Value:  
2nd Value:  
Value Percent:  
Continuous Index:  
Within 8" of Joint: **NO**  
Remarks: **M-507-074**

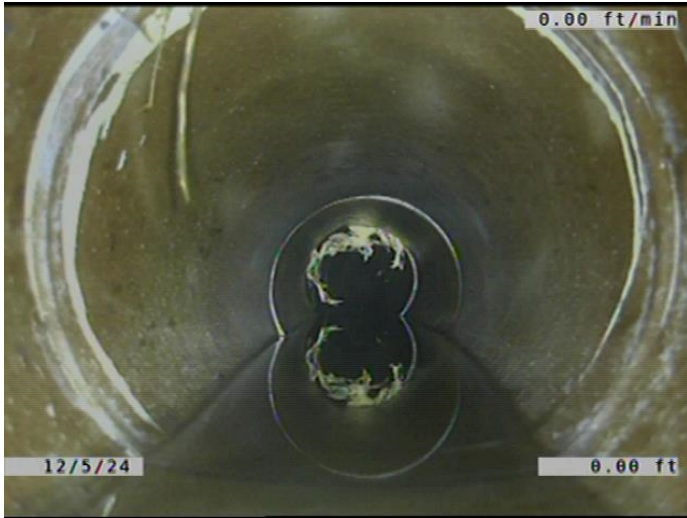
Code: **MWL**  
Description: **Miscellaneous Water Level**

Distance (ft): **.0**  
Structural Grade: **0**  
O&M Grade: **0**  
Clock Start/From:  
Clock To:  
1st Value:  
2nd Value:  
Value Percent: **5.000**  
Continuous Index:  
Within 8" of Joint: **NO**  
Remarks:

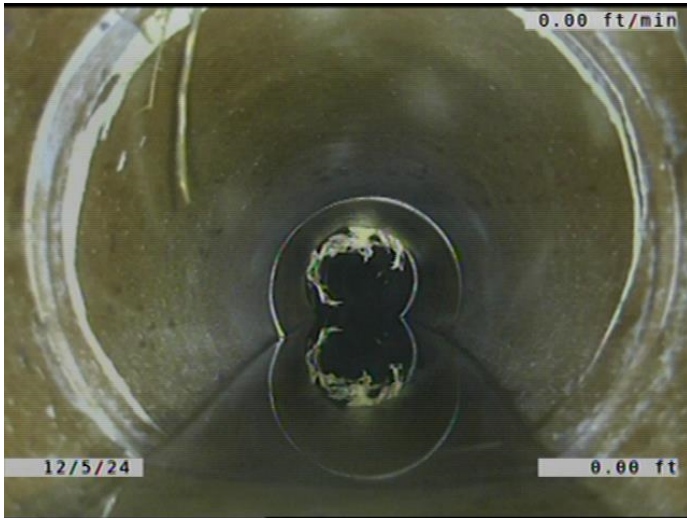
Code: **MWLS**  
Description: **Miscellaneous Water Level Sag**

Distance (ft): **.0**  
Structural Grade: **2**  
O&M Grade: **0**  
Clock Start/From:  
Clock To:  
1st Value:  
2nd Value:  
Value Percent: **15.000**  
Continuous Index: **S01**  
Within 8" of Joint: **NO**  
Remarks:

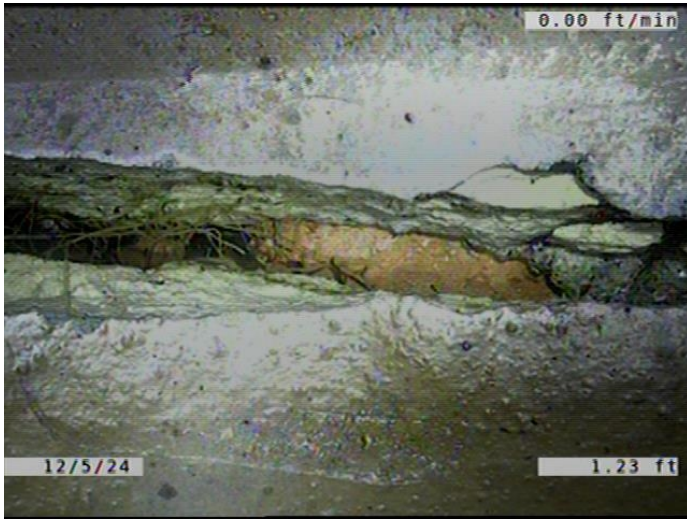
Code: **B**  
Description: **Broken**

Distance (ft): **1.2**  
Structural Grade: **4**  
O&M Grade: **0**  
Clock Start/From: **12**  
Clock To: **12**  
1st Value:  
2nd Value:  
Value Percent:  
Continuous Index:  
Within 8" of Joint: **YES**  
Remarks:

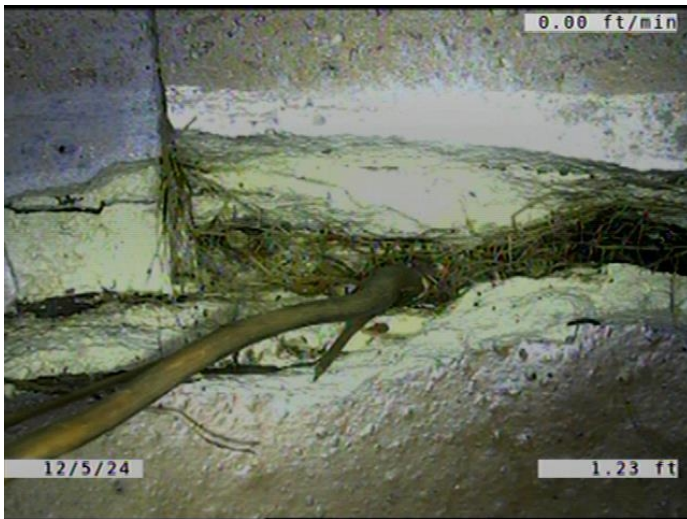
Code: **RFB**  
Description: **Roots Fine Barrel**

Distance (ft): **1.2**  
Structural Grade: **0**  
O&M Grade: **2**  
Clock Start/From: **8**  
Clock To: **4**  
1st Value:  
2nd Value:  
Value Percent:  
Continuous Index:  
Within 8" of Joint: **NO**  
Remarks:

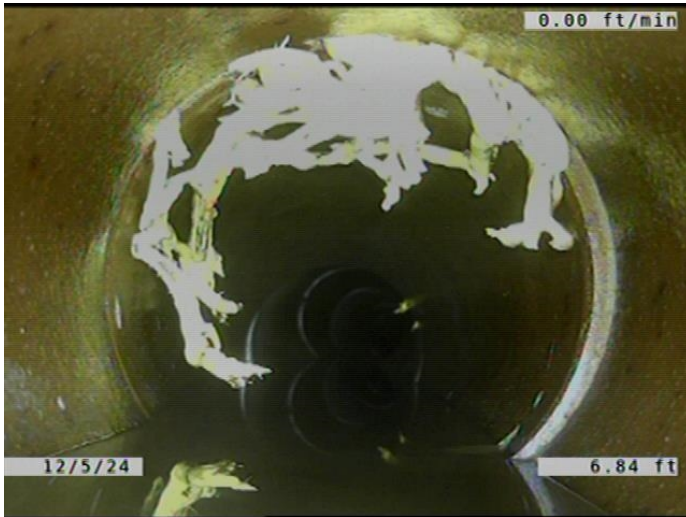
Code: **RTJ**  
Description: **Roots Tap Joint**

Distance (ft): **6.8**  
Structural Grade: **0**  
O&M Grade: **2**  
Clock Start/From: **10**  
Clock To: **2**  
1st Value:  
2nd Value:  
Value Percent: **10.000**  
Continuous Index:  
Within 8" of Joint: **YES**  
Remarks:

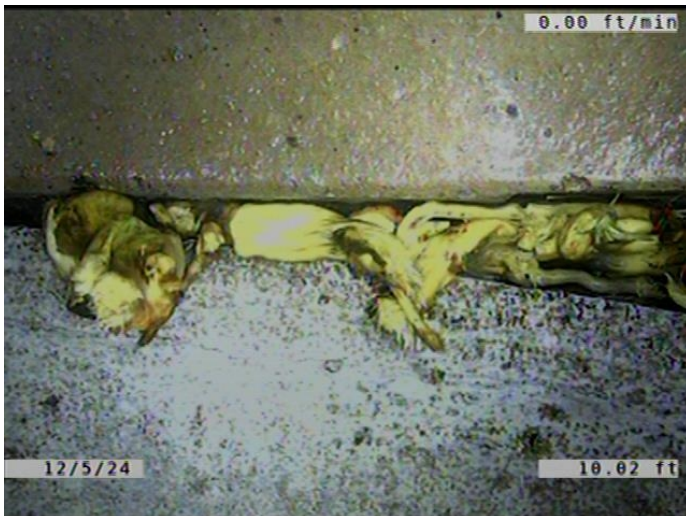
Code: **RTJ**  
Description: **Roots Tap Joint**

Distance (ft): **10.0**  
Structural Grade: **0**  
O&M Grade: **2**  
Clock Start/From: **1**  
Clock To: **3**  
1st Value:  
2nd Value:  
Value Percent: **5.000**  
Continuous Index:  
Within 8" of Joint: **YES**  
Remarks:

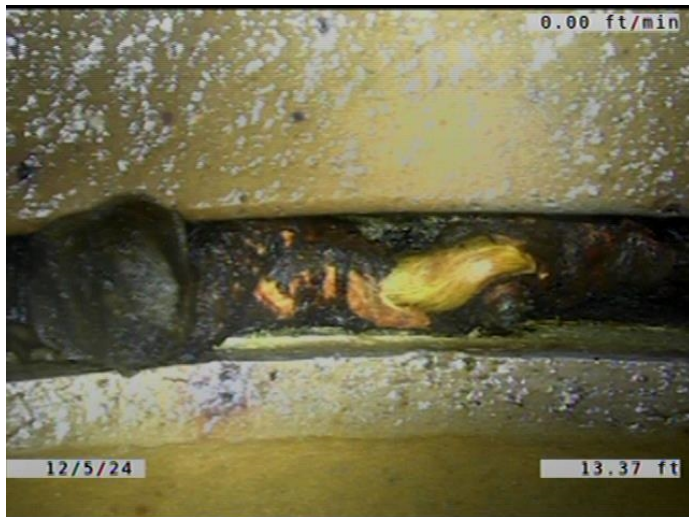
Code: **RFJ**  
Description: **Roots Fine Joint**

Distance (ft): **13.4**  
Structural Grade: **0**  
O&M Grade: **1**  
Clock Start/From: **9**  
Clock To: **2**  
1st Value:  
2nd Value:  
Value Percent:  
Continuous Index:  
Within 8" of Joint: **YES**  
Remarks:

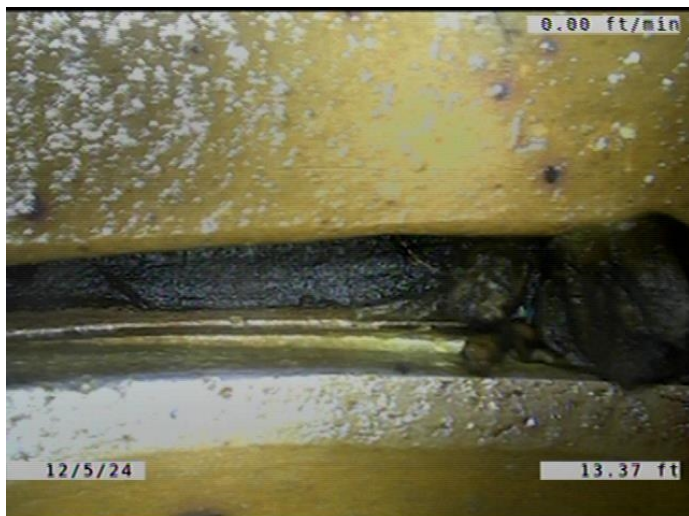
Code: **JAM**  
Description: **Joint Angular Medium**

Distance (ft): **13.4**  
Structural Grade: **3**  
O&M Grade: **0**  
Clock Start/From:  
Clock To:  
1st Value:  
2nd Value:  
Value Percent:  
Continuous Index:  
Within 8" of Joint: **NO**  
Remarks:

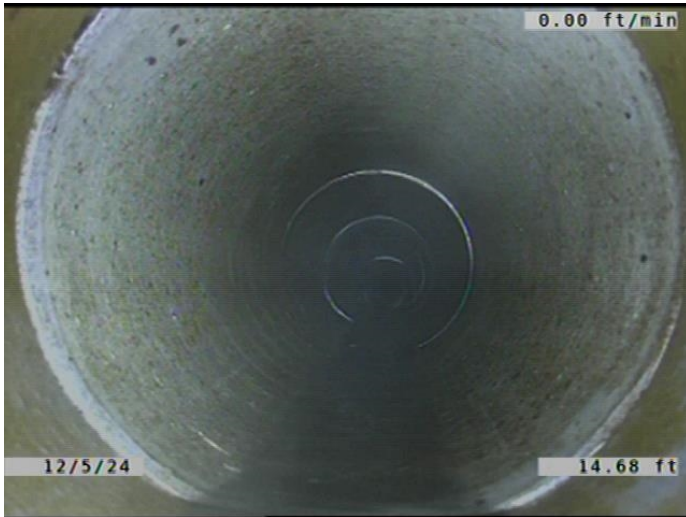
Code: **MWLS**  
Description: **Miscellaneous Water Level Sag**

Distance (ft): **14.7**  
Structural Grade: **2**  
O&M Grade: **0**  
Clock Start/From:  
Clock To:  
1st Value:  
2nd Value:  
Value Percent: **15.000**  
Continuous Index: **F01**  
Within 8" of Joint: **NO**  
Remarks:

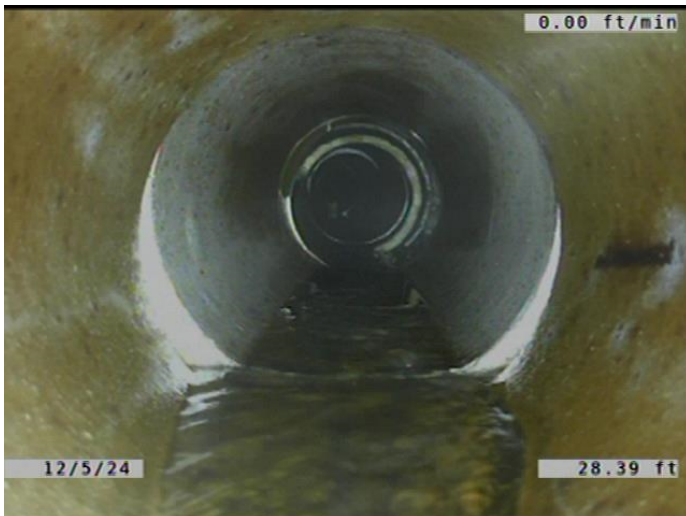
Code: **MWLS**  
Description: **Miscellaneous Water Level Sag**

Distance (ft): **28.4**  
Structural Grade: **2**  
O&M Grade: **0**  
Clock Start/From:  
Clock To:  
1st Value:  
2nd Value:  
Value Percent: **10.000**  
Continuous Index: **S02**  
Within 8" of Joint: **NO**  
Remarks:

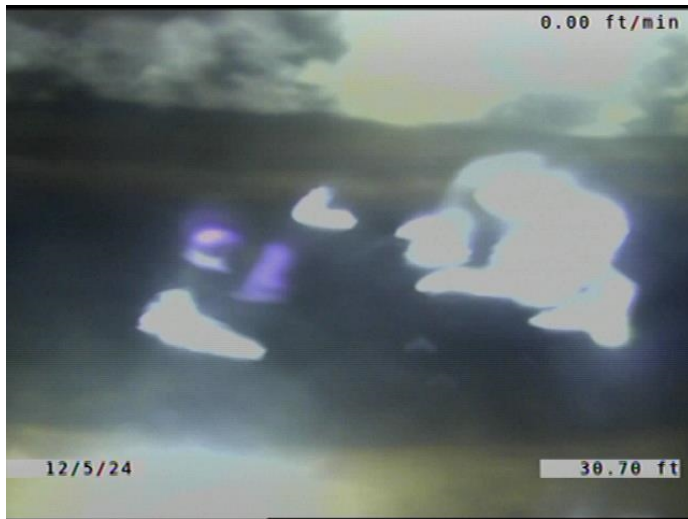
Code: **JAM**  
Description: **Joint Angular Medium**

Distance (ft): **30.7**  
Structural Grade: **3**  
O&M Grade: **0**  
Clock Start/From:  
Clock To:  
1st Value:  
2nd Value:  
Value Percent:  
Continuous Index:  
Within 8" of Joint: **NO**  
Remarks:

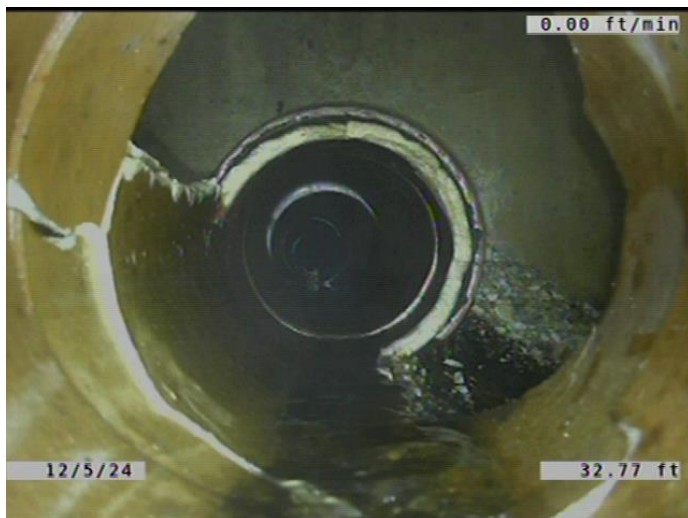
Code: **MWLS**  
Description: **Miscellaneous Water Level Sag**

Distance (ft): **32.8**  
Structural Grade: **2**  
O&M Grade: **0**  
Clock Start/From:  
Clock To:  
1st Value:  
2nd Value:  
Value Percent: **10.000**  
Continuous Index: **F02**  
Within 8" of Joint: **NO**  
Remarks:

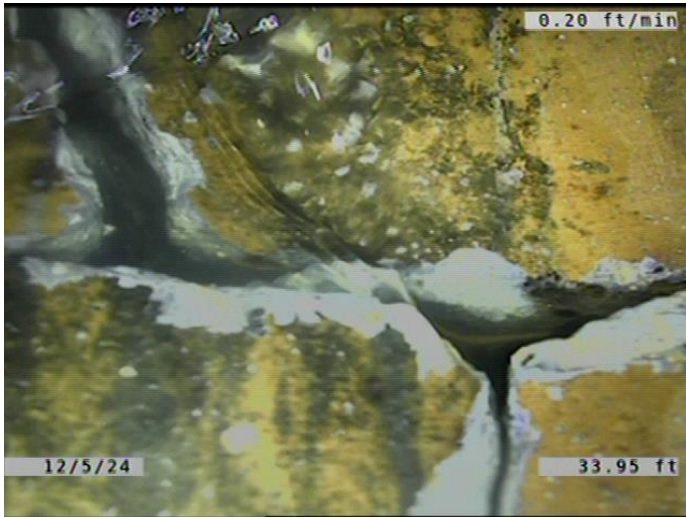
Code: **B**  
 Description: **Broken**

Distance (ft): **33.9**  
 Structural Grade: **4**  
 O&M Grade: **0**  
 Clock Start/From: **12**  
 Clock To: **12**  
 1st Value:  
 2nd Value:  
 Value Percent:  
 Continuous Index:  
 Within 8" of Joint: **YES**  
 Remarks:

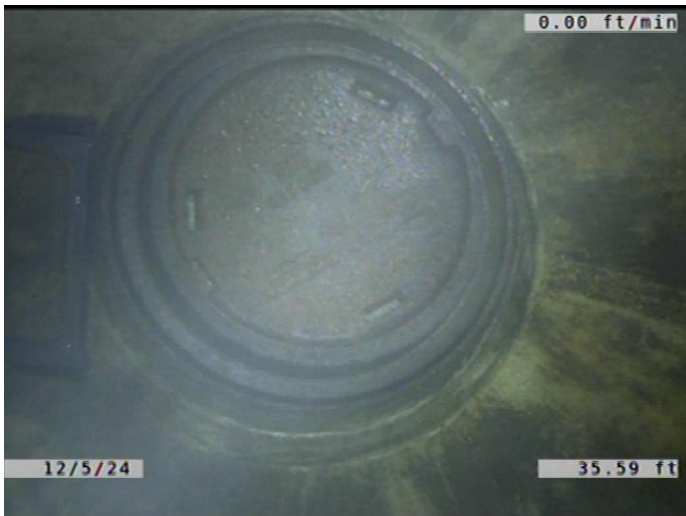
Code: **AMH**  
 Description: **Manhole**

Distance (ft): **35.6**  
 Structural Grade: **0**  
 O&M Grade: **0**  
 Clock Start/From:  
 Clock To:  
 1st Value:  
 2nd Value:  
 Value Percent:  
 Continuous Index:  
 Within 8" of Joint: **NO**  
 Remarks: **M-507-085**
