Profile/Photo Observation Report

Street:	S VIRGINIA ST	Flow Control:	Not Controlled
City:	Hobart, IN	Year Renewed:	
Location:	Light Highway	Tape/Media #:	
Purpose:	Routine Assessment	Dia/Height:	8"
Use:	Sanitary	Material:	PVC
Drain Area:	NA	Lining:	
Category:	NA		
Comment:			
Location Details:		Direction of Survey:	Downstream
US MH:	M-507-081	DS MH:	M-507-050
		Total Length Surveyed (ft):	56.9

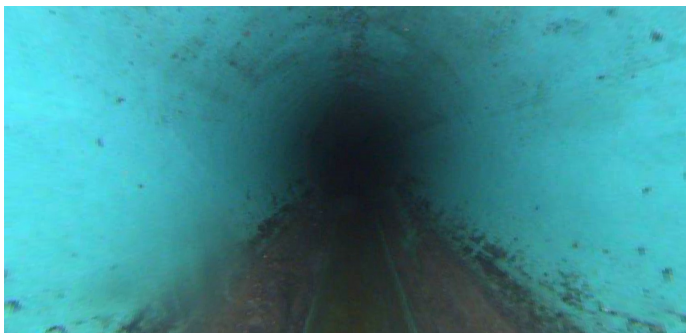
Code: **AMH**
Description: **Manhole**

Distance (ft): **.0**
Structural Grade: **0**
O&M Grade: **0**
Clock Start/From:
Clock To:
1st Value:
2nd Value:
Value Percent:
Continuous Index:
Within 8" of Joint: **NO**
Remarks: **M-507-081**

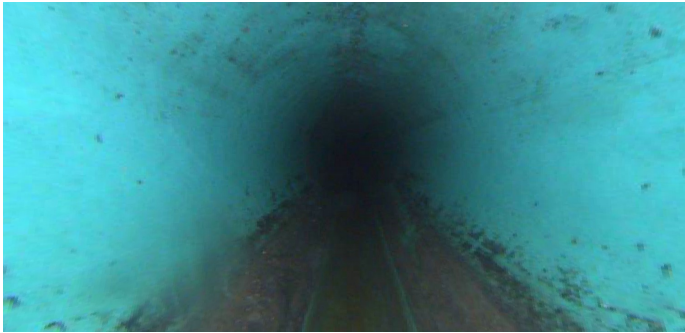
Code:	MWL
Description:	Water Level

Distance (ft):	.0
Structural Grade:	0
O&M Grade:	0
Clock Start/From:	
Clock To:	
1st Value:	
2nd Value:	
Value Percent:	5.000
Continuous Index:	
Within 8" of Joint:	NO
Remarks:

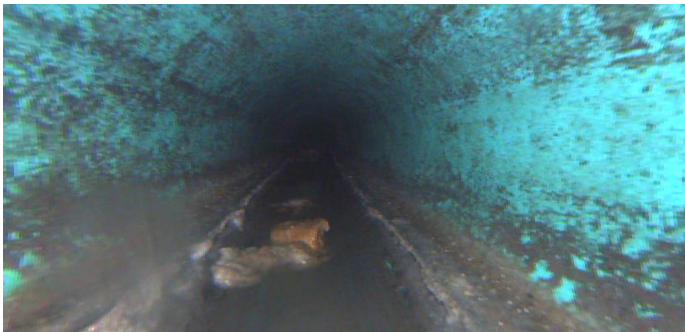
Code:	DSZ
Description:	Deposits Settled Other

Distance (ft):	38.3
Structural Grade:	0
O&M Grade:	2
Clock Start/From:	6
Clock To:	
1st Value:	
2nd Value:	
Value Percent:	5.000
Continuous Index:	S01
Within 8" of Joint:	NO
Remarks:	debris/tissue

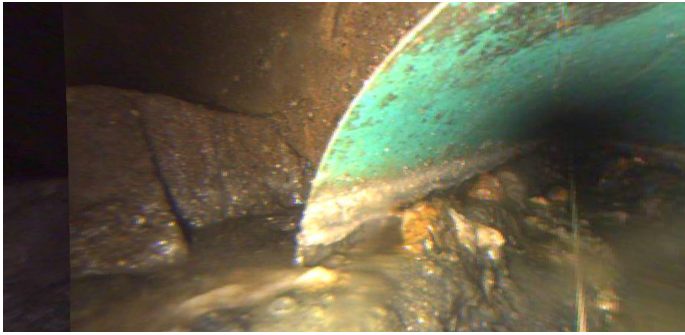
Code: **DSZ**
Description: **Deposits Settled Other**

Distance (ft): **54.9**
Structural Grade: **0**
O&M Grade: **2**
Clock Start/From: **6**
Clock To:
1st Value:
2nd Value:
Value Percent: **5.000**
Continuous Index: **F01**
Within 8" of Joint: **NO**
Remarks: **debris/tissue**

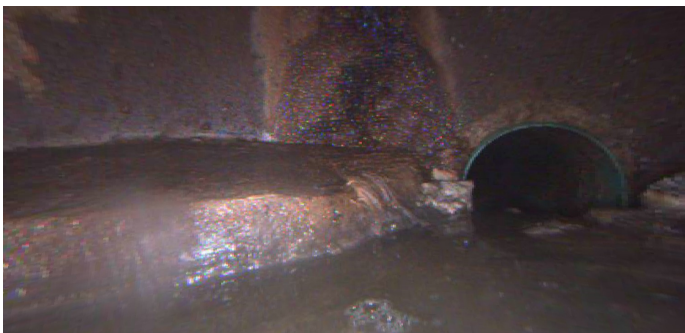
Code: **AMH**
Description: **Manhole**

Distance (ft): **56.9**
Structural Grade: **0**
O&M Grade: **0**
Clock Start/From:
Clock To:
1st Value:
2nd Value:
Value Percent:
Continuous Index:
Within 8" of Joint: **NO**
Remarks: **M-507-050**
