Profile/Photo Observation Report

Street:	S VIRGINIA ST	Flow Control:	Not Controlled
City:	Hobart, IN	Year Renewed:	
Location:	Light Highway	Tape/Media #:	
Purpose:	Routine Assessment	Dia/Height:	8"
Use:	Sanitary	Material:	PVC
Drain Area:	NA	Lining:	
Category:	NA		
Comment:	P_C at 4 ft debris		
Location Details:		Direction of Survey:	Upstream
US MH:	M-507-081	DS MH:	M-507-050
		Total Length Surveyed (ft):	6.0

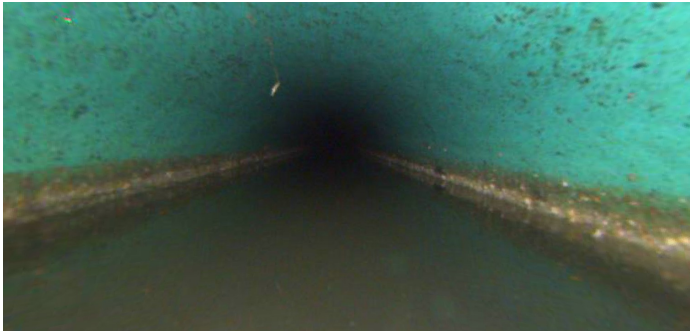
Code: AMH

Description: Manhole

Distance (ft): .0

Remarks: M-507-050

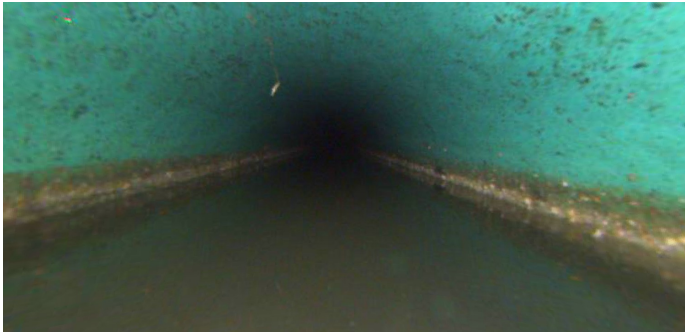
Code:	MWL
Description:	Water Level

Distance (ft):	.0
Structural Grade:	0
O&M Grade:	0
Clock Start/From:	
Clock To:	
1st Value:	
2nd Value:	
Value Percent:	40.000
Continuous Index:	
Within 8" of Joint:	NO
Remarks:

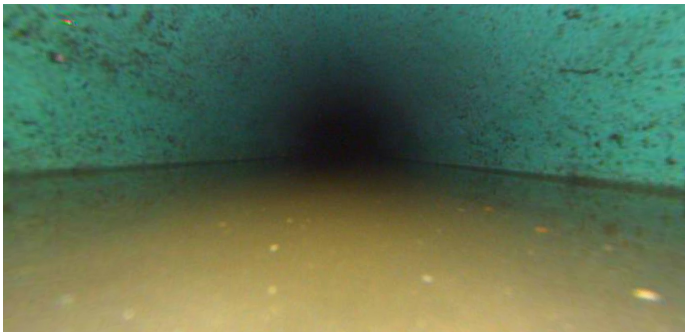
Code:	MSA
Description:	Abandoned Survey

Distance (ft):	6.0
Structural Grade:	0
O&M Grade:	0
Clock Start/From:	
Clock To:	
1st Value:	
2nd Value:	
Value Percent:	
Continuous Index:	
Within 8" of Joint:	NO
Remarks:	high water
