Profile/Photo Observation Report

Street:	FOXCROFT STREET	Flow Control:	Not Controlled
City:	Hobart, IN	Year Renewed:	
Location:	Light Highway	Tape/Media #:	
Purpose:	Routine Assessment	Dia/Height:	8"
Use:	Sanitary	Material:	PVC
Drain Area:	NA	Lining:	
Category:	NA		
Comment:	P_C at 4 ft debris

Location Details:		Direction of Survey:	Upstream
US MH:	M-507-081	DS MH:	M-507-050
		Total Length Surveyed (ft):	6.0

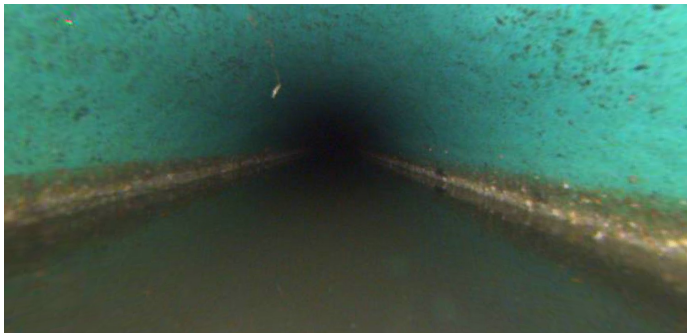
Code: **AMH**
Description: **Manhole**

Distance (ft): **.0**
Structural Grade: **0**
O&M Grade: **0**
Clock Start/From:
Clock To:
1st Value:
2nd Value:
Value Percent:
Continuous Index:
Within 8" of Joint: **NO**
Remarks: **M-507-050**

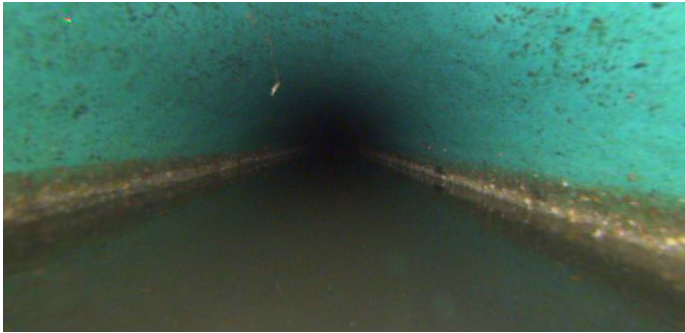
Code:	MWL
Description:	Water Level

Distance (ft):	.0
Structural Grade:	0
O&M Grade:	0
Clock Start/From:	
Clock To:	
1st Value:	
2nd Value:	
Value Percent:	40.000
Continuous Index:	
Within 8" of Joint:	NO
Remarks:

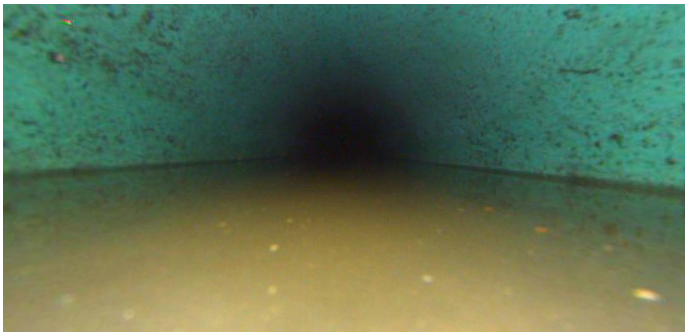
Code:	MSA
Description:	Abandoned Survey

Distance (ft):	6.0
Structural Grade:	0
O&M Grade:	0
Clock Start/From:	
Clock To:	
1st Value:	
2nd Value:	
Value Percent:	
Continuous Index:	
Within 8" of Joint:	NO
Remarks:	high water
