Profile/Photo Observation Report

Street:	W 10TH PL	Flow Control:	Not Controlled
City:	Hobart, IN	Year Renewed:	
Location:	Yard	Tape/Media #:	
Purpose:	Routine Assessment	Dia/Height:	8"
Use:	Sanitary	Material:	PVC
Drain Area:	NA	Lining:	
Category:	NA		
Comment:

Location Details:		Direction of Survey:	Downstream
US MH:	M-507-083	DS MH:	M-507-084
		Total Length Surveyed (ft):	166.5

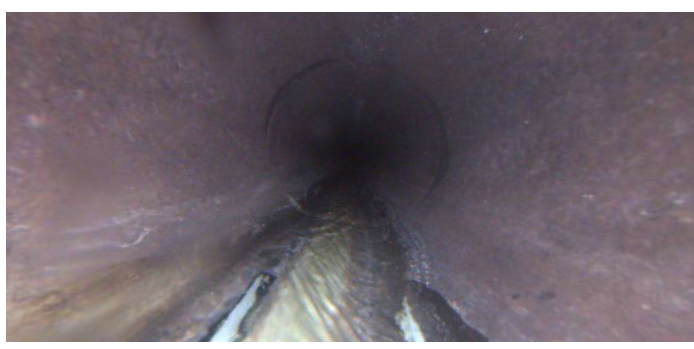
Code: **AMH**
Description: **Manhole**

Distance (ft): **.0**
Structural Grade: **0**
O&M Grade: **0**
Clock Start/From:
Clock To:
1st Value:
2nd Value:
Value Percent:
Continuous Index:
Within 8" of Joint: **NO**
Remarks: **M-507-083**

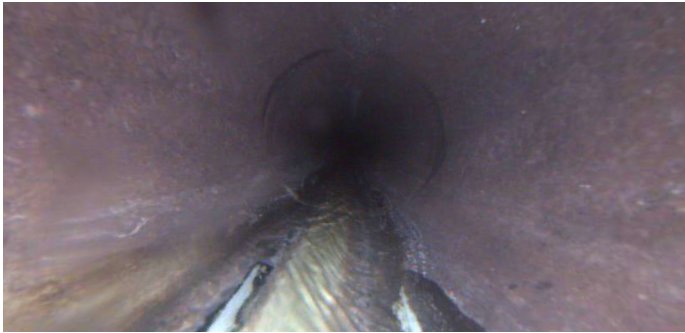
Code:	MWL
Description:	Water Level

Distance (ft):	.0
Structural Grade:	0
O&M Grade:	0
Clock Start/From:	
Clock To:	
1st Value:	
2nd Value:	
Value Percent:	5.000
Continuous Index:	
Within 8" of Joint:	NO
Remarks:

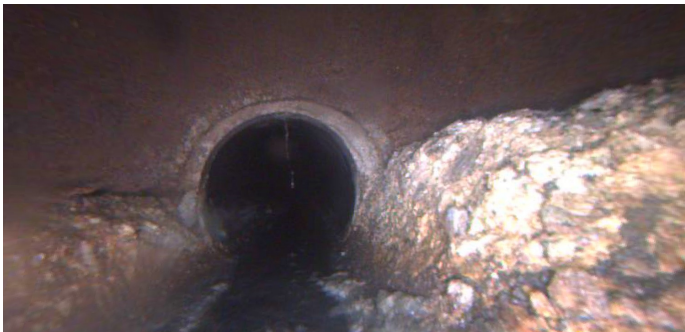
Code:	AMH
Description:	Manhole

Distance (ft):	166.5
Structural Grade:	0
O&M Grade:	0
Clock Start/From:	
Clock To:	
1st Value:	
2nd Value:	
Value Percent:	
Continuous Index:	
Within 8" of Joint:	NO
Remarks:	M-507-084
