Profile/Photo Observation Report

Street:	FOXCROFT STREET	Flow Control:	Not Controlled
City:	Hobart, IN	Year Renewed:	
Location:	Yard	Tape/Media #:	
Purpose:	Routine Assessment	Dia/Height:	8"
Use:	Sanitary	Material:	PVC
Drain Area:	NA	Lining:	
Category:	NA		
Comment:

Location Details:		Direction of Survey:	Downstream
US MH:	M-507-083	DS MH:	M-507-084
		Total Length Surveyed (ft):	166.5

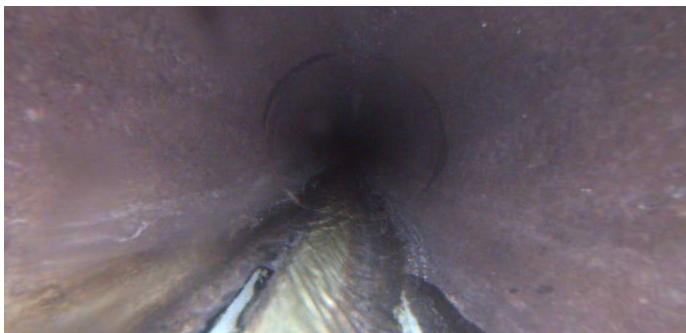
Code: **AMH**
Description: **Manhole**

Distance (ft): **.0**
Structural Grade: **0**
O&M Grade: **0**
Clock Start/From:
Clock To:
1st Value:
2nd Value:
Value Percent:
Continuous Index:
Within 8" of Joint: **NO**
Remarks: **M-507-083**

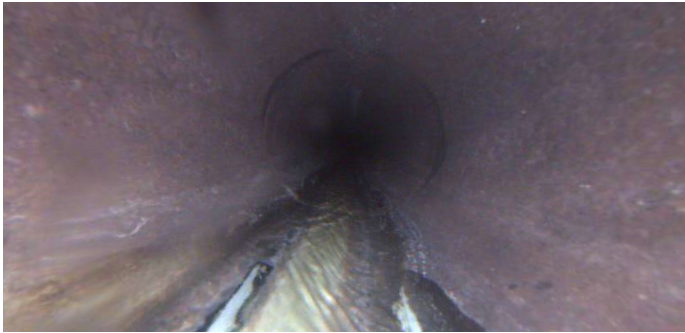
Code:	MWL
Description:	Water Level

Distance (ft):	.0
Structural Grade:	0
O&M Grade:	0
Clock Start/From:	
Clock To:	
1st Value:	
2nd Value:	
Value Percent:	5.000
Continuous Index:	
Within 8" of Joint:	NO
Remarks:

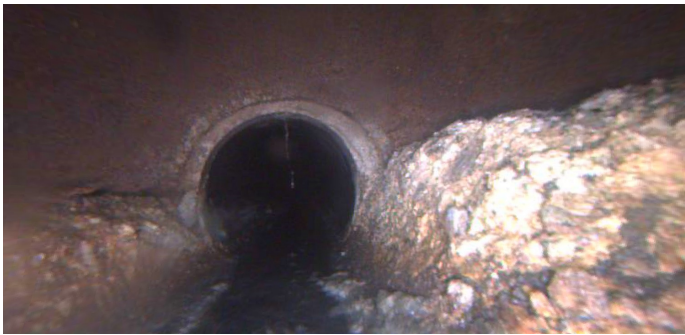
Code:	AMH
Description:	Manhole

Distance (ft):	166.5
Structural Grade:	0
O&M Grade:	0
Clock Start/From:	
Clock To:	
1st Value:	
2nd Value:	
Value Percent:	
Continuous Index:	
Within 8" of Joint:	NO
Remarks:	M-507-084
