## Profile/Photo Observation Report

Date:	<b>12/12/2024</b>	Weather:		Coding:	<b>PACP 7.0</b>
Pipe Length (ft):	<b>173.0</b>	Owner:	<b>City of Hobart</b>	Pre Clean:	<b>Heavy Cleaning</b>
P.O.#:	<b>YES502259</b>	Surveyor:	<b>S. Bucklin</b>	PSR:	<b>P-507-085-084</b>
Customer:	<b>City of Hobart</b>	Clean Date:	<b>09/11/2024</b>	Shape:	<b>C</b>

Street:	<b>South Colorado Street</b>	Flow Control:	<b>Not Controlled</b>
City:	<b>Hobart, IN</b>	Year Renewed:	
Location:	<b>Local rural streets with light traffic, t</b>	Tape/Media #:	
Purpose:	<b>Sewer System Evaluation Survey (SS</b>	Dia/Height:	<b>8"</b>
Use:	<b>Sanitary Sewage Pipe</b>	Material:	<b>PVC</b>
Drain Area:		Lining:	<b>None</b>
Category:	<b>NA</b>		
Comment:			
Location Details:		Direction of Survey:	<b>Upstream</b>
US MH:	<b>M-507-085</b>	DS MH:	<b>M-507-084</b>
		Total Length Surveyed (ft):	<b>167.5</b>

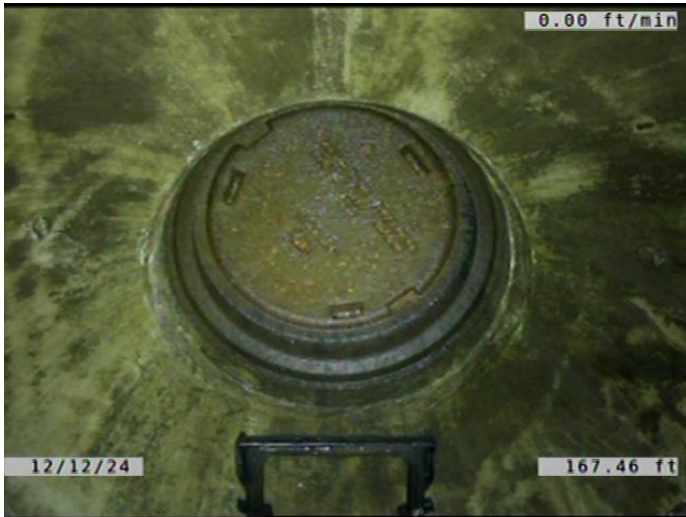
Code:	AMH
Description:	Manhole
Distance (ft):	167.5
Structural Grade:	0
O&M Grade:	0
Clock Start/From:	
Clock To:	
1st Value:	
2nd Value:	
Value Percent:	
Continuous Index:	
Within 8" of Joint:	NO
Remarks:	M-507-085
