Profile/Photo Observation Report

Street:	Off 10th Place	Flow Control:	
City:	Hobart, IN	Year Renewed:	
Location:	Yard	Tape/Media #:	961
Purpose:	Routine Assessment	Dia/Height:	12"
Use:	Sanitary	Material:	VCP
Drain Area:		Lining:	
Category:	NA		
Comment:

Location Details:		Direction of Survey:	Downstream
US MH:	M-507-86	DS MH:	M-507-27
		Total Length Surveyed (ft):	44.0

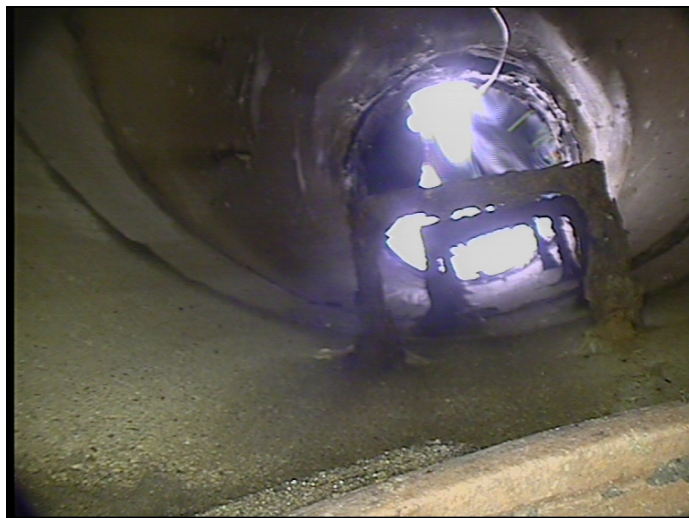
Code: **AMH**
Description: **Manhole**

Distance (ft): **.0**
Structural Grade: **0**
O&M Grade: **0**
Clock Start/From:
Clock To:
1st Value:
2nd Value:
Value Percent:
Continuous Index:
Within 8" of Joint: **NO**
Remarks: **M-507-86**

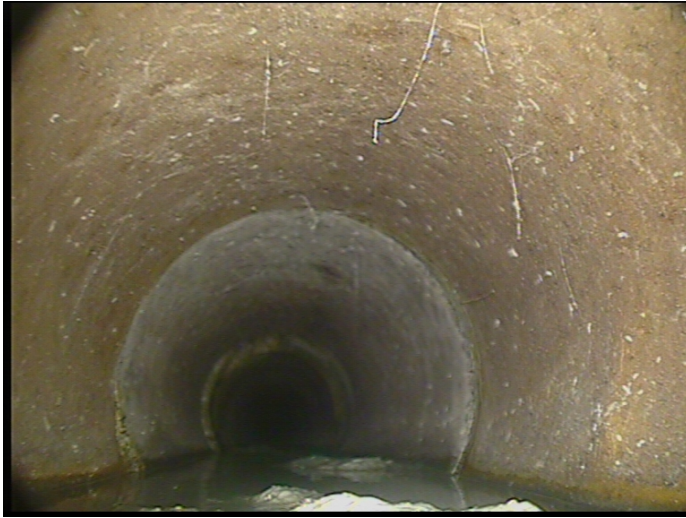
Code:	MWL
Description:	Water Level
Distance (ft):	.0
Structural Grade:	0
O&M Grade:	0
Clock Start/From:	
Clock To:	
1st Value:	
2nd Value:	
Value Percent:	5.000
Continuous Index:	
Within 8" of Joint:	NO
Remarks:

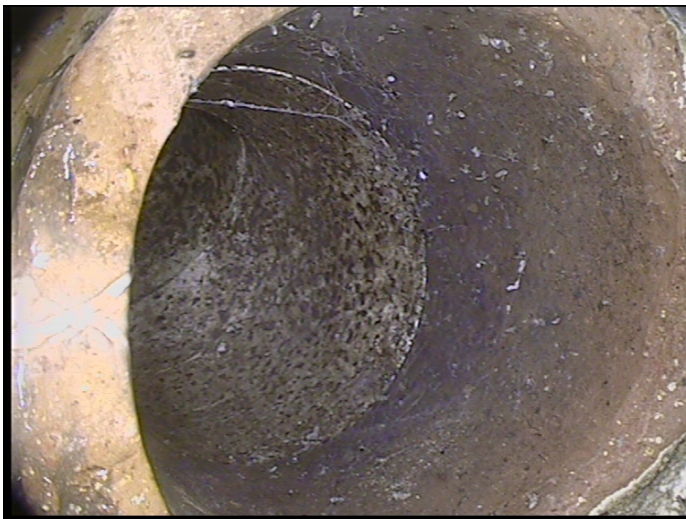
Code:	TB
Description:	Tap Break-in
Distance (ft):	9.0
Structural Grade:	0
O&M Grade:	0
Clock Start/From:	10
Clock To:	
1st Value:	4.000
2nd Value:	
Value Percent:	
Continuous Index:	
Within 8" of Joint:	NO
Remarks:

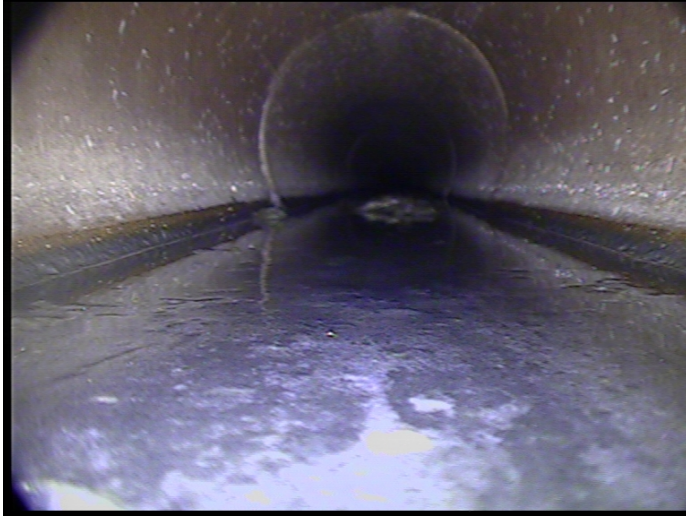
Code: **DSF**
Description: **Deposits Settled Fine**

Distance (ft): **30.5**
Structural Grade: **0**
O&M Grade: **2**
Clock Start/From: **4**
Clock To: **8**
1st Value:
2nd Value:
Value Percent: **10.000**
Continuous Index: **S01**
Within 8" of Joint: **YES**
Remarks:

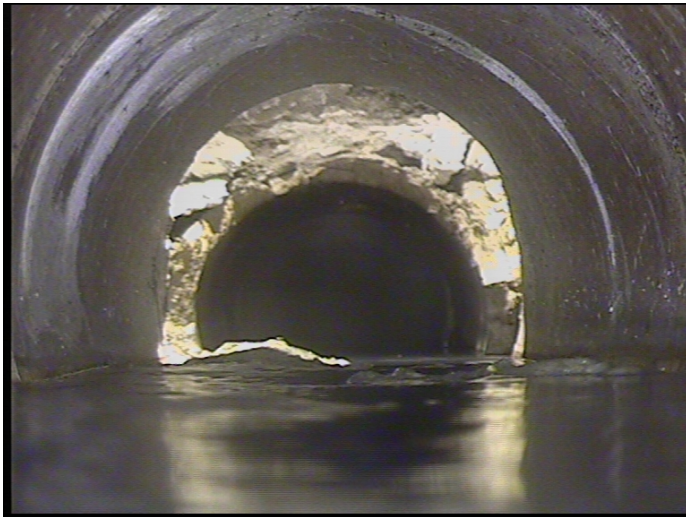
Code: **DSF**
Description: **Deposits Settled Fine**

Distance (ft): **43.3**
Structural Grade: **0**
O&M Grade: **2**
Clock Start/From: **4**
Clock To: **8**
1st Value:
2nd Value:
Value Percent: **10.000**
Continuous Index: **F01**
Within 8" of Joint: **NO**
Remarks:

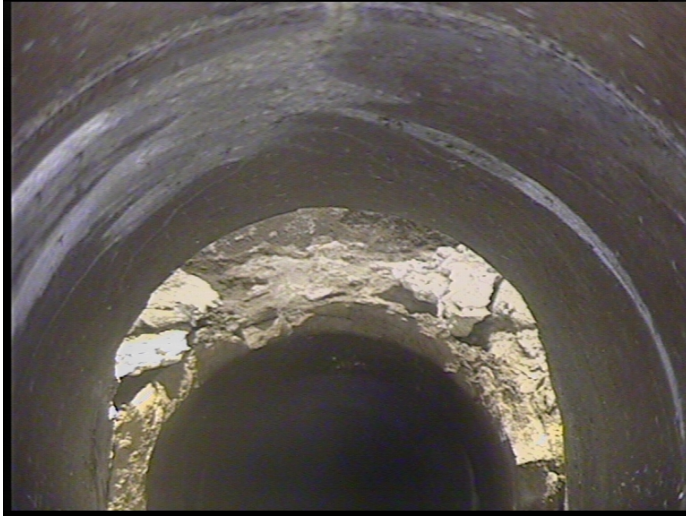
Code:	AMH
Description:	Manhole
Distance (ft):	44.0
Structural Grade:	0
O&M Grade:	0
Clock Start/From:	
Clock To:	
1st Value:	
2nd Value:	
Value Percent:	
Continuous Index:	
Within 8" of Joint:	NO
Remarks:	M-507-27
