Profile/Photo Observation Report

Street:	FOXCROFT STREET	Flow Control:	Not Controlled
City:	Hobart, IN	Year Renewed:	
Location:	Yard	Tape/Media #:	
Purpose:	Routine Assessment	Dia/Height:	8"
Use:	Sanitary	Material:	PVC
Drain Area:	NA	Lining:	
Category:	NA		
Comment:

Location Details:		Direction of Survey:	Downstream
US MH:	M-507-087	DS MH:	M-507-040
		Total Length Surveyed (ft):	233.3

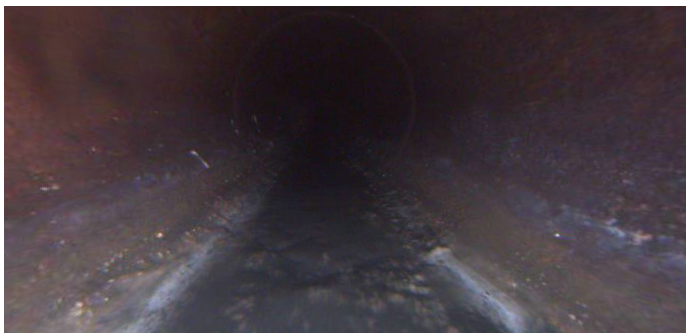
Code: **AMH**
Description: **Manhole**

Distance (ft): **.0**
Structural Grade: **0**
O&M Grade: **0**
Clock Start/From:
Clock To:
1st Value:
2nd Value:
Value Percent:
Continuous Index:
Within 8" of Joint: **NO**
Remarks: **M-507-087**

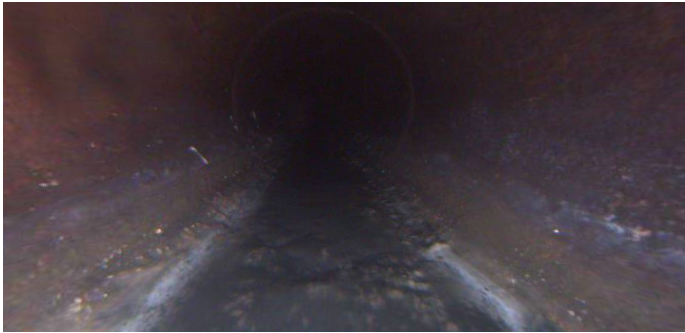
Code:	MWL
Description:	Water Level

Distance (ft):	.0
Structural Grade:	0
O&M Grade:	0
Clock Start/From:	
Clock To:	
1st Value:	
2nd Value:	
Value Percent:	5.000
Continuous Index:	
Within 8" of Joint:	NO
Remarks:

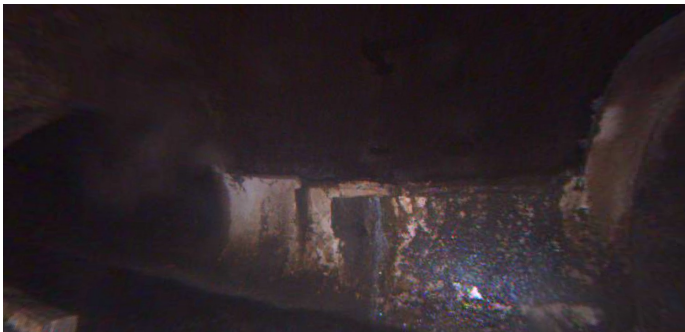
Code:	AMH
Description:	Manhole

Distance (ft):	233.3
Structural Grade:	0
O&M Grade:	0
Clock Start/From:	
Clock To:	
1st Value:	
2nd Value:	
Value Percent:	
Continuous Index:	
Within 8" of Joint:	NO
Remarks:	M-507-040
