Profile/Photo Observation Report

Street:	W 10TH PL	Flow Control:	Not Controlled
City:	Hobart, IN	Year Renewed:	
Location:	Yard	Tape/Media #:	
Purpose:	Routine Assessment	Dia/Height:	8"
Use:	Sanitary	Material:	PVC
Drain Area:	NA	Lining:	
Category:	NA		
Comment:

Location Details:		Direction of Survey:	Downstream
US MH:	M-507-087	DS MH:	M-507-084
		Total Length Surveyed (ft):	383.3

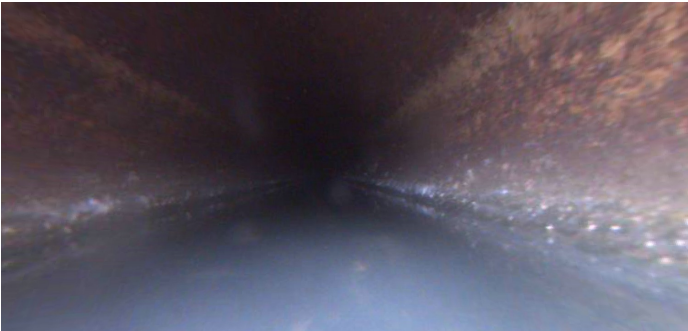
M-507-087

AMH

Manhole

.0

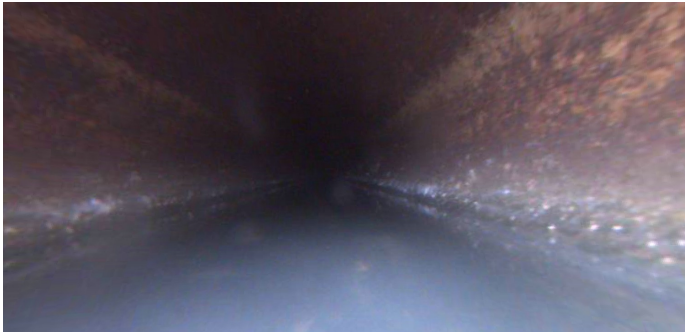
Code:	MWL
Description:	Water Level

Distance (ft):	.0
Structural Grade:	0
O&M Grade:	0
Clock Start/From:	
Clock To:	
1st Value:	
2nd Value:	
Value Percent:	20.000
Continuous Index:	
Within 8" of Joint:	NO
Remarks:

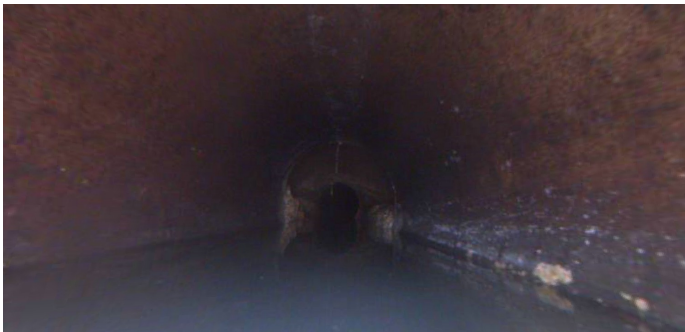
Code:	MSA
Description:	Abandoned Survey

Distance (ft):	383.3
Structural Grade:	0
O&M Grade:	0
Clock Start/From:	
Clock To:	
1st Value:	
2nd Value:	
Value Percent:	
Continuous Index:	
Within 8" of Joint:	NO
Remarks:	UNKNOWN NEAR MH
