Profile/Photo Observation Report

Street:	FOXCROFT STREET	Flow Control:	Not Controlled
City:	Hobart, IN	Year Renewed:	
Location:	Yard	Tape/Media #:	
Purpose:	Routine Assessment	Dia/Height:	8"
Use:	Sanitary	Material:	PVC
Drain Area:	NA	Lining:	
Category:	NA		
Comment:

Location Details:		Direction of Survey:	Downstream
US MH:	M-507-087	DS MH:	M-507-084
		Total Length Surveyed (ft):	383.3

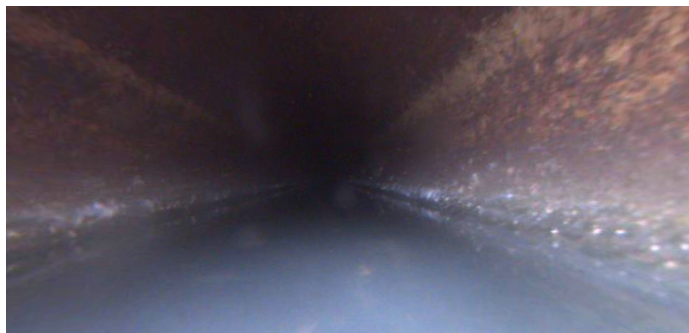
Code: **AMH**
Description: **Manhole**

Distance (ft): **.0**
Structural Grade: **0**
O&M Grade: **0**
Clock Start/From:
Clock To:
1st Value:
2nd Value:
Value Percent:
Continuous Index:
Within 8" of Joint: **NO**
Remarks: **M-507-087**

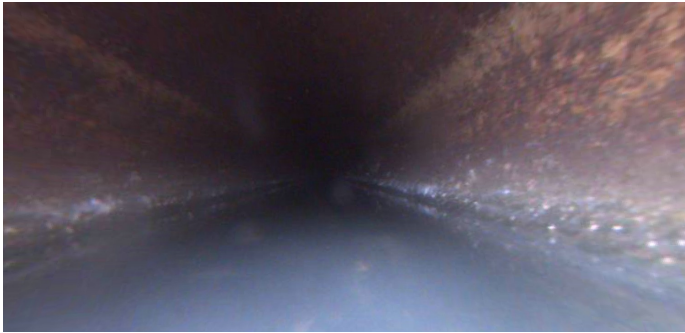
Code:	MWL
Description:	Water Level

Distance (ft):	.0
Structural Grade:	0
O&M Grade:	0
Clock Start/From:	
Clock To:	
1st Value:	
2nd Value:	
Value Percent:	20.000
Continuous Index:	
Within 8" of Joint:	NO
Remarks:

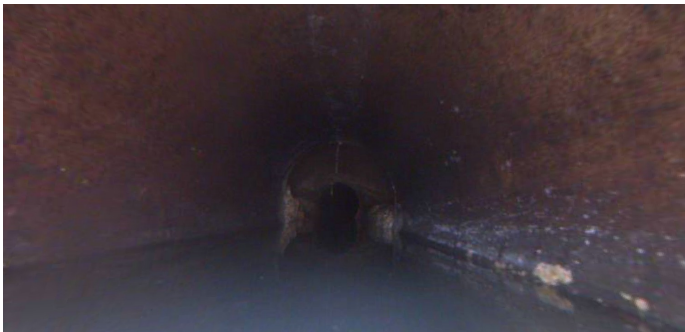
Code:	MSA
Description:	Abandoned Survey

Distance (ft):	383.3
Structural Grade:	0
O&M Grade:	0
Clock Start/From:	
Clock To:	
1st Value:	
2nd Value:	
Value Percent:	
Continuous Index:	
Within 8" of Joint:	NO
Remarks:	UNKNOWN NEAR MH
