Profile/Photo Observation Report

Date:	04/13/2018	Weather:		Coding:	PACP 6.0
Pipe Length (ft):	394.1	Owner:	NA	Pre Clean:	No Pre-Cleaning
P.O.#:		Surveyor:	Jen Costello	PSR:	P-507-084-087
Customer:		Clean Date:	01/01/1900	Shape:	C

Street:	W 10TH PL	Flow Control:	Not Controlled
City:	Hobart, IN	Year Renewed:	
Location:	Yard	Tape/Media #:	
Purpose:	Routine Assessment	Dia/Height:	8"
Use:	Sanitary	Material:	PVC
Drain Area:	NA	Lining:	
Category:	NA		
Comment:	Flow direction is marked wrong.		
Location Details:		Direction of Survey:	Upstream
US MH:	M-507-087	DS MH:	M-507-084
		Total Length Surveyed (ft):	391.3

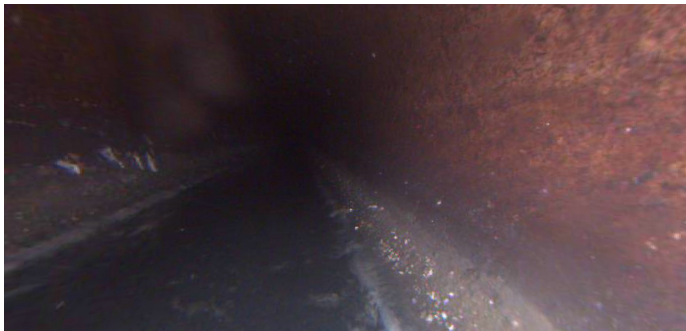
Code: **AMH**
Description: **Manhole**

Distance (ft): **.0**
Structural Grade: **0**
O&M Grade: **0**
Clock Start/From:
Clock To:
1st Value:
2nd Value:
Value Percent:
Continuous Index:
Within 8" of Joint: **NO**
Remarks: **M-507-084**

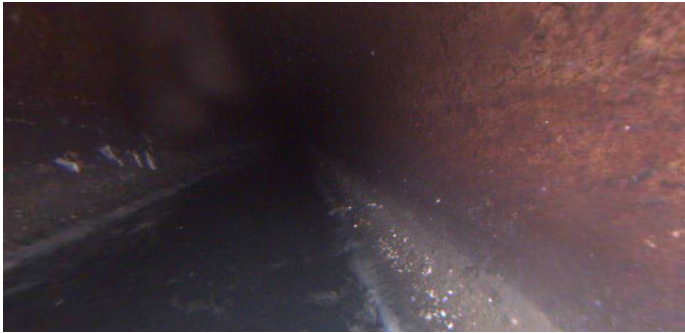
Code:	MWL
Description:	Water Level

Distance (ft):	.0
Structural Grade:	0
O&M Grade:	0
Clock Start/From:	
Clock To:	
1st Value:	
2nd Value:	
Value Percent:	10.000
Continuous Index:	
Within 8" of Joint:	NO
Remarks:

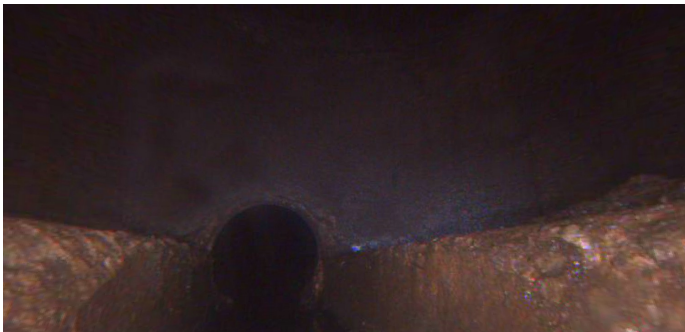
Code:	AMH
Description:	Manhole

Distance (ft):	391.3
Structural Grade:	0
O&M Grade:	0
Clock Start/From:	
Clock To:	
1st Value:	
2nd Value:	
Value Percent:	
Continuous Index:	
Within 8" of Joint:	NO
Remarks:	M-507-087
