Profile/Photo Observation Report

Street:	FOXCROFT STREET	Flow Control:	Not Controlled
City:	Hobart, IN	Year Renewed:	
Location:	Yard	Tape/Media #:	
Purpose:	Routine Assessment	Dia/Height:	8"
Use:	Sanitary	Material:	PVC
Drain Area:	NA	Lining:	
Category:	NA		
Comment:	Flow direction is marked wrong.

Location Details:		Direction of Survey:	Upstream
US MH:	M-507-087	DS MH:	M-507-084
		Total Length Surveyed (ft):	391.3

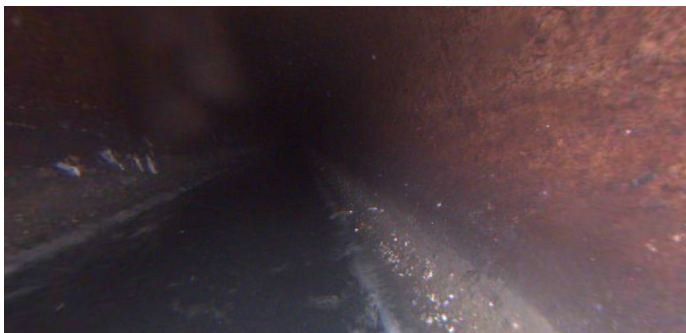
Code: **AMH**
Description: **Manhole**

Distance (ft): **.0**
Structural Grade: **0**
O&M Grade: **0**
Clock Start/From:
Clock To:
1st Value:
2nd Value:
Value Percent:
Continuous Index:
Within 8" of Joint: **NO**
Remarks: **M-507-084**

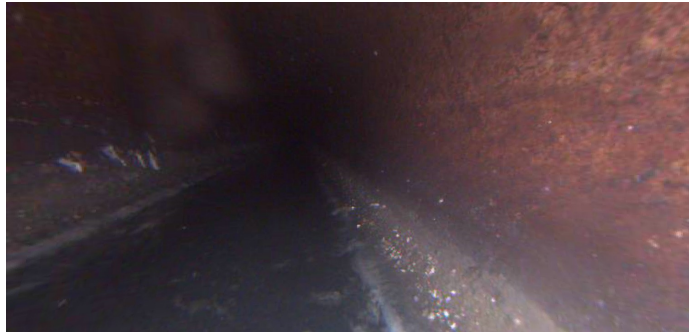
Code:	MWL
Description:	Water Level
Distance (ft):	.0
Structural Grade:	0
O&M Grade:	0
Clock Start/From:	
Clock To:	
1st Value:	
2nd Value:	
Value Percent:	10.000
Continuous Index:	
Within 8" of Joint:	NO
Remarks:

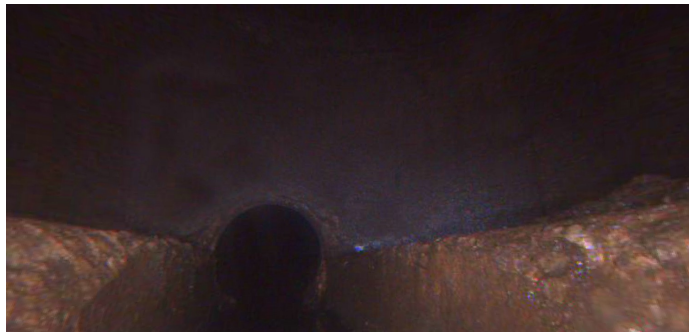
Code:	AMH
Description:	Manhole
Distance (ft):	391.3
Structural Grade:	0
O&M Grade:	0
Clock Start/From:	
Clock To:	
1st Value:	
2nd Value:	
Value Percent:	
Continuous Index:	
Within 8" of Joint:	NO
Remarks:	M-507-087
