## Profile/Photo Observation Report

Street:	<b>South Virginia Street</b>	Flow Control:	<b>Not Controlled</b>
City:	<b>Hobart, IN</b>	Year Renewed:	
Location:	<b>Light Highway</b>	Tape/Media #:	<b>DEP289</b>
Purpose:	<b>Routine Assessment</b>	Dia/Height:	<b>12"</b>
Use:	<b>Sanitary</b>	Material:	<b>PVC</b>
Drain Area:		Lining:	
Category:	<b>NA</b>		
Comment:	<b>5-21-2018</b>

Location Details:		Direction of Survey:	<b>Downstream</b>
US MH:	<b>M-507-089</b>	DS MH:	<b>M-507-040</b>
		Total Length Surveyed (ft):	<b>139.9</b>

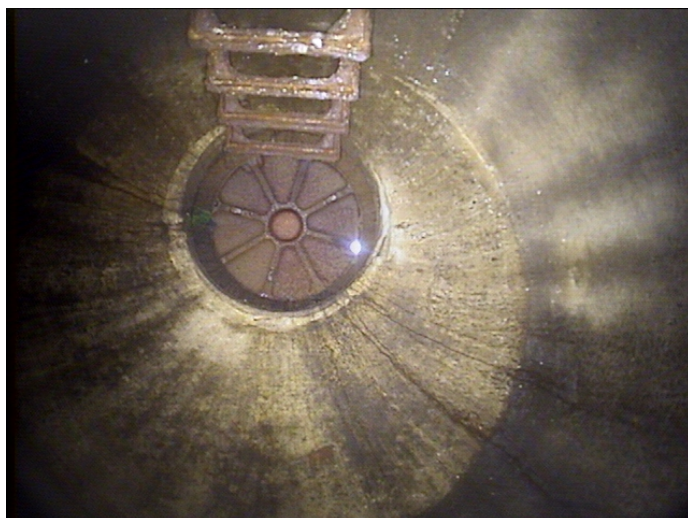
Code: **AMH**  
Description: **Manhole**

Distance (ft): **.0**  
Structural Grade: **0**  
O&M Grade: **0**  
Clock Start/From:  
Clock To:  
1st Value:  
2nd Value:  
Value Percent:  
Continuous Index:  
Within 8" of Joint: **NO**  
Remarks: **M-507-089**

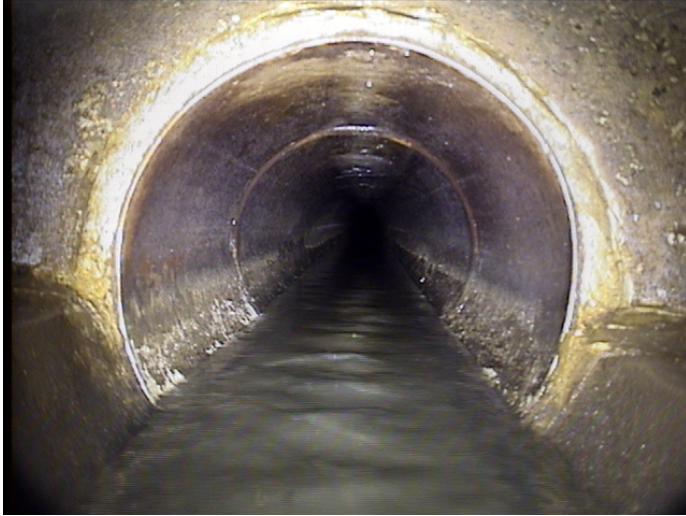
Code: **MWL**  
Description: **Water Level**

Distance (ft): **.0**  
Structural Grade: **0**  
O&M Grade: **0**  
Clock Start/From:  
Clock To:  
1st Value:  
2nd Value:  
Value Percent: **15.000**  
Continuous Index:  
Within 8" of Joint: **NO**  
Remarks:

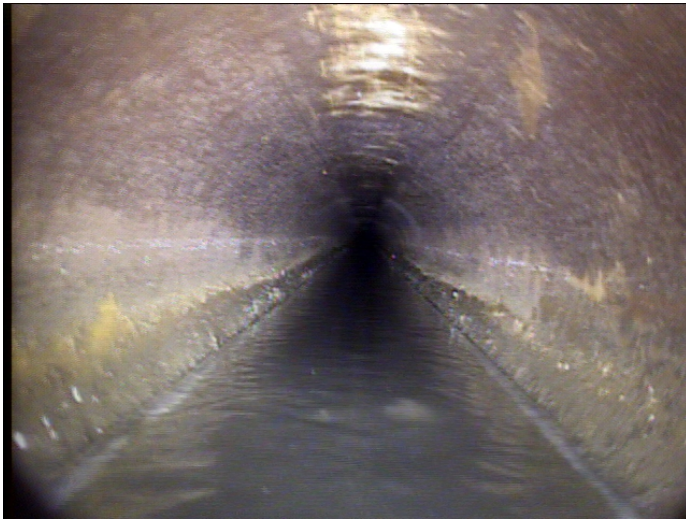
Code: **DSF**  
Description: **Deposits Settled Fine**

Distance (ft): **16.0**  
Structural Grade: **0**  
O&M Grade: **2**  
Clock Start/From: **5**  
Clock To: **7**  
1st Value:  
2nd Value:  
Value Percent: **5.000**  
Continuous Index: **S01**  
Within 8" of Joint: **NO**  
Remarks:

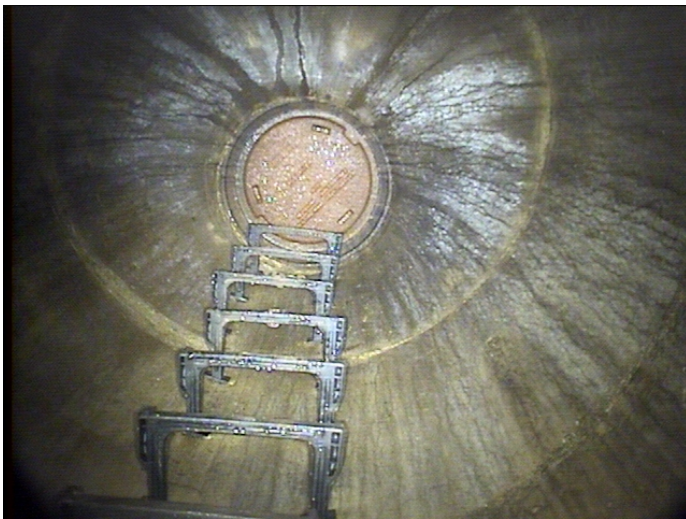
Code: **AMH**  
 Description: **Manhole**

Distance (ft): **139.9**  
 Structural Grade: **0**  
 O&M Grade: **0**  
 Clock Start/From:  
 Clock To:  
 1st Value:  
 2nd Value:  
 Value Percent:  
 Continuous Index:  
 Within 8" of Joint: **NO**  
 Remarks: **M-507-040**
