Profile/Photo Observation Report

Date:	04/12/2018	Weather:		Coding:	PACP 6.0
Pipe Length (ft):	293.7	Owner:	NA	Pre Clean:	No Pre-Cleaning
P.O.#:		Surveyor:	Jen Costello	PSR:	P-507-095-096
Customer:		Clean Date:	01/01/1900	Shape:	C

Street:	FOXCROFT STREET	Flow Control:	Not Controlled
City:	Hobart, IN	Year Renewed:	
Location:	Yard	Tape/Media #:	
Purpose:	Routine Assessment	Dia/Height:	8"
Use:	Sanitary	Material:	PVC
Drain Area:	NA	Lining:	
Category:	NA		
Comment:	Flow direction is marked wrong.		
Location Details:		Direction of Survey:	Upstream
US MH:	M-507-096	DS MH:	M-507-095
		Total Length Surveyed (ft):	286.4

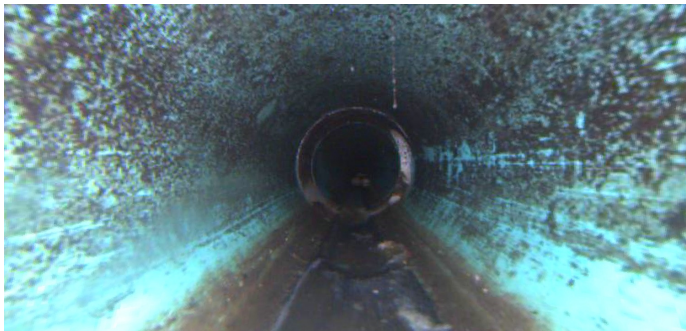
Code: **AMH**
Description: **Manhole**

Distance (ft): **.0**
Structural Grade: **0**
O&M Grade: **0**
Clock Start/From:
Clock To:
1st Value:
2nd Value:
Value Percent:
Continuous Index:
Within 8" of Joint: **NO**
Remarks: **M-507-095**

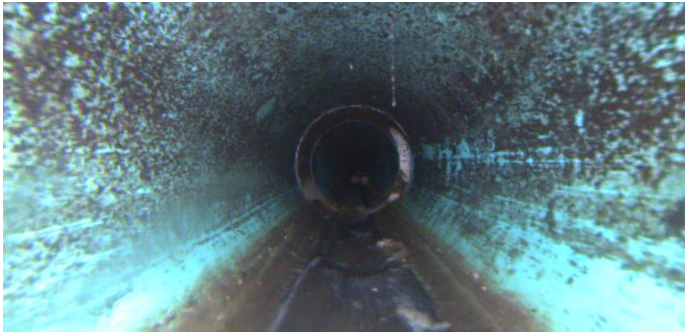
Code:	MWL
Description:	Water Level

Distance (ft):	.0
Structural Grade:	0
O&M Grade:	0
Clock Start/From:	
Clock To:	
1st Value:	
2nd Value:	
Value Percent:	5.000
Continuous Index:	
Within 8" of Joint:	NO
Remarks:

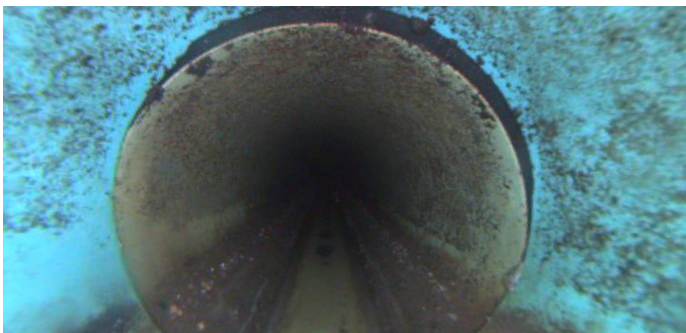
Code: **JOM**
Description: **Joint Offset Medium**

Distance (ft): **89.1**
Structural Grade: **1**
O&M Grade: **0**
Clock Start/From:
Clock To:
1st Value:
2nd Value:
Value Percent:
Continuous Index:
Within 8" of Joint: **NO**
Remarks:

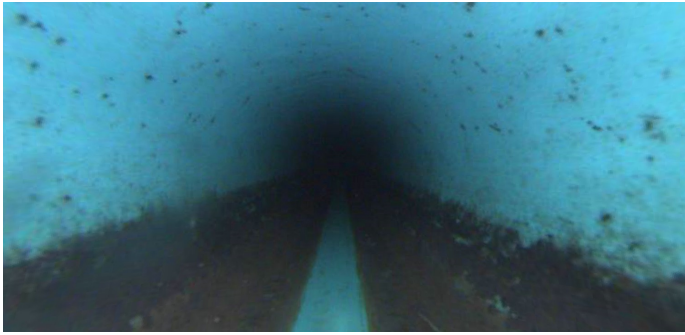
Code: **DAGS**
Description: **Deposits Attached Grease**

Distance (ft): **104.3**
Structural Grade: **0**
O&M Grade: **2**
Clock Start/From: **4**
Clock To: **8**
1st Value:
2nd Value:
Value Percent: **5.000**
Continuous Index: **S01**
Within 8" of Joint: **NO**
Remarks:

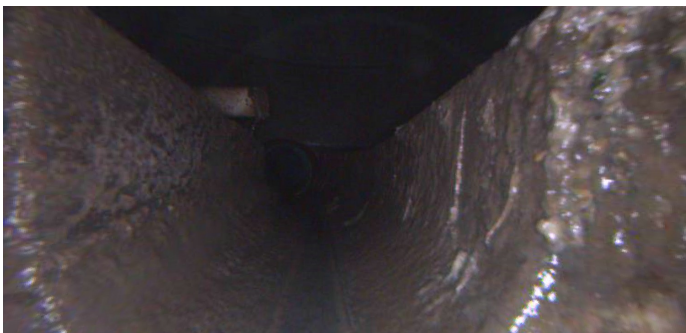
Code: **DAGS**
Description: **Deposits Attached Grease**

Distance (ft): **284.5**
Structural Grade: **0**
O&M Grade: **2**
Clock Start/From: **4**
Clock To: **8**
1st Value:
2nd Value:
Value Percent: **5.000**
Continuous Index: **F01**
Within 8" of Joint: **NO**
Remarks:

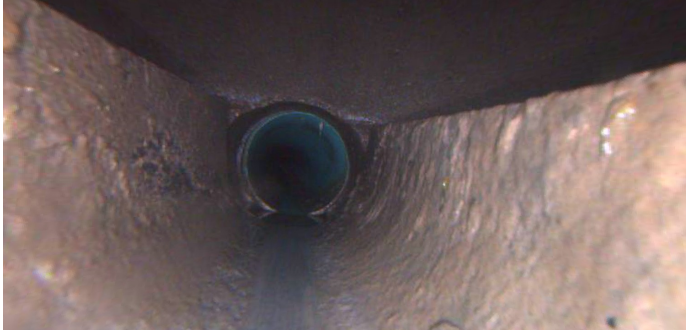
Code:	AMH
Description:	Manhole
Distance (ft):	286.4
Structural Grade:	0
O&M Grade:	0
Clock Start/From:	
Clock To:	
1st Value:	
2nd Value:	
Value Percent:	
Continuous Index:	
Within 8" of Joint:	NO
Remarks:	M-507-096
