Profile/Photo Observation Report

Street:	FOXCROFT STREET	Flow Control:	Not Controlled
City:	Hobart, IN	Year Renewed:	
Location:	Yard	Tape/Media #:	
Purpose:	Routine Assessment	Dia/Height:	8"
Use:	Sanitary	Material:	PVC
Drain Area:	NA	Lining:	
Category:	NA		
Comment:	Flow direction is marked wrong.

Location Details:		Direction of Survey:	Upstream
US MH:	M-507-098	DS MH:	M-507-097
		Total Length Surveyed (ft):	323.5

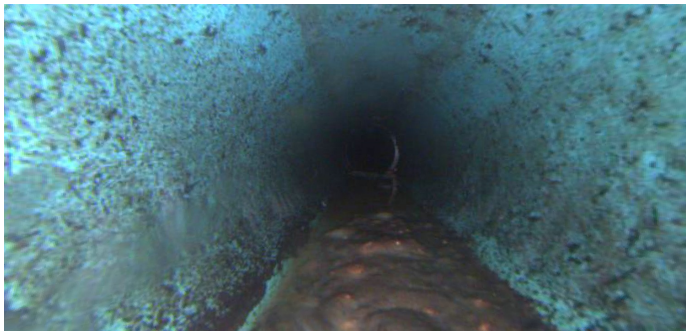
Code: **AMH**
Description: **Manhole**

Distance (ft): **.0**
Structural Grade: **0**
O&M Grade: **0**
Clock Start/From:
Clock To:
1st Value:
2nd Value:
Value Percent:
Continuous Index:
Within 8" of Joint: **NO**
Remarks: **M-507-097**

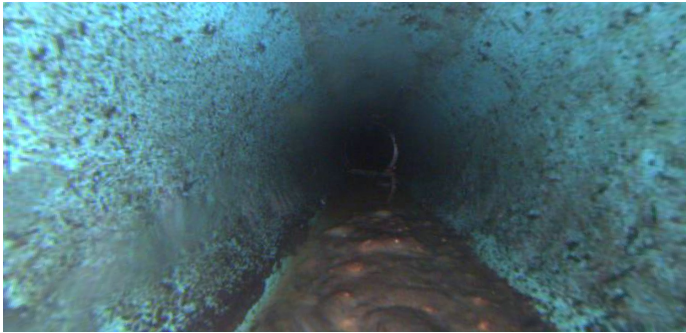
Code:	MWL
Description:	Water Level

Distance (ft):	.0
Structural Grade:	0
O&M Grade:	0
Clock Start/From:	
Clock To:	
1st Value:	
2nd Value:	
Value Percent:	5.000
Continuous Index:	
Within 8" of Joint:	NO
Remarks:

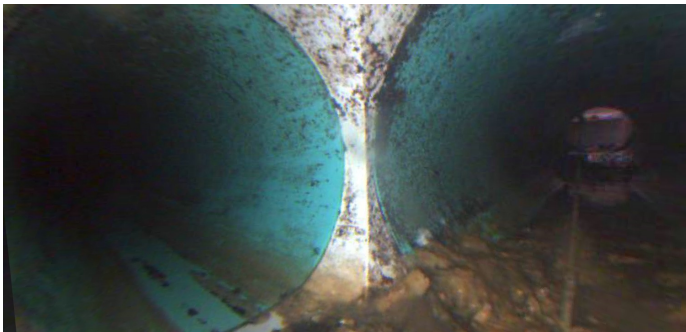
Code:	TF
Description:	Tap Factory

Distance (ft):	4.9
Structural Grade:	0
O&M Grade:	0
Clock Start/From:	3
Clock To:	
1st Value:	4.000
2nd Value:	
Value Percent:	
Continuous Index:	
Within 8" of Joint:	
Remarks:

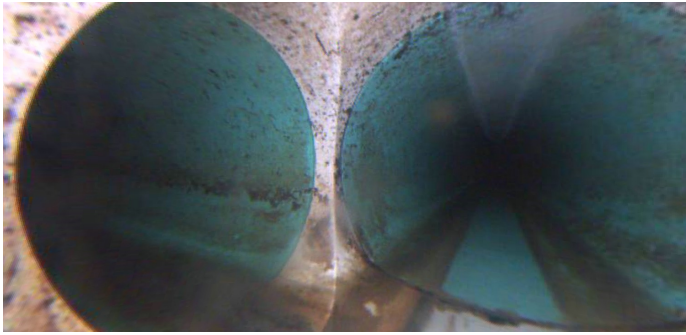
Code: **TF**
Description: **Tap Factory**

Distance (ft): **37.8**
Structural Grade: **0**
O&M Grade: **0**
Clock Start/From: **9**
Clock To:
1st Value: **4.000**
2nd Value:
Value Percent:
Continuous Index:
Within 8" of Joint:
Remarks:

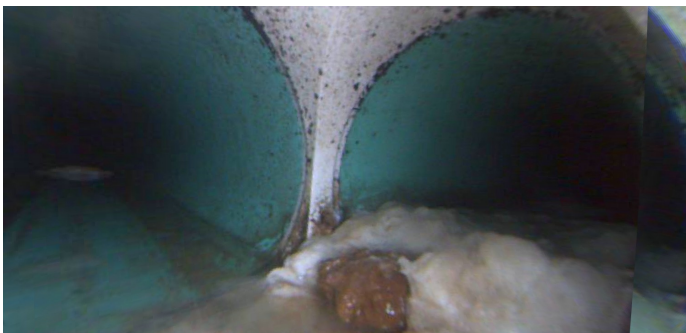
Code: **TFD**
Description: **Tap Factory Defective**

Distance (ft): **50.9**
Structural Grade: **0**
O&M Grade: **2**
Clock Start/From: **3**
Clock To:
1st Value: **4.000**
2nd Value:
Value Percent:
Continuous Index:
Within 8" of Joint:
Remarks: **deposits**

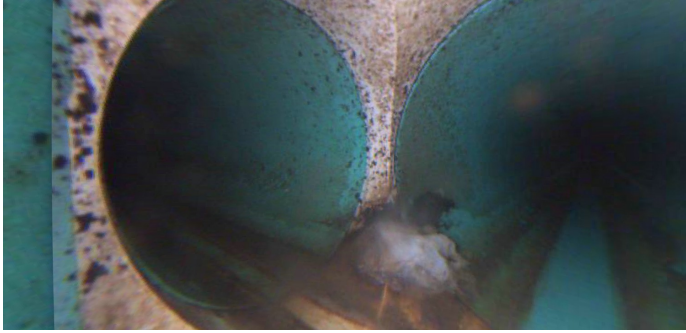
Code: **TF**
Description: **Tap Factory**

Distance (ft): **101.6**
Structural Grade: **0**
O&M Grade: **0**
Clock Start/From: **9**
Clock To:
1st Value: **4.000**
2nd Value:
Value Percent:
Continuous Index:
Within 8" of Joint:
Remarks:

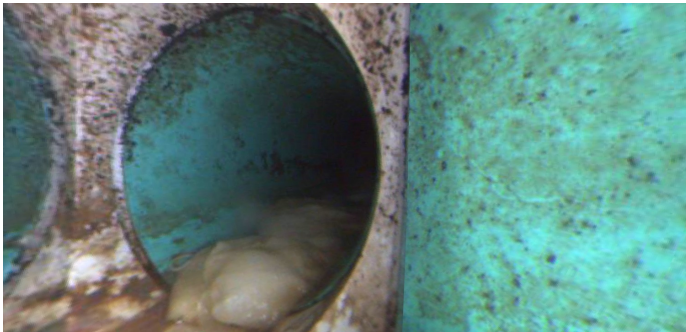
Code: **TF**
Description: **Tap Factory**

Distance (ft): **127.3**
Structural Grade: **0**
O&M Grade: **0**
Clock Start/From: **3**
Clock To:
1st Value: **4.000**
2nd Value:
Value Percent:
Continuous Index:
Within 8" of Joint:
Remarks:

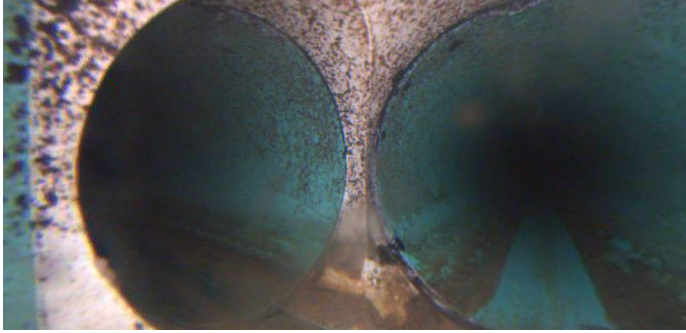
Code: **TFA**
Description: **Tap Factory Active**

Distance (ft): **178.1**
Structural Grade: **0**
O&M Grade: **0**
Clock Start/From: **9**
Clock To:
1st Value: **4.000**
2nd Value:
Value Percent:
Continuous Index:
Within 8" of Joint:
Remarks:

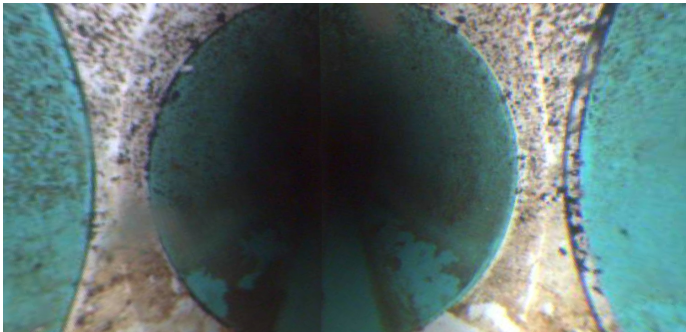
Code: **TF**
Description: **Tap Factory**

Distance (ft): **239.3**
Structural Grade: **0**
O&M Grade: **0**
Clock Start/From: **3**
Clock To:
1st Value: **4.000**
2nd Value:
Value Percent:
Continuous Index:
Within 8" of Joint:
Remarks:

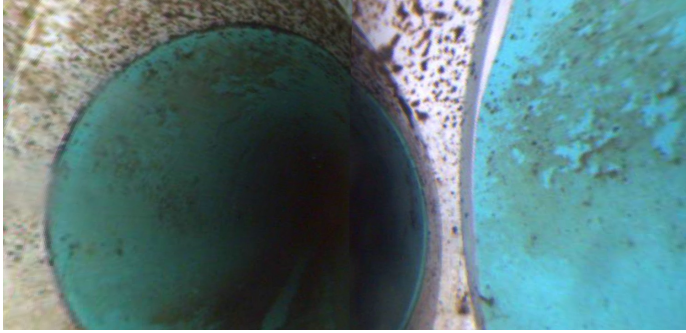
Code: **TF**
Description: **Tap Factory**

Distance (ft): **242.5**
Structural Grade: **0**
O&M Grade: **0**
Clock Start/From: **9**
Clock To:
1st Value: **4.000**
2nd Value:
Value Percent:
Continuous Index:
Within 8" of Joint:
Remarks:

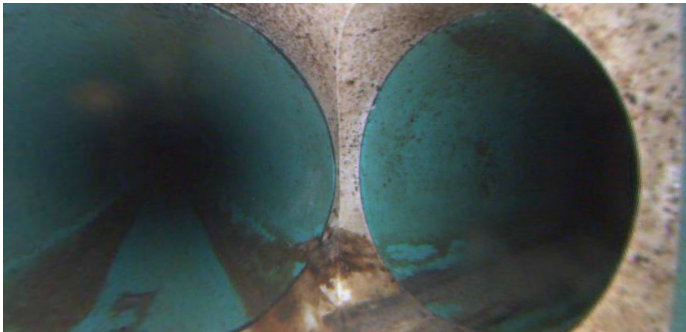
Code: **TFA**
Description: **Tap Factory Active**

Distance (ft): **293.1**
Structural Grade: **0**
O&M Grade: **0**
Clock Start/From: **3**
Clock To:
1st Value: **4.000**
2nd Value:
Value Percent:
Continuous Index:
Within 8" of Joint:
Remarks:

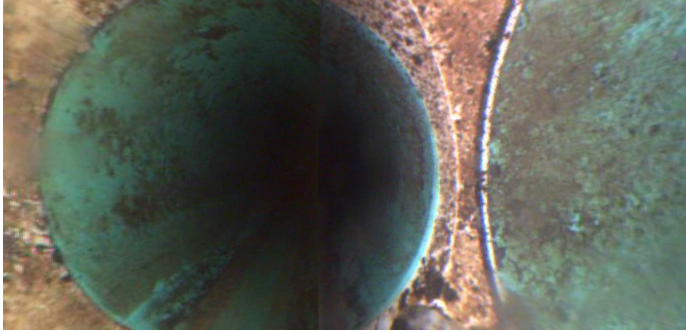
Code: **TFA**
Description: **Tap Factory Active**

Distance (ft): **315.3**
Structural Grade: **0**
O&M Grade: **0**
Clock Start/From: **9**
Clock To:
1st Value: **4.000**
2nd Value:
Value Percent:
Continuous Index:
Within 8" of Joint:
Remarks:

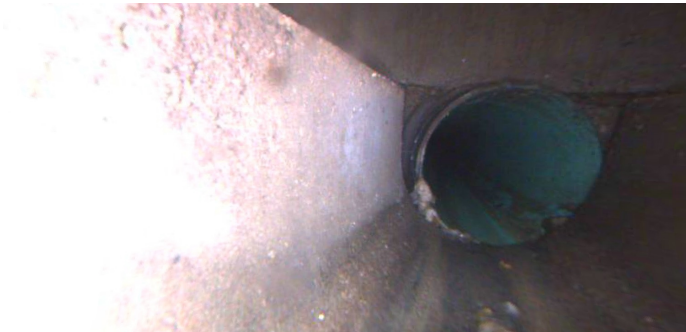
Code: **AMH**
Description: **Manhole**

Distance (ft): **323.5**
Structural Grade: **0**
O&M Grade: **0**
Clock Start/From:
Clock To:
1st Value:
2nd Value:
Value Percent:
Continuous Index:
Within 8" of Joint: **NO**
Remarks: **M-507-098**
