Profile/Photo Observation Report

Street:	METZ CT	Flow Control:	Not Controlled
City:	Hobart, IN	Year Renewed:	
Location:	Light Highway	Tape/Media #:	
Purpose:	Routine Assessment	Dia/Height:	8"
Use:	Sanitary	Material:	PVC
Drain Area:	NA	Lining:	
Category:	NA		
Comment:	Flow direction wrong

Location Details:		Direction of Survey:	Downstream
US MH:	M-507-099	DS MH:	M-507-098
		Total Length Surveyed (ft):	204.8

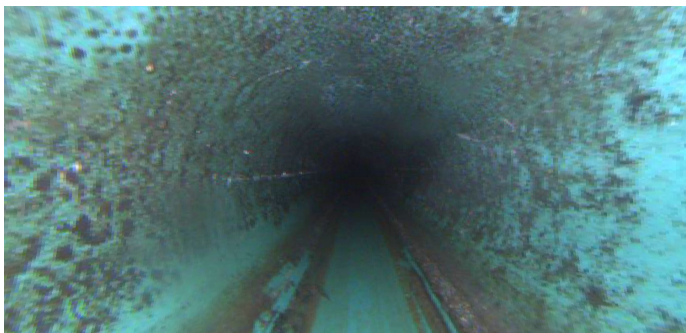
Code: **AMH**
Description: **Manhole**

Distance (ft): **.0**
Structural Grade: **0**
O&M Grade: **0**
Clock Start/From:
Clock To:
1st Value:
2nd Value:
Value Percent:
Continuous Index:
Within 8" of Joint: **NO**
Remarks: **M-507-099**

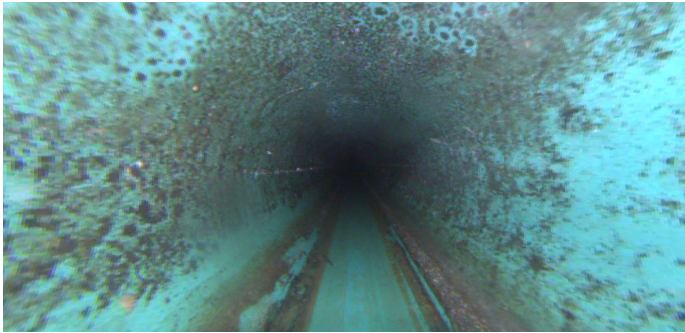
Code:	MWL
Description:	Water Level

Distance (ft):	.0
Structural Grade:	0
O&M Grade:	0
Clock Start/From:	
Clock To:	
1st Value:	
2nd Value:	
Value Percent:	5.000
Continuous Index:	
Within 8" of Joint:	NO
Remarks:

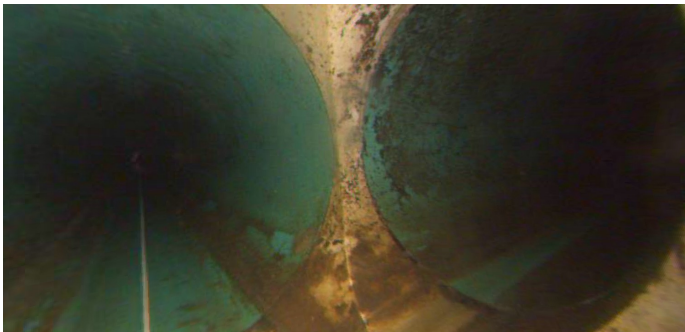
Code:	TFA
Description:	Tap Factory Active

Distance (ft):	19.3
Structural Grade:	0
O&M Grade:	0
Clock Start/From:	9
Clock To:	
1st Value:	4.000
2nd Value:	
Value Percent:	
Continuous Index:	
Within 8" of Joint:	
Remarks:

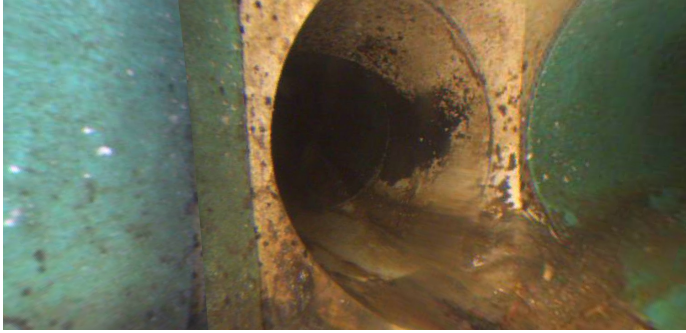
Code: **TFA**
Description: **Tap Factory Active**

Distance (ft): **22.2**
Structural Grade: **0**
O&M Grade: **0**
Clock Start/From: **3**
Clock To:
1st Value: **4.000**
2nd Value:
Value Percent:
Continuous Index:
Within 8" of Joint:
Remarks:

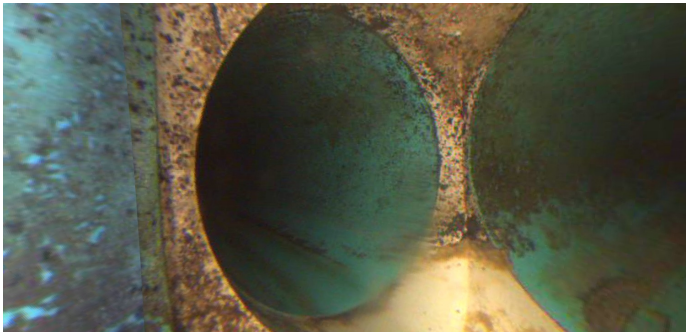
Code: **TF**
Description: **Tap Factory**

Distance (ft): **133.9**
Structural Grade: **0**
O&M Grade: **0**
Clock Start/From: **3**
Clock To:
1st Value: **4.000**
2nd Value:
Value Percent:
Continuous Index:
Within 8" of Joint:
Remarks:

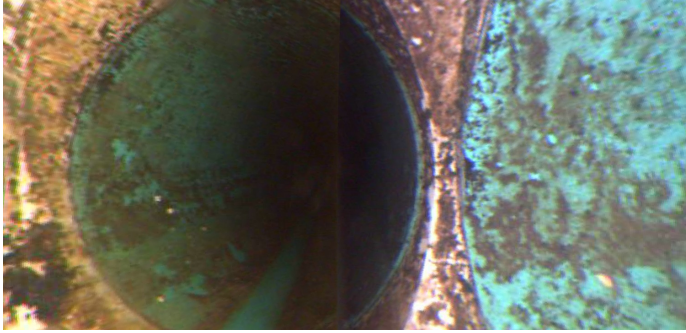
Code: **TF**
Description: **Tap Factory**

Distance (ft): **135.4**
Structural Grade: **0**
O&M Grade: **0**
Clock Start/From: **9**
Clock To:
1st Value: **4.000**
2nd Value:
Value Percent:
Continuous Index:
Within 8" of Joint:
Remarks:

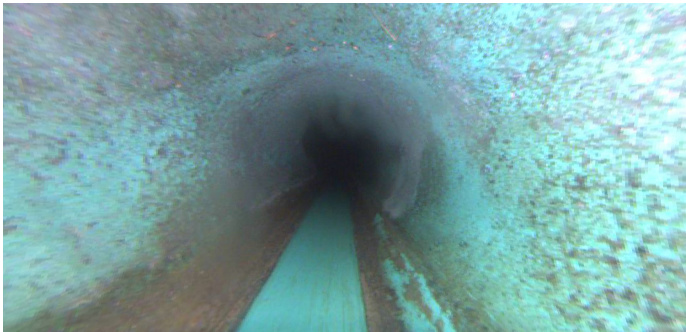
Code: **AMH**
Description: **Manhole**

Distance (ft): **204.8**
Structural Grade: **0**
O&M Grade: **0**
Clock Start/From:
Clock To:
1st Value:
2nd Value:
Value Percent:
Continuous Index:
Within 8" of Joint: **NO**
Remarks: **M-507-098**
