Profile/Photo Observation Report

Street:	FOXCROFT STREET	Flow Control:	Not Controlled
City:	Hobart, IN	Year Renewed:	
Location:	Light Highway	Tape/Media #:	
Purpose:	Routine Assessment	Dia/Height:	12"
Use:	Sanitary	Material:	PVC
Drain Area:	NA	Lining:	
Category:	NA		
Comment:	P_C at 141 ft nothing visible .Flow direction wrong		
Location Details:		Direction of Survey:	Upstream
US MH:	M-507-100	DS MH:	M-407-013
		Total Length Surveyed (ft):	142.1

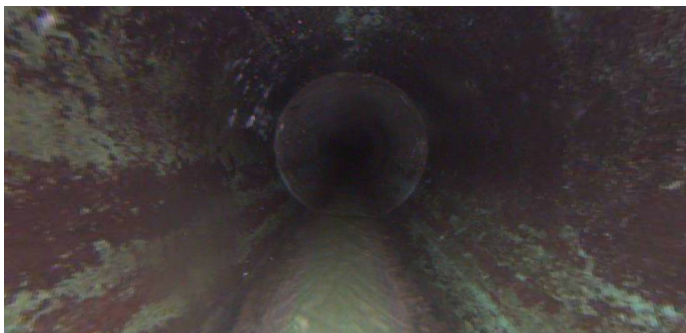
Code: **AMH**
Description: **Manhole**

Distance (ft): **.0**
Structural Grade: **0**
O&M Grade: **0**
Clock Start/From:
Clock To:
1st Value:
2nd Value:
Value Percent:
Continuous Index:
Within 8" of Joint: **NO**
Remarks: **M-407-013**

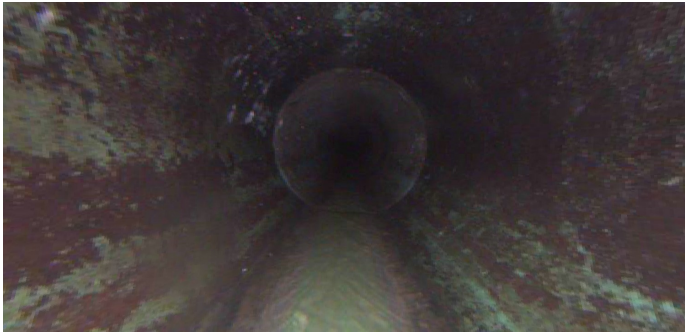
Code:	MWL
Description:	Water Level

Distance (ft):	.0
Structural Grade:	0
O&M Grade:	0
Clock Start/From:	
Clock To:	
1st Value:	
2nd Value:	
Value Percent:	5.000
Continuous Index:	
Within 8" of Joint:	NO
Remarks:

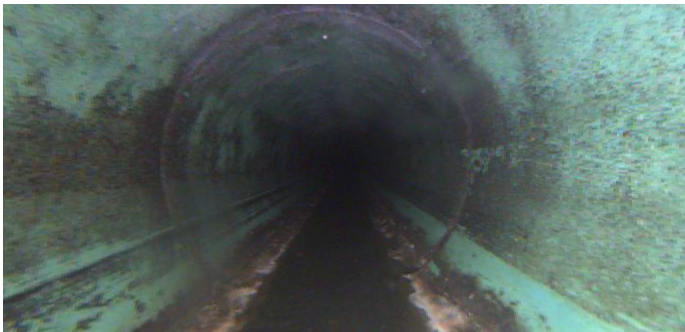
Code:	MSA
Description:	Abandoned Survey

Distance (ft):	142.1
Structural Grade:	0
O&M Grade:	0
Clock Start/From:	
Clock To:	
1st Value:	
2nd Value:	
Value Percent:	
Continuous Index:	
Within 8" of Joint:	NO
Remarks:	camera stopped
