## Profile/Photo Observation Report

Street:	<b>OFF S DECATUR ST</b>	Flow Control:	<b>Not Controlled</b>
City:	<b>Hobart, IN</b>	Year Renewed:	
Location:	<b>Woods</b>	Tape/Media #:	
Purpose:	<b>Routine Assessment</b>	Dia/Height:	<b>8"</b>
Use:	<b>Sanitary</b>	Material:	<b>PVC</b>
Drain Area:	<b>NA</b>	Lining:	
Category:	<b>NA</b>		
Comment:	<b>Flow direction wrong</b>

Location Details:		Direction of Survey:	<b>Downstream</b>
US MH:	<b>M-507-100</b>	DS MH:	<b>M-507-099</b>
		Total Length Surveyed (ft):	<b>279.7</b>

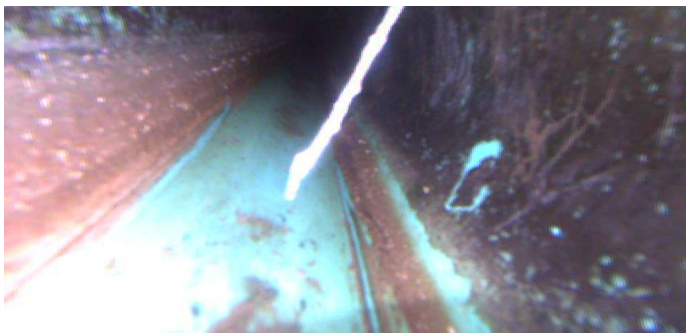
Code: **AMH**  
Description: **Manhole**

Distance (ft): **.0**  
Structural Grade: **0**  
O&M Grade: **0**  
Clock Start/From:  
Clock To:  
1st Value:  
2nd Value:  
Value Percent:  
Continuous Index:  
Within 8" of Joint: **NO**  
Remarks: **M-507-100**

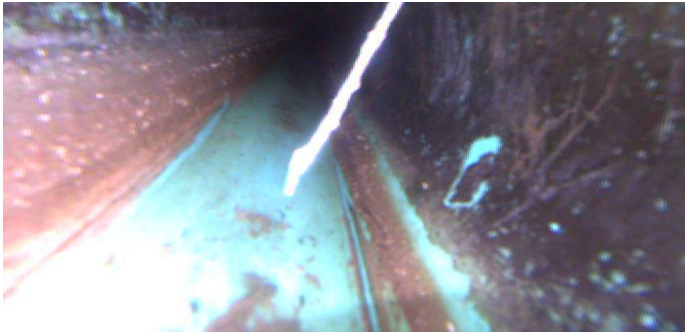
Code:	<b>MWL</b>
Description:	<b>Water Level</b>

Distance (ft):	<b>.0</b>
Structural Grade:	<b>0</b>
O&M Grade:	<b>0</b>
Clock Start/From:	
Clock To:	
1st Value:	
2nd Value:	
Value Percent:	<b>5.000</b>
Continuous Index:	
Within 8" of Joint:	<b>NO</b>
Remarks:

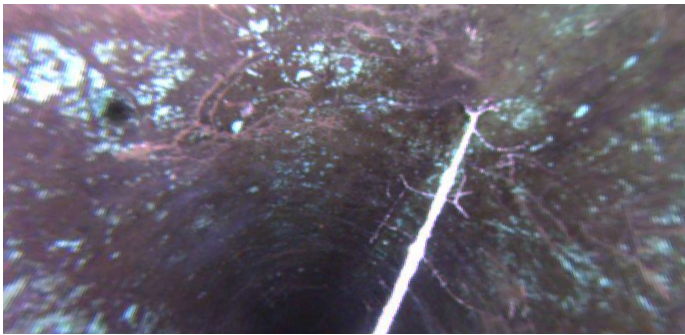
Code:	<b>RFB</b>
Description:	<b>Roots Fine Barrel</b>

Distance (ft):	<b>.0</b>
Structural Grade:	<b>0</b>
O&M Grade:	<b>2</b>
Clock Start/From:	<b>1</b>
Clock To:	
1st Value:	
2nd Value:	
Value Percent:	
Continuous Index:	
Within 8" of Joint:	<b>NO</b>
Remarks:

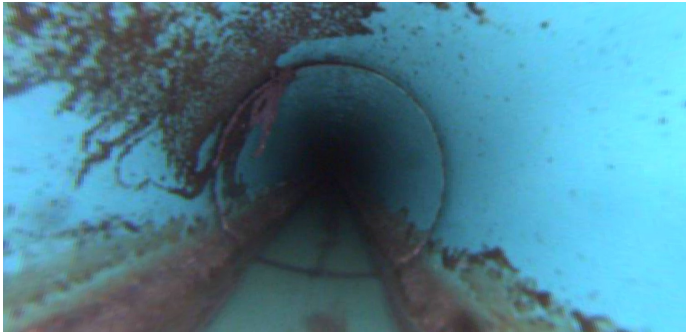
Code: **RFJ**  
Description: **Roots Fine Joint**

Distance (ft): **11.9**  
Structural Grade: **0**  
O&M Grade: **1**  
Clock Start/From: **9**  
Clock To: **12**  
1st Value:  
2nd Value:  
Value Percent:  
Continuous Index:  
Within 8" of Joint: **YES**  
Remarks:

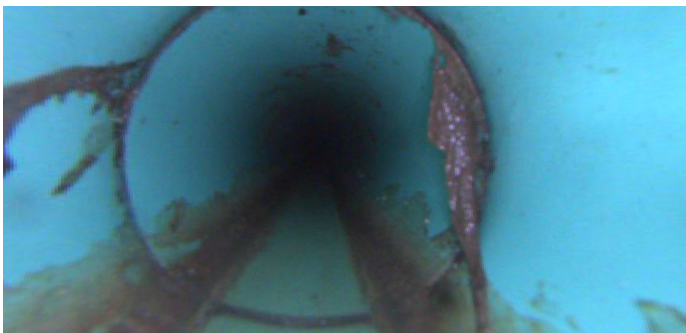
Code: **RFJ**  
Description: **Roots Fine Joint**

Distance (ft): **64.0**  
Structural Grade: **0**  
O&M Grade: **1**  
Clock Start/From: **1**  
Clock To: **5**  
1st Value:  
2nd Value:  
Value Percent:  
Continuous Index:  
Within 8" of Joint: **YES**  
Remarks:

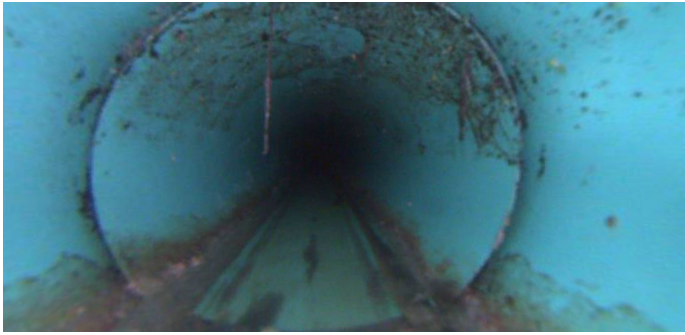
Code: **RFJ**  
Description: **Roots Fine Joint**

Distance (ft): **233.2**  
Structural Grade: **0**  
O&M Grade: **1**  
Clock Start/From: **12**  
Clock To: **1**  
1st Value:  
2nd Value:  
Value Percent:  
Continuous Index:  
Within 8" of Joint: **YES**  
Remarks:

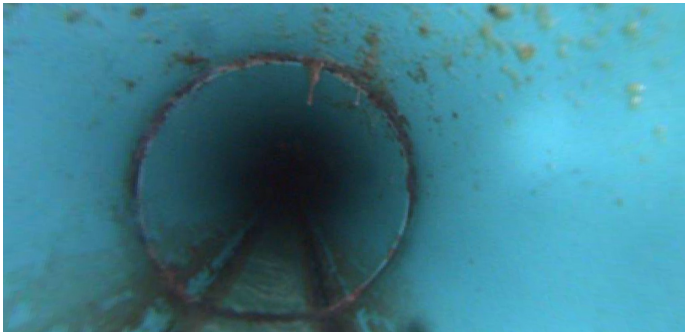
Code: **RFJ**  
Description: **Roots Fine Joint**

Distance (ft): **272.1**  
Structural Grade: **0**  
O&M Grade: **1**  
Clock Start/From: **12**  
Clock To:  
1st Value:  
2nd Value:  
Value Percent:  
Continuous Index:  
Within 8" of Joint: **YES**  
Remarks:

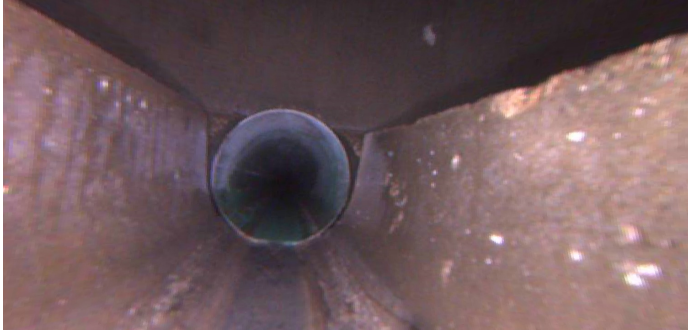
Code:	AMH
Description:	Manhole
Distance (ft):	279.7
Structural Grade:	0
O&M Grade:	0
Clock Start/From:	
Clock To:	
1st Value:	
2nd Value:	
Value Percent:	
Continuous Index:	
Within 8" of Joint:	NO
Remarks:	M-507-099
