Profile/Photo Observation Report

Date:	03/27/2024	Weather:		Coding:	PACP 7.0
Pipe Length (ft):	210.0	Owner:	City of Hobart	Pre Clean:	Heavy Cleaning
P.O.#:		Surveyor:	S. Bucklin	PSR:	P-603-001-049
Customer:	City of Hobart	Clean Date:	03/25/2024	Shape:	C

Street:	W 39TH PL	Flow Control:	De-watered Using Jetter
City:	Hobart, IN	Year Renewed:	
Location:	Easement/Right of Way	Tape/Media #:	
Purpose:	Sewer System Evaluation Survey (SS)	Dia/Height:	10"
Use:	Sanitary Sewage Pipe	Material:	VCP
Drain Area:		Lining:	None
Category:	NA		
Comment:			
Location Details:		Direction of Survey:	Downstream
US MH:	M-603-001	DS MH:	M-604-049
		Total Length Surveyed (ft):	228.2

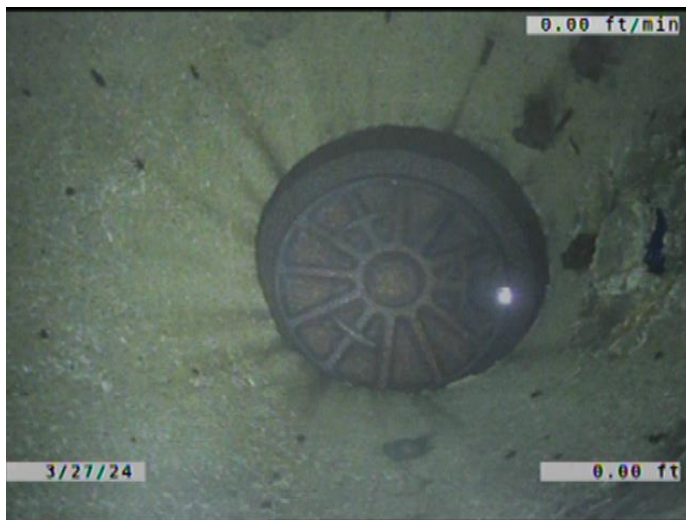
Code:	AMH
Description:	Manhole
Distance (ft):	.0
Structural Grade:	0
O&M Grade:	0
Clock Start/From:	
Clock To:	
1st Value:	
2nd Value:	
Value Percent:	
Continuous Index:	
Within 8" of Joint:	NO
Remarks:	M-603-001

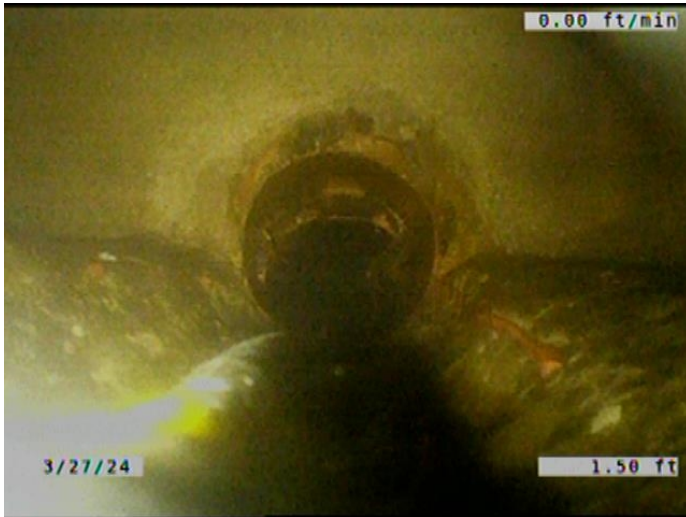
Code:	MGO
Description:	Miscellaneous General Observation
Distance (ft):	1.5
Structural Grade:	0
O&M Grade:	0
Clock Start/From:	
Clock To:	
1st Value:	
2nd Value:	
Value Percent:	
Continuous Index:	
Within 8" of Joint:	NO
Remarks:	BACK UP CAMERA OF THE MANHOLE.

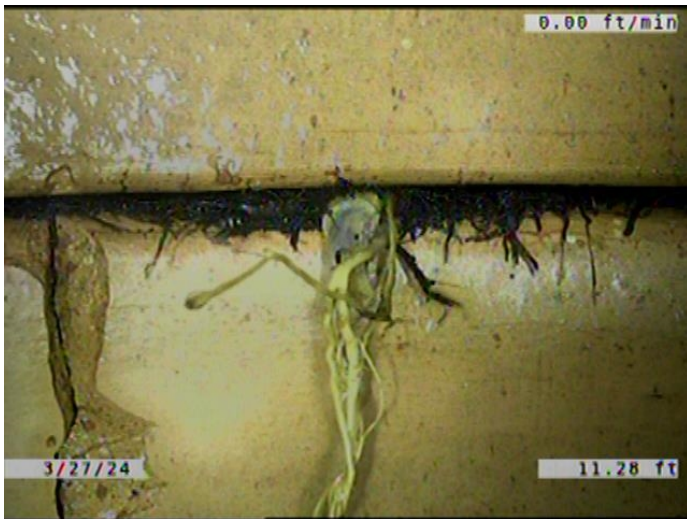
Code: **RFJ**
Description: **Roots Fine Joint**

Distance (ft): **11.3**
Structural Grade: **0**
O&M Grade: **1**
Clock Start/From: **9**
Clock To: **1**
1st Value:
2nd Value:
Value Percent:
Continuous Index:
Within 8" of Joint: **YES**
Remarks:

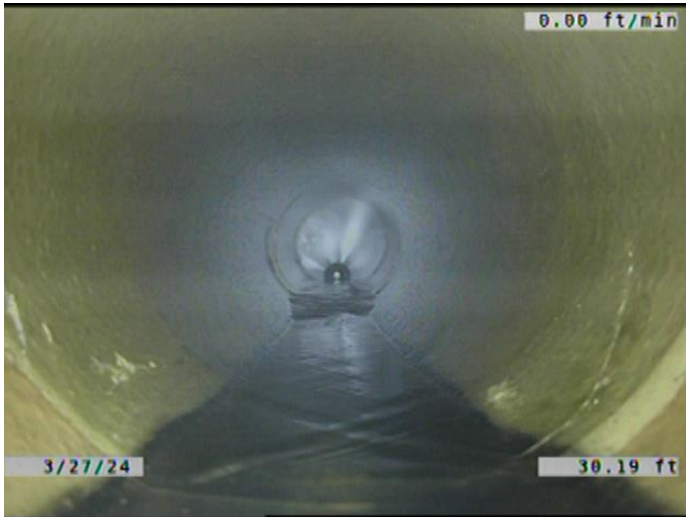
Code: **MWLS**
Description: **Miscellaneous Water Level Sag**

Distance (ft): **30.2**
Structural Grade: **2**
O&M Grade: **0**
Clock Start/From:
Clock To:
1st Value:
2nd Value:
Value Percent: **15.000**
Continuous Index: **F01**
Within 8" of Joint: **NO**
Remarks:

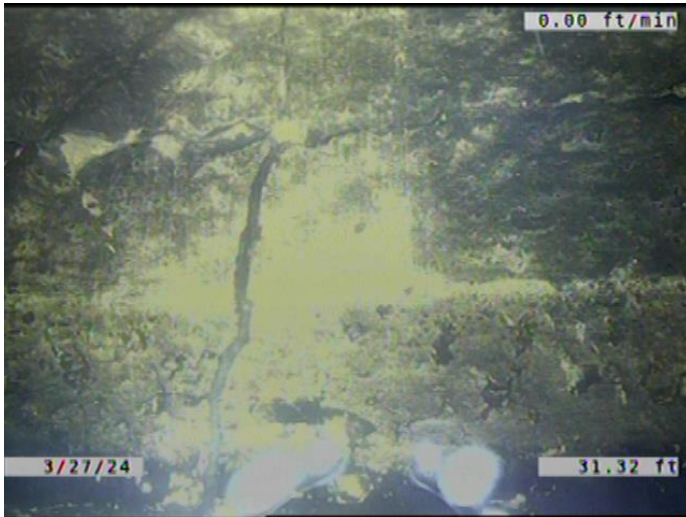
Code: **FM**
 Description: **Fracture Multiple**

Distance (ft): **31.3**
 Structural Grade: **4**
 O&M Grade: **0**
 Clock Start/From: **1**
 Clock To: **8**
 1st Value:
 2nd Value:
 Value Percent:
 Continuous Index:
 Within 8" of Joint: **YES**
 Remarks:

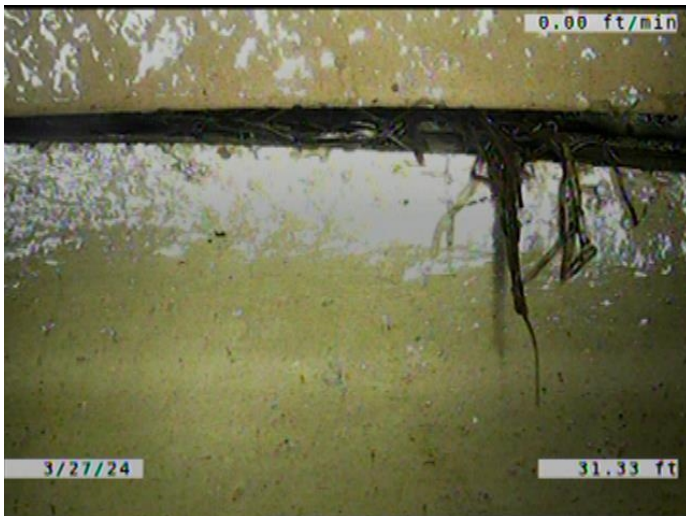
Code: **RFJ**
 Description: **Roots Fine Joint**

Distance (ft): **31.3**
 Structural Grade: **0**
 O&M Grade: **1**
 Clock Start/From: **10**
 Clock To: **11**
 1st Value:
 2nd Value:
 Value Percent:
 Continuous Index:
 Within 8" of Joint: **YES**
 Remarks:

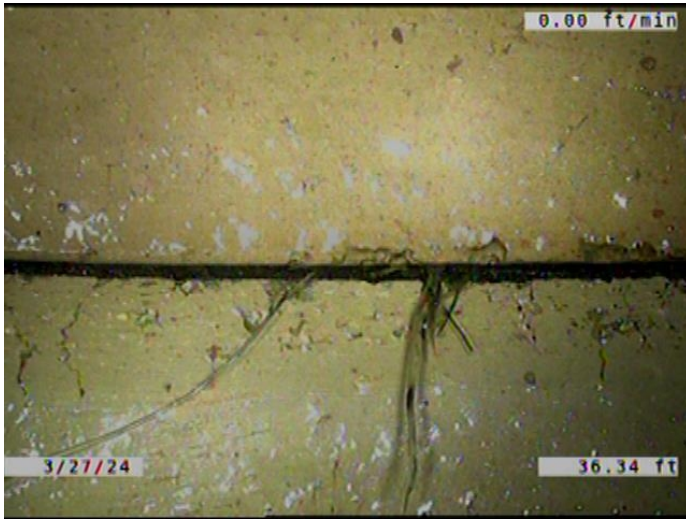
Code: **RFJ**
Description: **Roots Fine Joint**

Distance (ft): **36.3**
Structural Grade: **0**
O&M Grade: **1**
Clock Start/From: **7**
Clock To: **10**
1st Value:
2nd Value:
Value Percent:
Continuous Index:
Within 8" of Joint: **YES**
Remarks:

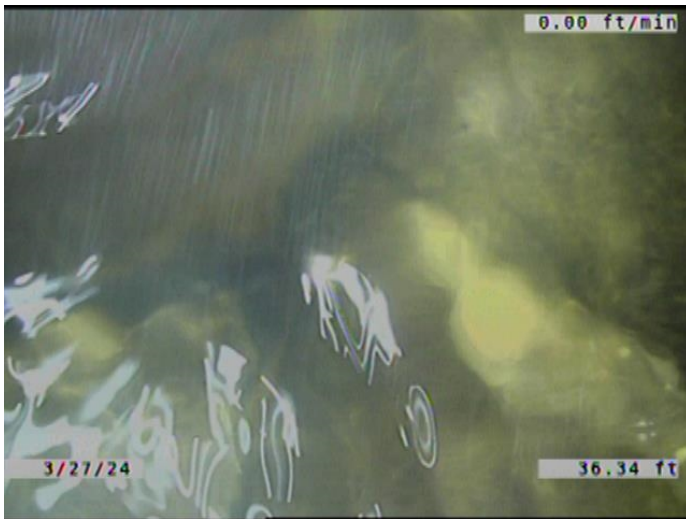
Code: **B**
Description: **Broken**

Distance (ft): **36.3**
Structural Grade: **4**
O&M Grade: **0**
Clock Start/From: **12**
Clock To: **12**
1st Value:
2nd Value:
Value Percent:
Continuous Index:
Within 8" of Joint: **YES**
Remarks:

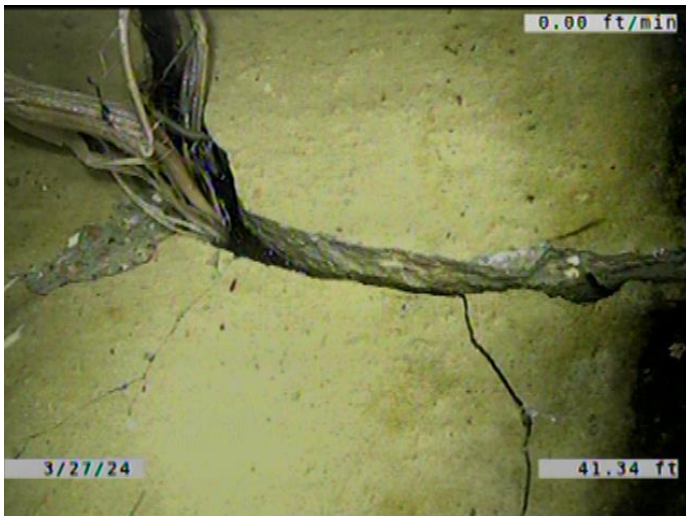
Code: **B**
 Description: **Broken**

Distance (ft): **41.3**
 Structural Grade: **4**
 O&M Grade: **0**
 Clock Start/From: **4**
 Clock To: **12**
 1st Value:
 2nd Value:
 Value Percent:
 Continuous Index:
 Within 8" of Joint: **YES**
 Remarks:

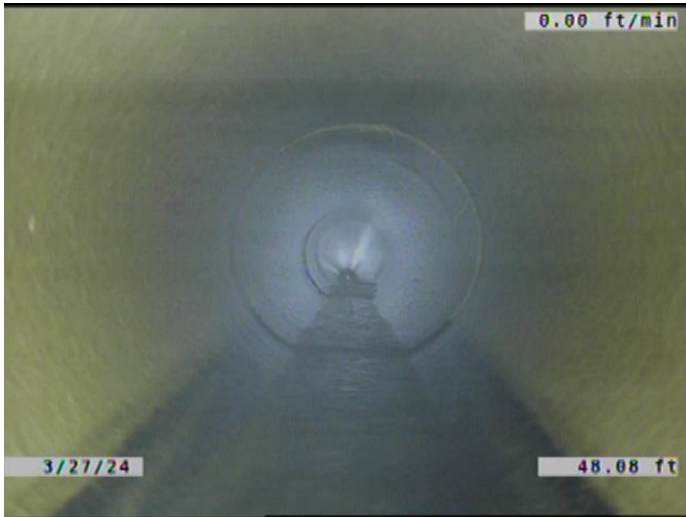
Code: **MWLS**
Description: **Miscellaneous Water Level Sag**

Distance (ft): **48.1**
Structural Grade: **2**
O&M Grade: **0**
Clock Start/From:
Clock To:
1st Value:
2nd Value:
Value Percent: **25.000**
Continuous Index: **S02**
Within 8" of Joint: **NO**
Remarks:

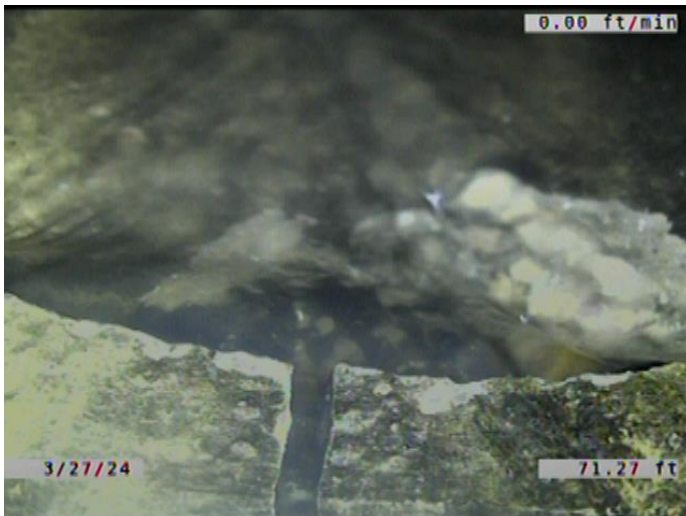
Code: **SMW**
Description: **Surface Damage Missing Wall**

Distance (ft): **71.3**
Structural Grade: **5**
O&M Grade: **0**
Clock Start/From: **5**
Clock To: **7**
1st Value:
2nd Value:
Value Percent:
Continuous Index:
Within 8" of Joint: **YES**
Remarks:

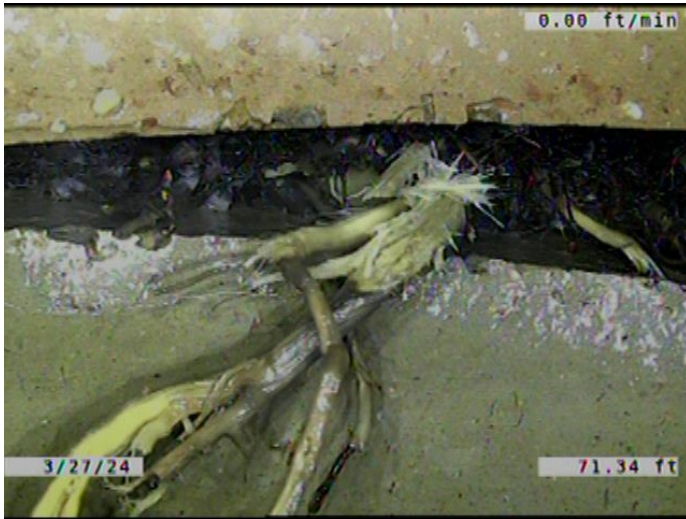
Code: **RFJ**
Description: **Roots Fine Joint**

Distance (ft): **71.3**
Structural Grade: **0**
O&M Grade: **1**
Clock Start/From: **8**
Clock To: **4**
1st Value:
2nd Value:
Value Percent:
Continuous Index:
Within 8" of Joint: **YES**
Remarks:

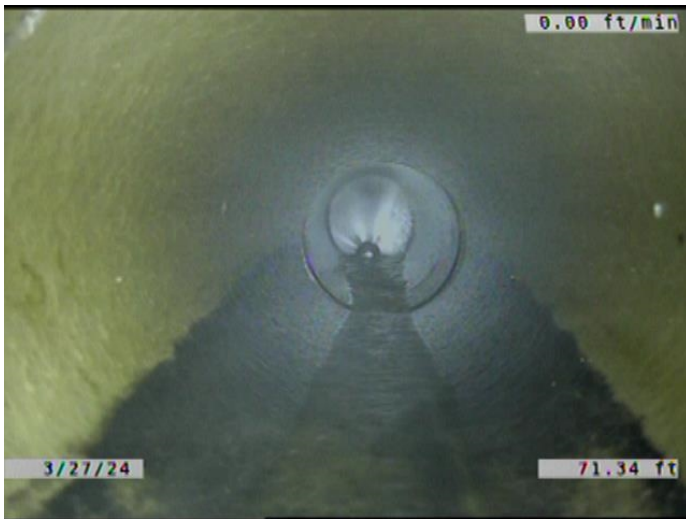
Code: **LD**
Description: **Line Down**

Distance (ft): **71.3**
Structural Grade: **0**
O&M Grade: **1**
Clock Start/From:
Clock To:
1st Value:
2nd Value:
Value Percent: **10.000**
Continuous Index:
Within 8" of Joint: **NO**
Remarks:

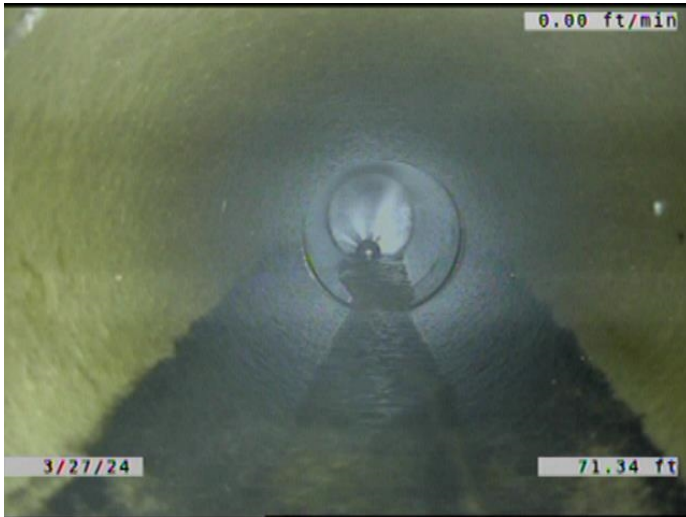
Code: **MWLS**
Description: **Miscellaneous Water Level Sag**

Distance (ft): **71.3**
Structural Grade: **2**
O&M Grade: **0**
Clock Start/From:
Clock To:
1st Value:
2nd Value:
Value Percent: **15.000**
Continuous Index: **S03**
Within 8" of Joint: **NO**
Remarks:

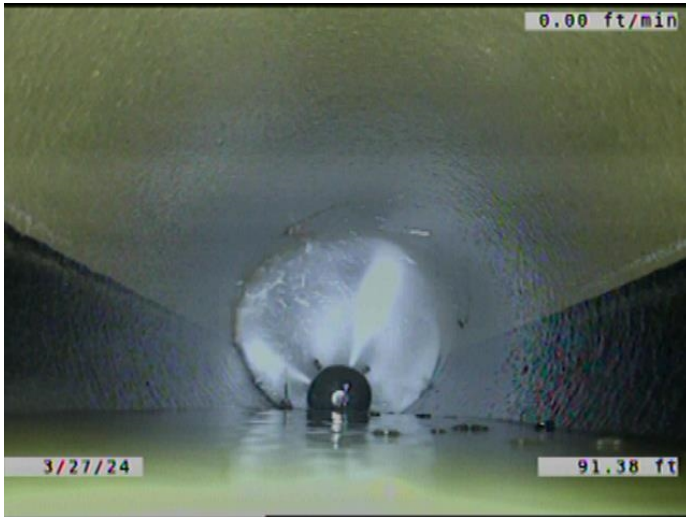
Code: **RFB**
Description: **Roots Fine Barrel**

Distance (ft): **91.4**
Structural Grade: **0**
O&M Grade: **2**
Clock Start/From: **11**
Clock To: **1**
1st Value:
2nd Value:
Value Percent:
Continuous Index: **F06**
Within 8" of Joint: **NO**
Remarks:

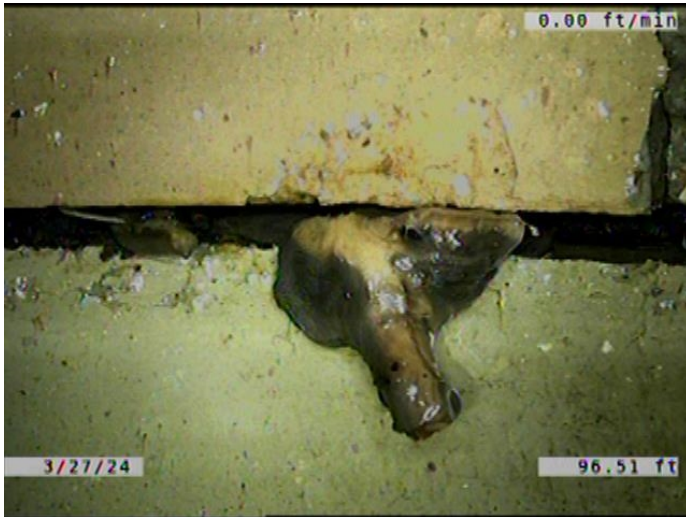
Code: **RFJ**
Description: **Roots Fine Joint**

Distance (ft): **96.5**
Structural Grade: **0**
O&M Grade: **1**
Clock Start/From: **8**
Clock To: **4**
1st Value:
2nd Value:
Value Percent:
Continuous Index:
Within 8" of Joint: **YES**
Remarks:

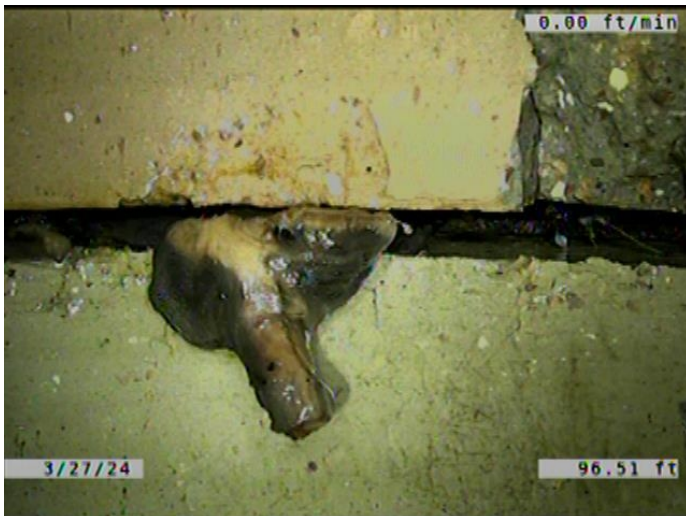
Code: **IWJ**
Description: **Infiltration Weeper Joint**

Distance (ft): **96.5**
Structural Grade: **0**
O&M Grade: **2**
Clock Start/From: **10**
Clock To: **2**
1st Value:
2nd Value:
Value Percent:
Continuous Index:
Within 8" of Joint: **YES**
Remarks:

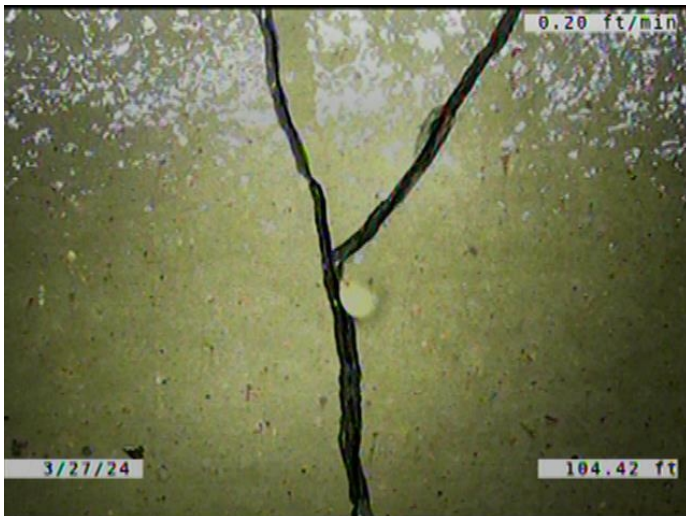
Code: **IWB**
Description: **Infiltration Weeper Barrel**

Distance (ft): **104.4**
Structural Grade: **0**
O&M Grade: **2**
Clock Start/From: **11**
Clock To: **1**
1st Value:
2nd Value:
Value Percent:
Continuous Index: **S09**
Within 8" of Joint: **YES**
Remarks:

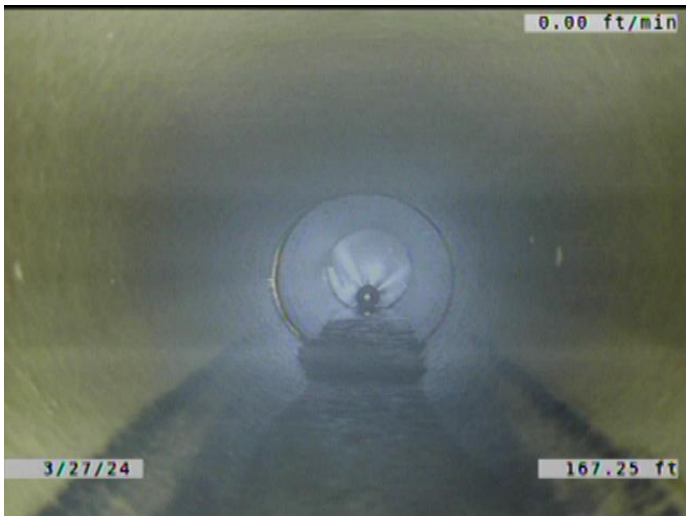
Code: **RFJ**
Description: **Roots Fine Joint**

Distance (ft): **151.9**
Structural Grade: **0**
O&M Grade: **1**
Clock Start/From: **2**
Clock To: **3**
1st Value:
2nd Value:
Value Percent:
Continuous Index:
Within 8" of Joint: **YES**
Remarks:

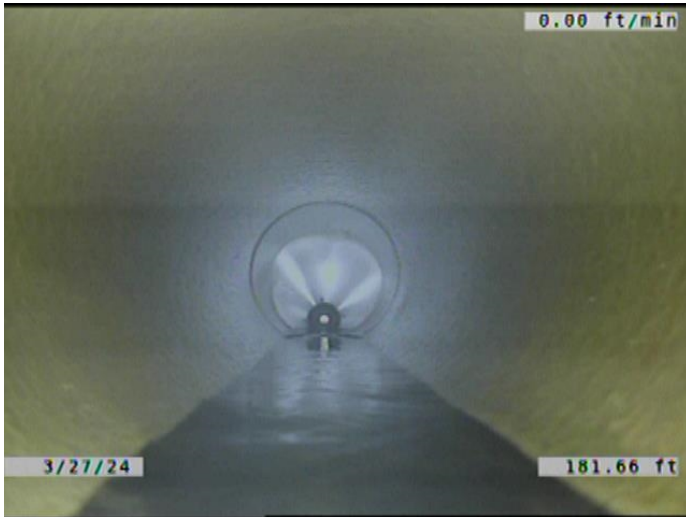
Code: **MWLS**
Description: **Miscellaneous Water Level Sag**

Distance (ft): **167.2**
Structural Grade: **2**
O&M Grade: **0**
Clock Start/From:
Clock To:
1st Value:
2nd Value:
Value Percent: **25.000**
Continuous Index: **S11**
Within 8" of Joint: **NO**
Remarks:

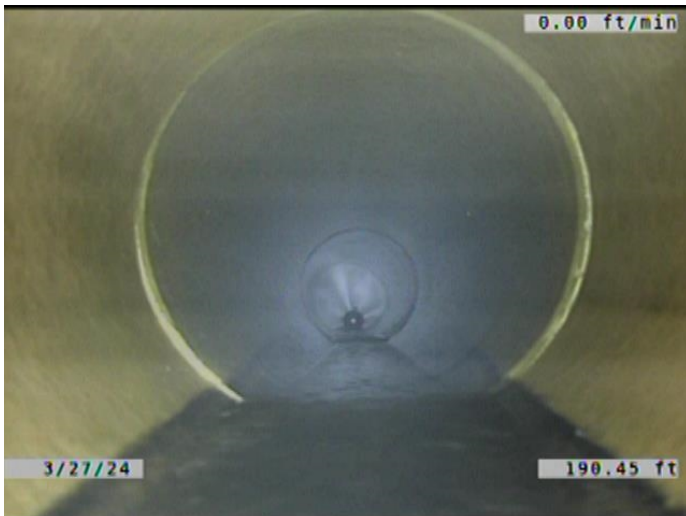
Code: **MWLS**
Description: **Miscellaneous Water Level Sag**

Distance (ft): **181.7**
Structural Grade: **2**
O&M Grade: **0**
Clock Start/From:
Clock To:
1st Value:
2nd Value:
Value Percent: **25.000**
Continuous Index: **F11**
Within 8" of Joint: **NO**
Remarks:

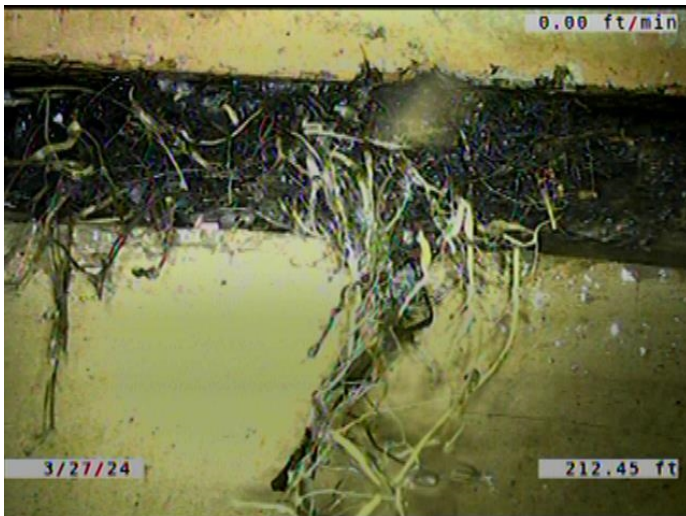
Code: **RFJ**
Description: **Roots Fine Joint**

Distance (ft): **207.3**
Structural Grade: **0**
O&M Grade: **1**
Clock Start/From: **1**
Clock To: **2**
1st Value:
2nd Value:
Value Percent:
Continuous Index:
Within 8" of Joint: **YES**
Remarks:

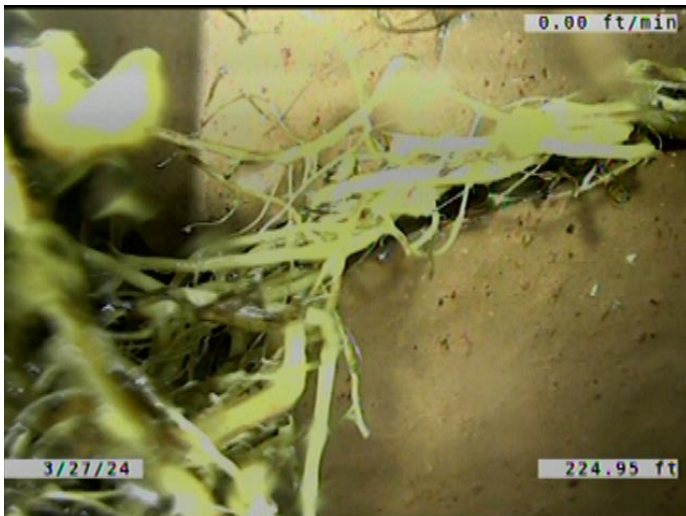
Code: **RMB**
 Description: **Roots Medium Barrel**

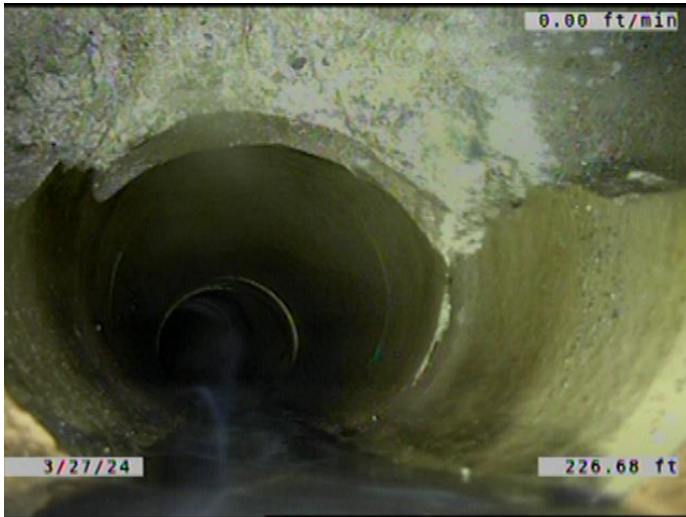
Distance (ft): **224.9**
 Structural Grade: **0**
 O&M Grade: **4**
 Clock Start/From: **7**
 Clock To: **9**
 1st Value:
 2nd Value:
 Value Percent: **5.000**
 Continuous Index:
 Within 8" of Joint: **NO**
 Remarks:

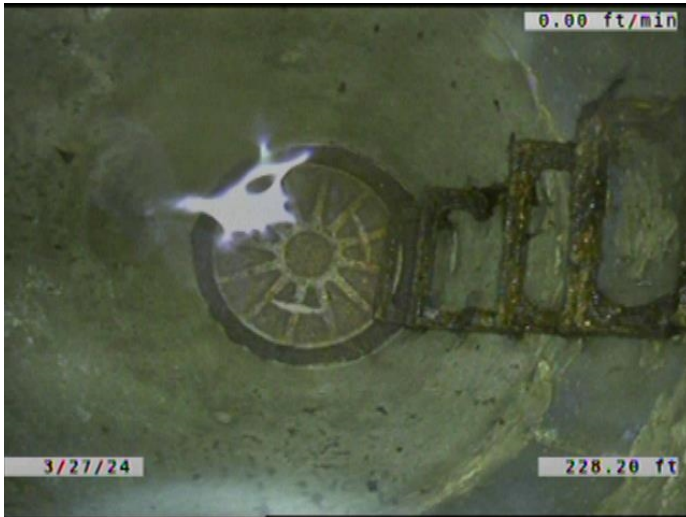
Code:	AMH
Description:	Manhole
Distance (ft):	228.2
Structural Grade:	0
O&M Grade:	0
Clock Start/From:	
Clock To:	
1st Value:	
2nd Value:	
Value Percent:	
Continuous Index:	
Within 8" of Joint:	NO
Remarks:	M-604-049
