Profile/Photo Observation Report

Street:	W 40th ave	Flow Control:	Not Controlled
City:	Hobart, IN	Year Renewed:	
Location:	Other	Tape/Media #:	
Purpose:	Not Known	Dia/Height:	10"
Use:	Sanitary	Material:	VCP
Drain Area:	NA	Lining:	
Category:	NA		
Comment:

Location Details:		Direction of Survey:	Upstream
US MH:	M-603-002	DS MH:	M-603-003
		Total Length Surveyed (ft):	5.5

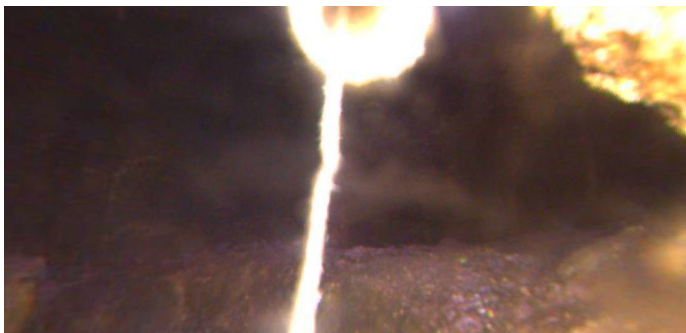
Code: **AMH**
Description: **Manhole**

Distance (ft): **.0**
Structural Grade: **0**
O&M Grade: **0**
Clock Start/From:
Clock To:
1st Value:
2nd Value:
Value Percent:
Continuous Index:
Within 8" of Joint: **NO**
Remarks: **M-603-002**

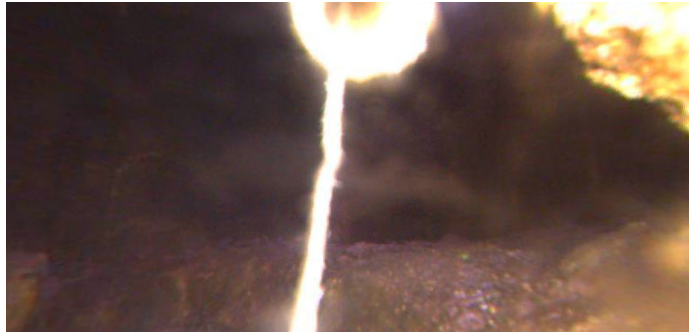
Code: **MWL**
Description: **Water Level**

Distance (ft): **.0**
Structural Grade: **0**
O&M Grade: **0**
Clock Start/From:
Clock To:
1st Value:
2nd Value:
Value Percent: **5.000**
Continuous Index:
Within 8" of Joint: **NO**
Remarks:

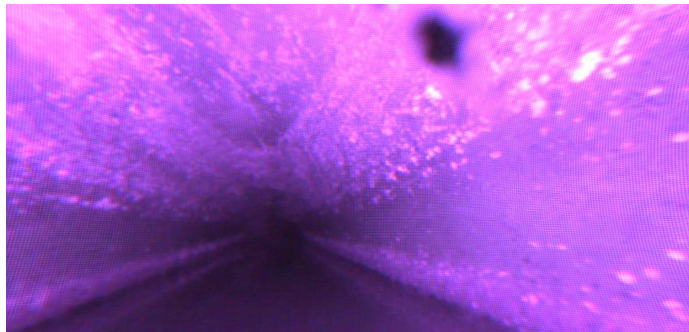
Code: **MSA**
Description: **Abandoned Survey**

Distance (ft): **5.5**
Structural Grade: **0**
O&M Grade: **0**
Clock Start/From:
Clock To:
1st Value:
2nd Value:
Value Percent:
Continuous Index:
Within 8" of Joint: **NO**
Remarks: **debris**
