Profile/Photo Observation Report

Street:	OFF W 39TH PL	Flow Control:	Not Controlled
City:	Hobart, IN	Year Renewed:	
Location:	Other	Tape/Media #:	
Purpose:	Not Known	Dia/Height:	8"
Use:	Sanitary	Material:	VCP
Drain Area:	NA	Lining:	
Category:	NA		
Comment:

Location Details:		Direction of Survey:	Upstream
US MH:	M-603-003	DS MH:	M-603-026
		Total Length Surveyed (ft):	76.7

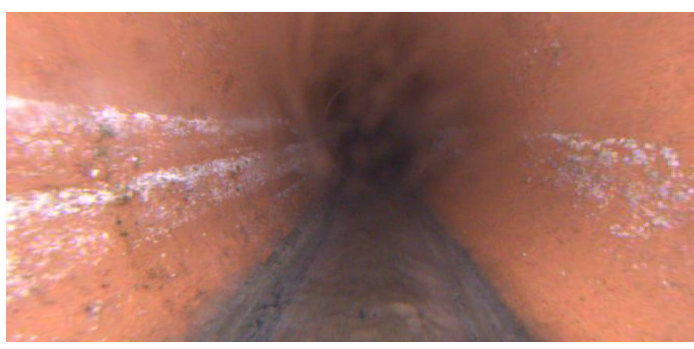
Code: **AMH**
Description: **Manhole**

Distance (ft): **.0**
Structural Grade: **0**
O&M Grade: **0**
Clock Start/From:
Clock To:
1st Value:
2nd Value:
Value Percent:
Continuous Index:
Within 8" of Joint: **NO**
Remarks: **M-603-003**

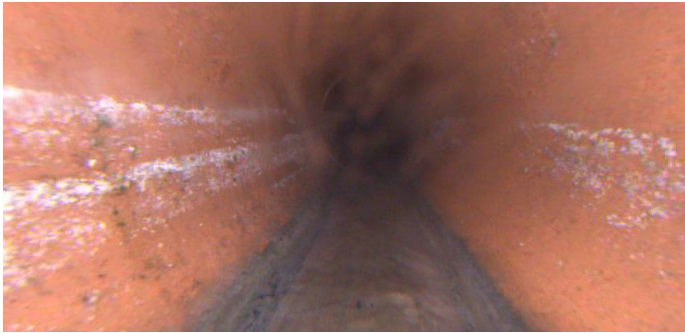
Code:	MWL
Description:	Water Level

Distance (ft):	.0
Structural Grade:	0
O&M Grade:	0
Clock Start/From:	
Clock To:	
1st Value:	
2nd Value:	
Value Percent:	5.000
Continuous Index:	
Within 8" of Joint:	NO
Remarks:

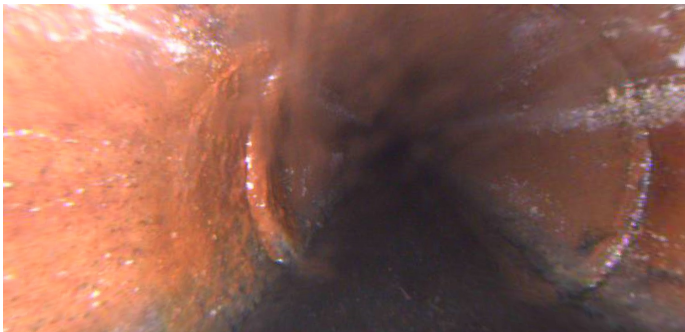
Code:	IW
Description:	Infil Weeper

Distance (ft):	26.9
Structural Grade:	0
O&M Grade:	2
Clock Start/From:	8
Clock To:	10
1st Value:	
2nd Value:	
Value Percent:	
Continuous Index:	
Within 8" of Joint:	YES
Remarks:

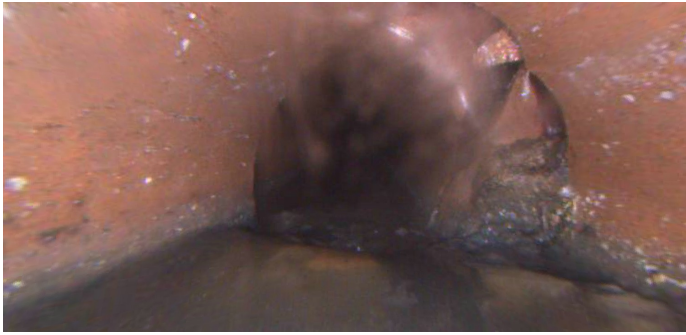
Code: **BVV**
Description: **Broken Void Visible**

Distance (ft): **75.9**
Structural Grade: **5**
O&M Grade: **0**
Clock Start/From: **1**
Clock To: **4**
1st Value:
2nd Value:
Value Percent:
Continuous Index:
Within 8" of Joint: **YES**
Remarks:

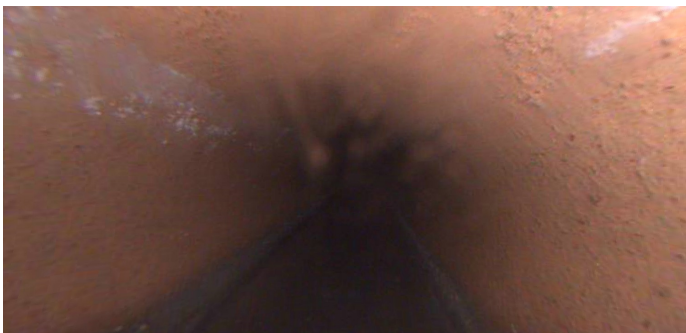
Code: **MSA**
Description: **Abandoned Survey**

Distance (ft): **76.7**
Structural Grade: **0**
O&M Grade: **0**
Clock Start/From:
Clock To:
1st Value:
2nd Value:
Value Percent:
Continuous Index:
Within 8" of Joint: **NO**
Remarks: **bvv**
