Profile/Photo Observation Report

Date:	04/11/2018	Weather:		Coding:	PACP 6.0
Pipe Length (ft):	122.7	Owner:	NA	Pre Clean:	Not Known
P.O.#:		Surveyor:	Jen Costello	PSR:	P-603-008-007
Customer:		Clean Date:	01/01/1900	Shape:	C

Street:	W 40TH PL	Flow Control:	Not Controlled
City:	Hobart, IN	Year Renewed:	
Location:	Other	Tape/Media #:	
Purpose:	Not Known	Dia/Height:	10"
Use:	Sanitary	Material:	VCP
Drain Area:	NA	Lining:	
Category:	NA		
Comment:

Location Details:		Direction of Survey:	Downstream
US MH:	M-603-007	DS MH:	M-603-008
		Total Length Surveyed (ft):	32.2

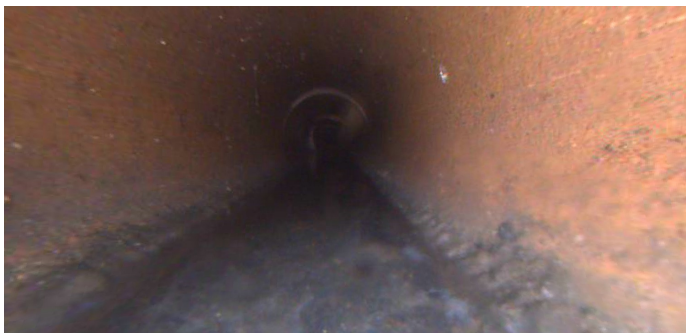
Code: **AMH**
Description: **Manhole**

Distance (ft): **.0**
Structural Grade: **0**
O&M Grade: **0**
Clock Start/From:
Clock To:
1st Value:
2nd Value:
Value Percent:
Continuous Index:
Within 8" of Joint: **NO**
Remarks: **M-603-007**

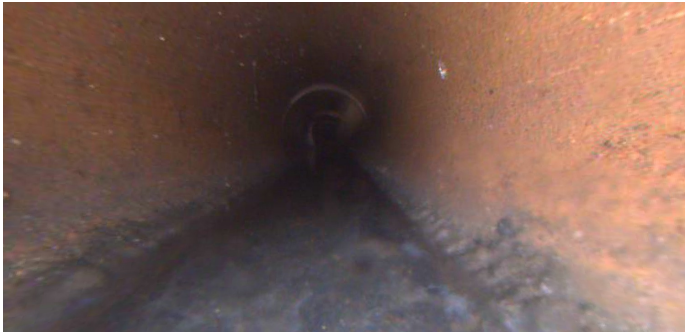
Code:	MWL
Description:	Water Level

Distance (ft):	.0
Structural Grade:	0
O&M Grade:	0
Clock Start/From:	
Clock To:	
1st Value:	
2nd Value:	
Value Percent:	10.000
Continuous Index:	
Within 8" of Joint:	NO
Remarks:

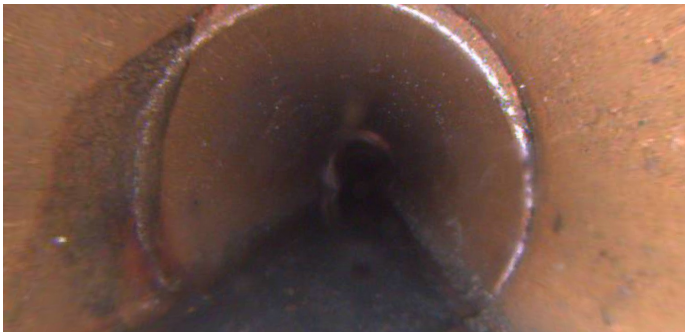
Code:	IW
Description:	Infil Weeper

Distance (ft):	3.6
Structural Grade:	0
O&M Grade:	2
Clock Start/From:	8
Clock To:	10
1st Value:	
2nd Value:	
Value Percent:	
Continuous Index:	
Within 8" of Joint:	YES
Remarks:

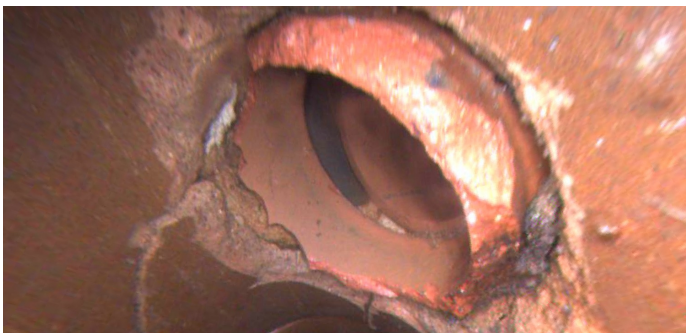
Code: **TBI**
Description: **Tap Break-in Intruding**

Distance (ft): **6.0**
Structural Grade: **0**
O&M Grade: **2**
Clock Start/From: **12**
Clock To:
1st Value: **4.000**
2nd Value: **1.000**
Value Percent:
Continuous Index:
Within 8" of Joint:
Remarks:

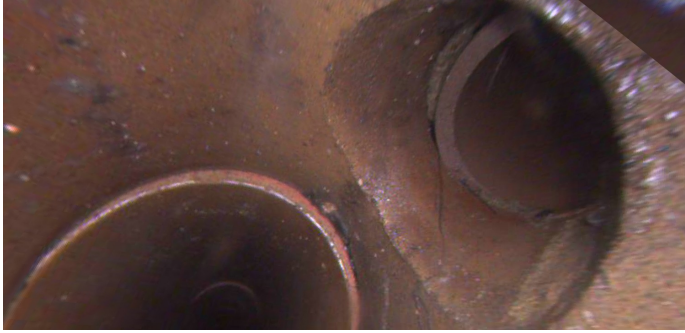
Code: **TF**
Description: **Tap Factory**

Distance (ft): **12.3**
Structural Grade: **0**
O&M Grade: **0**
Clock Start/From: **2**
Clock To:
1st Value: **4.000**
2nd Value:
Value Percent:
Continuous Index:
Within 8" of Joint:
Remarks:

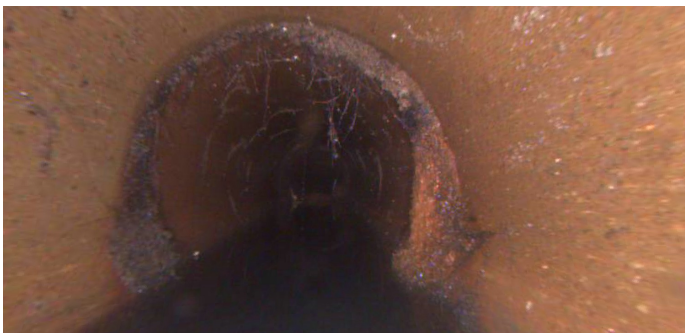
Code: **DAE**
Description: **Deposits Attached Encrustation**

Distance (ft): **27.8**
Structural Grade: **0**
O&M Grade: **2**
Clock Start/From: **8**
Clock To: **4**
1st Value:
2nd Value:
Value Percent: **5.000**
Continuous Index:
Within 8" of Joint: **YES**
Remarks:

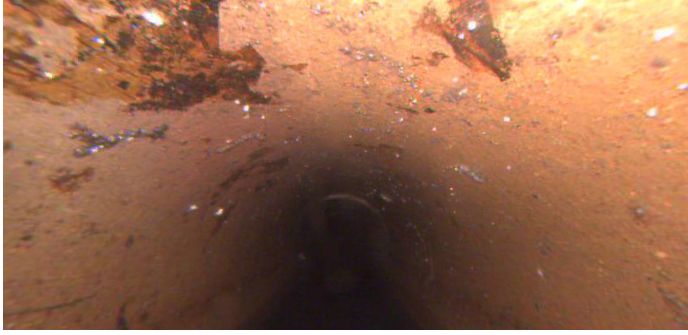
Code:	MSA
Description:	Abandoned Survey
Distance (ft):	32.2
Structural Grade:	0
O&M Grade:	0
Clock Start/From:	
Clock To:	
1st Value:	
2nd Value:	
Value Percent:	
Continuous Index:	
Within 8" of Joint:	NO
Remarks:	rmj
