Profile/Photo Observation Report

Street:	W 40th ave	Flow Control:	Not Controlled
City:	Hobart, IN	Year Renewed:	
Location:	Other	Tape/Media #:	
Purpose:	Not Known	Dia/Height:	10"
Use:	Sanitary	Material:	VCP
Drain Area:	NA	Lining:	
Category:	NA		
Comment:

Location Details:		Direction of Survey:	Downstream
US MH:	M-603-007	DS MH:	M-603-009
		Total Length Surveyed (ft):	4.7

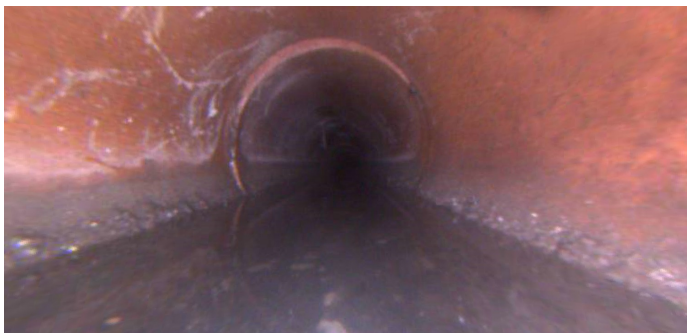
Code: **AMH**
Description: **Manhole**

Distance (ft): **.0**
Structural Grade: **0**
O&M Grade: **0**
Clock Start/From:
Clock To:
1st Value:
2nd Value:
Value Percent:
Continuous Index:
Within 8" of Joint: **NO**
Remarks: **M-603-007**

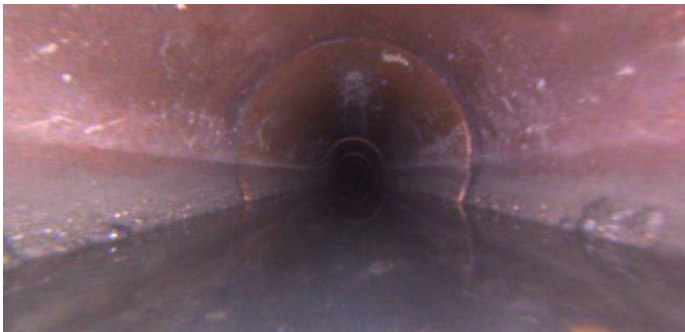
Code:	MSA
Description:	Abandoned Survey

Distance (ft):	4.7
Structural Grade:	0
O&M Grade:	0
Clock Start/From:	
Clock To:	
1st Value:	
2nd Value:	
Value Percent:	
Continuous Index:	
Within 8" of Joint:	NO
Remarks:	debris under water
