Profile/Photo Observation Report

Date:	04/11/2018	Weather:		Coding:	PACP 6.0
Pipe Length (ft):	281.6	Owner:	NA	Pre Clean:	Not Known
P.O.#:		Surveyor:	Jen Costello	PSR:	P-603-022-007
Customer:		Clean Date:	01/01/1900	Shape:	C

Street:	W 40TH PL	Flow Control:	Not Controlled
City:	Hobart, IN	Year Renewed:	
Location:	Other	Tape/Media #:	
Purpose:	Not Known	Dia/Height:	8"
Use:	Sanitary	Material:	VCP
Drain Area:	NA	Lining:	
Category:	NA		
Comment:

Location Details:		Direction of Survey:	Downstream
US MH:	M-603-007	DS MH:	M-603-022
		Total Length Surveyed (ft):	276.0

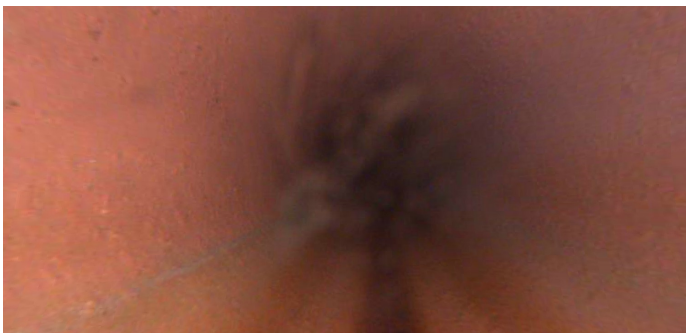
Code: **MMC**
Description: **Material Change**

Distance (ft): **12.2**
Structural Grade: **0**
O&M Grade: **0**
Clock Start/From:
Clock To:
1st Value:
2nd Value:
Value Percent:
Continuous Index:
Within 8" of Joint: **NO**
Remarks: **vcp**

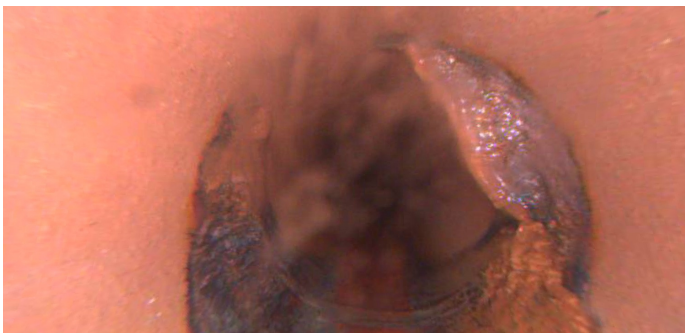
Code: **DAE**
Description: **Deposits Attached Encrustation**

Distance (ft): **75.2**
Structural Grade: **0**
O&M Grade: **2**
Clock Start/From: **8**
Clock To: **4**
1st Value:
2nd Value:
Value Percent: **10.000**
Continuous Index:
Within 8" of Joint: **YES**
Remarks:

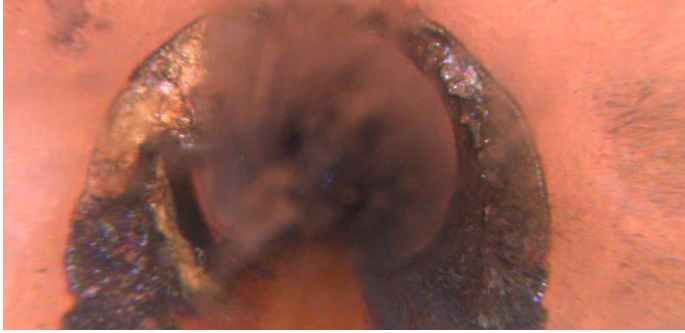
Code: **DAE**
Description: **Deposits Attached Encrustation**

Distance (ft): **272.8**
Structural Grade: **0**
O&M Grade: **2**
Clock Start/From: **7**
Clock To: **5**
1st Value:
2nd Value:
Value Percent: **10.000**
Continuous Index:
Within 8" of Joint: **YES**
Remarks:

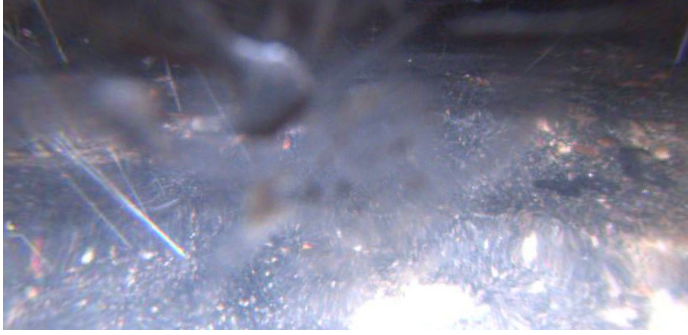
Code:	AMH
Description:	Manhole
Distance (ft):	276.0
Structural Grade:	0
O&M Grade:	0
Clock Start/From:	
Clock To:	
1st Value:	
2nd Value:	
Value Percent:	
Continuous Index:	
Within 8" of Joint:	NO
Remarks:	M-603-022
