## Profile/Photo Observation Report

Date:	<b>04/11/2018</b>	Weather:		Coding:	<b>PACP 6.0</b>
Pipe Length (ft):	<b>281.6</b>	Owner:	<b>NA</b>	Pre Clean:	<b>Not Known</b>
P.O.#:		Surveyor:	<b>Jen Costello</b>	PSR:	<b>P-603-022-007</b>
Customer:		Clean Date:	<b>01/01/1900</b>	Shape:	<b>C</b>

Street:	<b>W 40th ave</b>	Flow Control:	<b>Not Controlled</b>
City:	<b>Hobart, IN</b>	Year Renewed:	
Location:	<b>Other</b>	Tape/Media #:	
Purpose:	<b>Not Known</b>	Dia/Height:	<b>8"</b>
Use:	<b>Sanitary</b>	Material:	<b>VCP</b>
Drain Area:	<b>NA</b>	Lining:	
Category:	<b>NA</b>		
Comment:

Location Details:		Direction of Survey:	<b>Downstream</b>
US MH:	<b>M-603-007</b>	DS MH:	<b>M-603-022</b>
		Total Length Surveyed (ft):	<b>276.0</b>

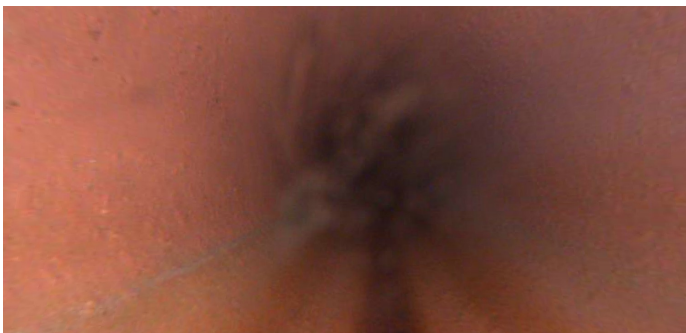
Code: **MMC**  
Description: **Material Change**

Distance (ft): **12.2**  
Structural Grade: **0**  
O&M Grade: **0**  
Clock Start/From:  
Clock To:  
1st Value:  
2nd Value:  
Value Percent:  
Continuous Index:  
Within 8" of Joint: **NO**  
Remarks: **vcp**

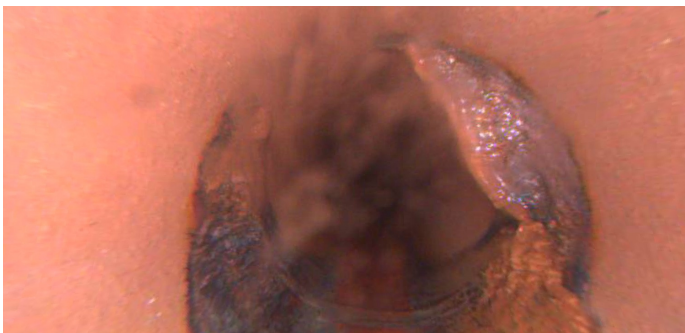
Code: **DAE**  
Description: **Deposits Attached Encrustation**

Distance (ft): **75.2**  
Structural Grade: **0**  
O&M Grade: **2**  
Clock Start/From: **8**  
Clock To: **4**  
1st Value:  
2nd Value:  
Value Percent: **10.000**  
Continuous Index:  
Within 8" of Joint: **YES**  
Remarks:

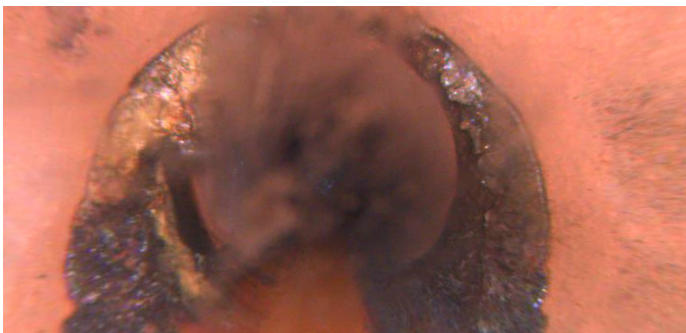
Code: **IW**  
Description: **Infil Weeper**

Distance (ft): **272.8**  
Structural Grade: **0**  
O&M Grade: **2**  
Clock Start/From: **8**  
Clock To: **4**  
1st Value:  
2nd Value:  
Value Percent:  
Continuous Index:  
Within 8" of Joint: **YES**  
Remarks:
