Profile/Photo Observation Report

Street:	W 39TH PL	Flow Control:	Not Controlled
City:	Hobart, IN	Year Renewed:	
Location:	Other	Tape/Media #:	
Purpose:	Not Known	Dia/Height:	8"
Use:	Sanitary	Material:	VCP
Drain Area:	NA	Lining:	
Category:	NA		
Comment:

Location Details:		Direction of Survey:	Downstream
US MH:	M-603-010	DS MH:	M-603-011
		Total Length Surveyed (ft):	29.7

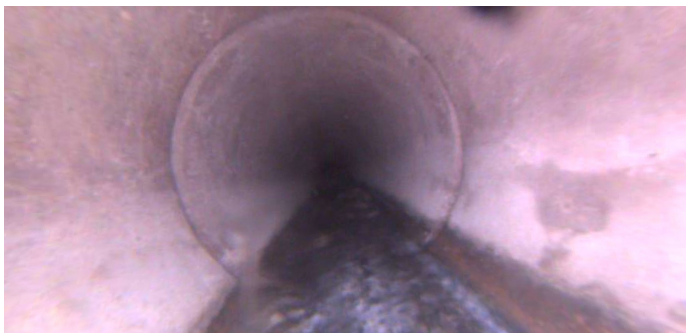
Code: **AMH**
Description: **Manhole**

Distance (ft): **.0**
Structural Grade: **0**
O&M Grade: **0**
Clock Start/From:
Clock To:
1st Value:
2nd Value:
Value Percent:
Continuous Index:
Within 8" of Joint: **NO**
Remarks: **M-603-010**

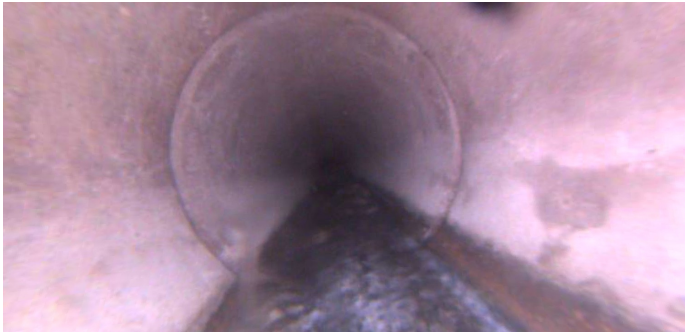
Code:	MWL
Description:	Water Level

Distance (ft):	.0
Structural Grade:	0
O&M Grade:	0
Clock Start/From:	
Clock To:	
1st Value:	
2nd Value:	
Value Percent:	5.000
Continuous Index:	
Within 8" of Joint:	NO
Remarks:

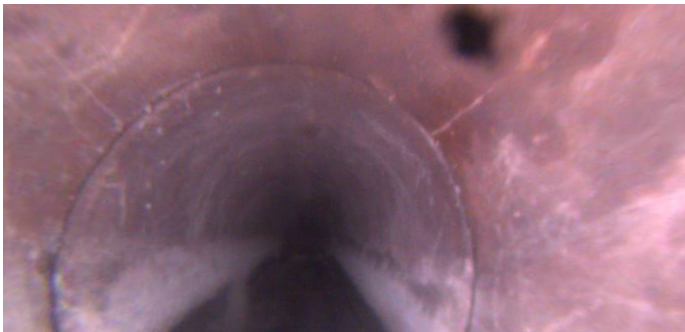
Code:	CM
Description:	Crack Multiple

Distance (ft):	10.6
Structural Grade:	3
O&M Grade:	0
Clock Start/From:	10
Clock To:	2
1st Value:	
2nd Value:	
Value Percent:	
Continuous Index:	
Within 8" of Joint:	YES
Remarks:

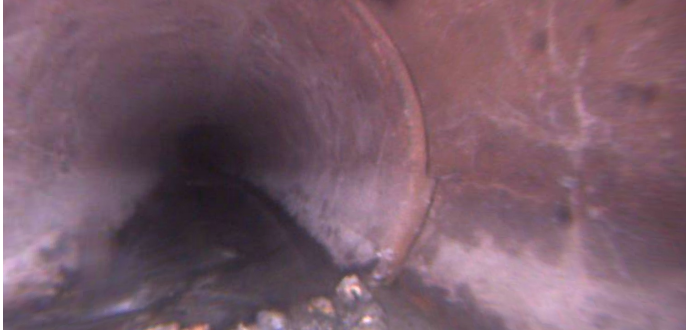
Code: **CL**
Description: **Crack Longitudinal**

Distance (ft): **13.7**
Structural Grade: **2**
O&M Grade: **0**
Clock Start/From: **3**
Clock To:
1st Value:
2nd Value:
Value Percent:
Continuous Index:
Within 8" of Joint: **YES**
Remarks:

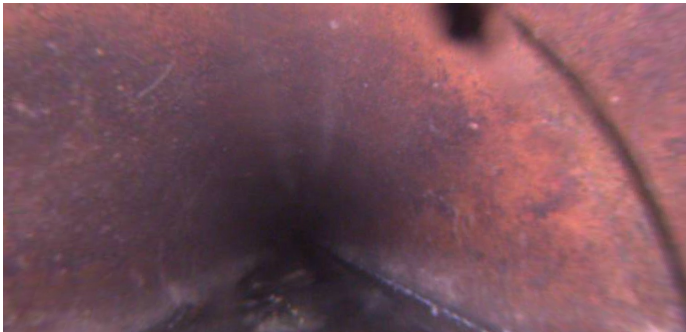
Code: **MSA**
Description: **Abandoned Survey**

Distance (ft): **29.7**
Structural Grade: **0**
O&M Grade: **0**
Clock Start/From:
Clock To:
1st Value:
2nd Value:
Value Percent:
Continuous Index:
Within 8" of Joint: **NO**
Remarks: **DEBRIS UNDER WATER**
