## Profile/Photo Observation Report

Date:	<b>08/04/2023</b>	Weather:		Coding:	<b>PACP 7.0</b>
Pipe Length (ft):	<b>48.5</b>	Owner:	<b>City of Hobart</b>	Pre Clean:	<b>Heavy Cleaning</b>
P.O.#:	<b>YES502259</b>	Surveyor:	<b>S. Bucklin</b>	PSR:	<b>P-603-012-011</b>
Customer:	<b>City of Hobart</b>	Clean Date:	<b>03/24/2023</b>	Shape:	<b>C</b>

Street:	<b>West 39th Place</b>	Flow Control:	<b>Not Controlled</b>
City:	<b>Hobart, IN</b>	Year Renewed:	
Location:	<b>Local rural streets with light traffic, t</b>	Tape/Media #:	
Purpose:	<b>Routine Assessment</b>	Dia/Height:	<b>10"</b>
Use:	<b>Sanitary Sewage Pipe</b>	Material:	<b>VCP</b>
Drain Area:		Lining:	<b>None</b>
Category:	<b>NA</b>		
Comment:			
Location Details:		Direction of Survey:	<b>Downstream</b>
US MH:	<b>M-603-011</b>	DS MH:	<b>M-603-012</b>
		Total Length Surveyed (ft):	<b>48.5</b>

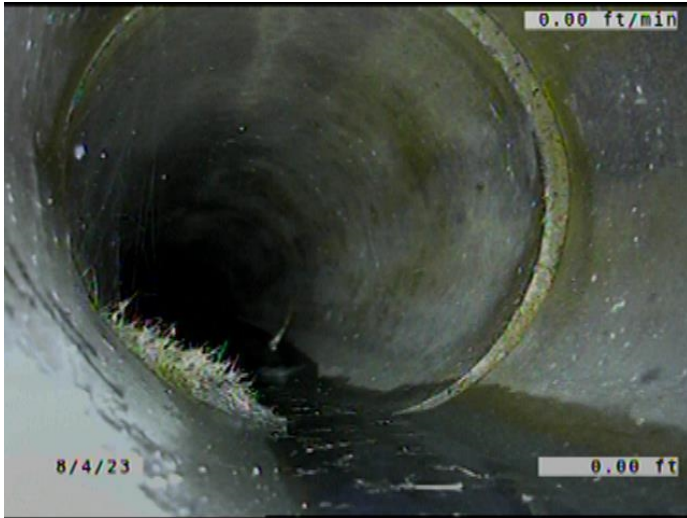
Code:	<b>MWL</b>
Description:	<b>Miscellaneous Water Level</b>
Distance (ft):	<b>.0</b>
Structural Grade:	<b>0</b>
O&M Grade:	<b>0</b>
Clock Start/From:	
Clock To:	
1st Value:	
2nd Value:	
Value Percent:	<b>5.000</b>
Continuous Index:	
Within 8" of Joint:	<b>NO</b>
Remarks:

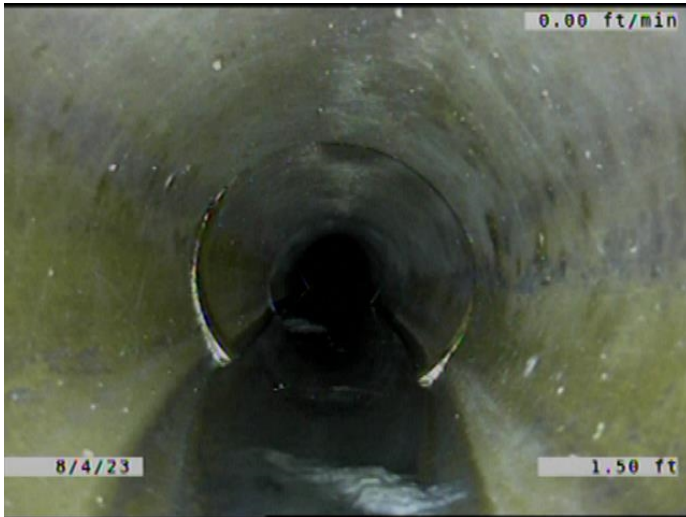
Code: **MWLS**  
Description: **Miscellaneous Water Level Sag**

Distance (ft): **1.5**  
Structural Grade: **2**  
O&M Grade: **0**  
Clock Start/From:  
Clock To:  
1st Value:  
2nd Value:  
Value Percent: **15.000**  
Continuous Index: **S01**  
Within 8" of Joint: **NO**  
Remarks:

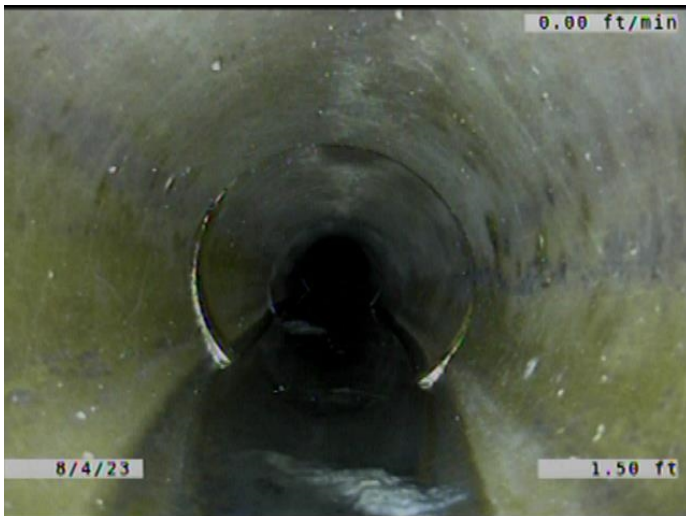
Code: **DSF**  
Description: **Deposits Settled Fine**

Distance (ft): **1.5**  
Structural Grade: **0**  
O&M Grade: **2**  
Clock Start/From: **5**  
Clock To: **7**  
1st Value:  
2nd Value:  
Value Percent: **5.000**  
Continuous Index: **S02**  
Within 8" of Joint: **YES**  
Remarks:

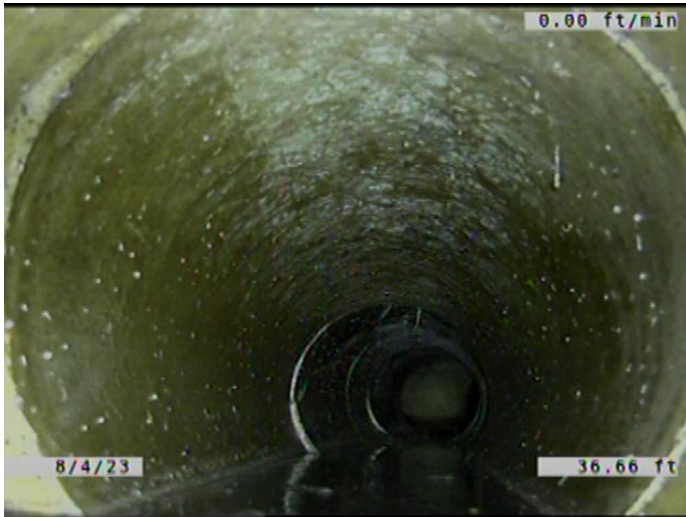
Code: **LR**  
Description: **Line Right**

Distance (ft): **36.7**  
Structural Grade: **0**  
O&M Grade: **1**  
Clock Start/From:  
Clock To:  
1st Value:  
2nd Value:  
Value Percent: **5.000**  
Continuous Index:  
Within 8" of Joint: **NO**  
Remarks:

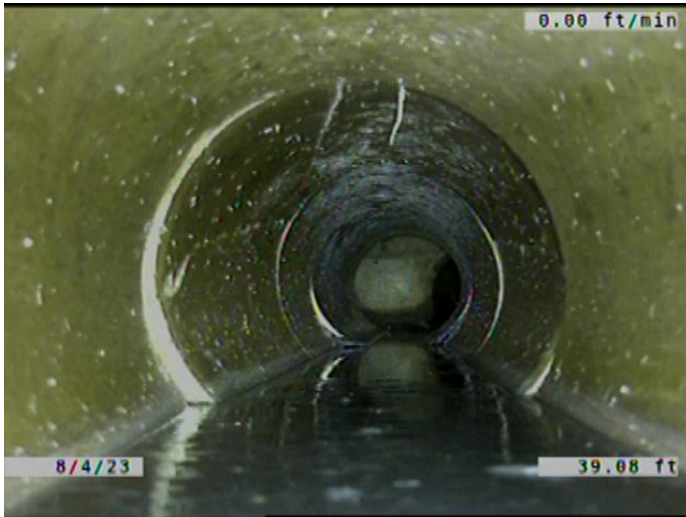
Code: **MWLS**  
 Description: **Miscellaneous Water Level Sag**

Distance (ft): **39.1**  
 Structural Grade: **2**  
 O&M Grade: **0**  
 Clock Start/From:  
 Clock To:  
 1st Value:  
 2nd Value:  
 Value Percent: **15.000**  
 Continuous Index: **F01**  
 Within 8" of Joint: **NO**  
 Remarks:

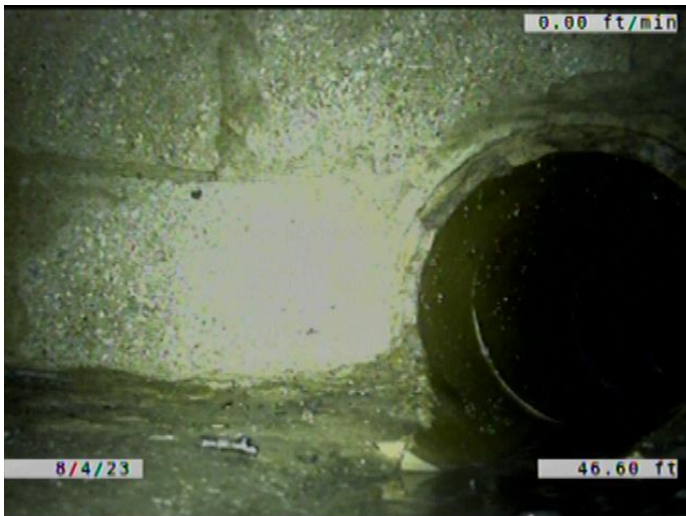
Code: **DSF**  
Description: **Deposits Settled Fine**

Distance (ft): **46.6**  
Structural Grade: **0**  
O&M Grade: **2**  
Clock Start/From: **5**  
Clock To: **7**  
1st Value:  
2nd Value:  
Value Percent: **5.000**  
Continuous Index: **F02**  
Within 8" of Joint: **YES**  
Remarks:
