Profile/Photo Observation Report

Street:	OFF W 39TH PL	Flow Control:	Not Controlled
City:	Hobart, IN	Year Renewed:	
Location:	Other	Tape/Media #:	
Purpose:	Not Known	Dia/Height:	8"
Use:	Sanitary	Material:	VCP
Drain Area:	NA	Lining:	
Category:	NA		
Comment:

Location Details:		Direction of Survey:	Upstream
US MH:	M-603-026	DS MH:	M-603-025
		Total Length Surveyed (ft):	19.1

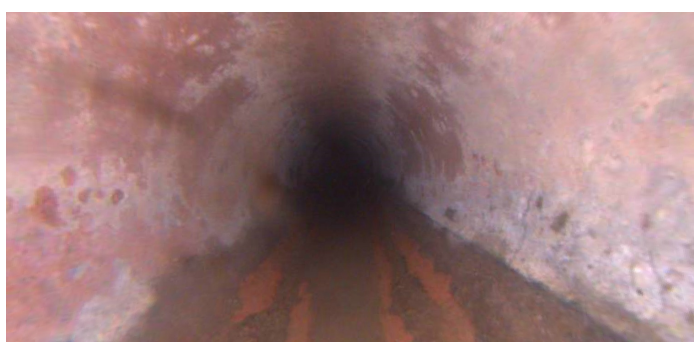
Code: **AMH**
Description: **Manhole**

Distance (ft): **.0**
Structural Grade: **0**
O&M Grade: **0**
Clock Start/From:
Clock To:
1st Value:
2nd Value:
Value Percent:
Continuous Index:
Within 8" of Joint: **NO**
Remarks: **M-603-026**

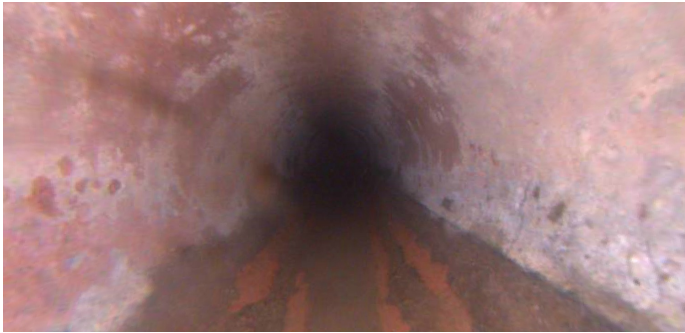
Code:	MWL
Description:	Water Level

Distance (ft):	.0
Structural Grade:	0
O&M Grade:	0
Clock Start/From:	
Clock To:	
1st Value:	
2nd Value:	
Value Percent:	5.000
Continuous Index:	
Within 8" of Joint:	NO
Remarks:

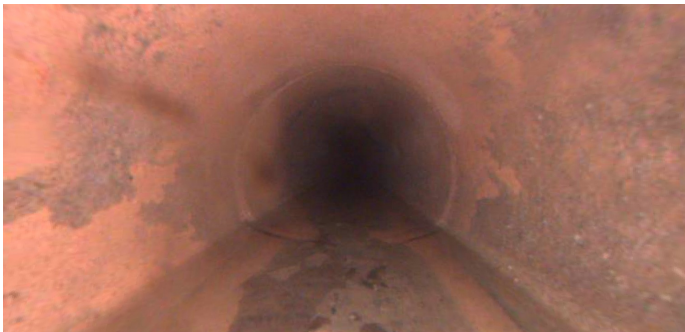
Code:	MSA
Description:	Abandoned Survey

Distance (ft):	19.1
Structural Grade:	0
O&M Grade:	0
Clock Start/From:	
Clock To:	
1st Value:	
2nd Value:	
Value Percent:	
Continuous Index:	
Within 8" of Joint:	NO
Remarks:	debris under water
