# Profile/Photo Observation Report

Date:	<b>02/01/2025</b>	Weather:		Coding:	<b>PACP 7.0</b>
Pipe Length (ft):	<b>190.5</b>	Owner:	<b>City of Hobart</b>	Pre Clean:	<b>Heavy Cleaning</b>
P.O.#:	<b>YES502259</b>	Surveyor:	<b>S. Bucklin</b>	PSR:	<b>P-603-025-026</b>
Customer:	<b>City of Hobart</b>	Clean Date:	<b>02/07/2022</b>	Shape:	<b>C</b>

Street:	<b>West 39th Place</b>	Flow Control:	<b>Not Controlled</b>
City:	<b>Hobart, IN</b>	Year Renewed:	
Location:	<b>Yard</b>	Tape/Media #:	
Purpose:	<b>Sewer System Evaluation Survey (SS)</b>	Dia/Height:	<b>8"</b>
Use:	<b>Sanitary Sewage Pipe</b>	Material:	<b>VCP</b>
Drain Area:		Lining:	<b>None</b>
Category:	<b>NA</b>		
Comment:			
Location Details:		Direction of Survey:	<b>Downstream</b>
US MH:	<b>M-603-025</b>	DS MH:	<b>M-603-026</b>
		Total Length Surveyed (ft):	<b>195.4</b>

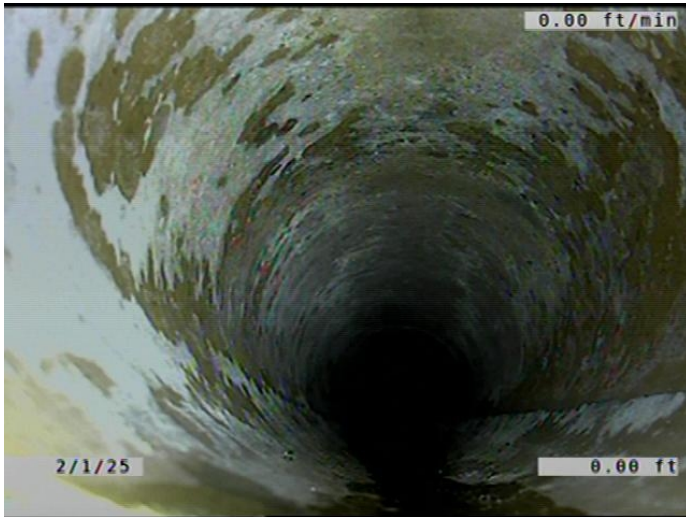
Code: **MWL**  
Description: **Miscellaneous Water Level**

Distance (ft): **.0**  
Structural Grade: **0**  
O&M Grade: **0**  
Clock Start/From:  
Clock To:  
1st Value:  
2nd Value:  
Value Percent: **5.000**  
Continuous Index:  
Within 8" of Joint: **NO**  
Remarks:

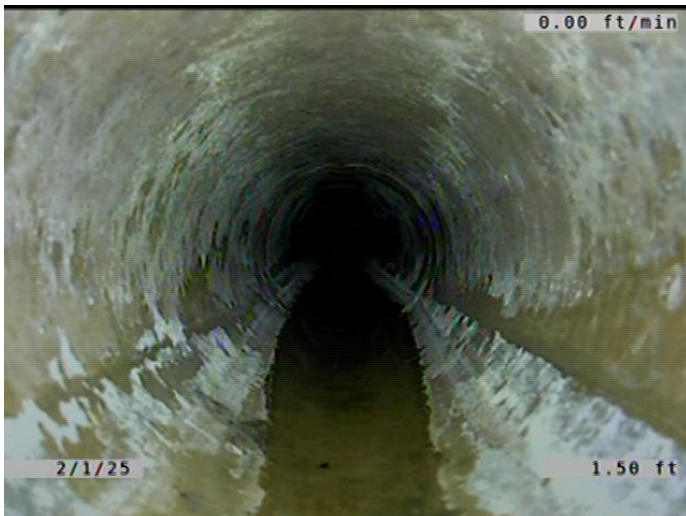
Code: **MWLS**  
Description: **Miscellaneous Water Level Sag**

Distance (ft): **1.5**  
Structural Grade: **2**  
O&M Grade: **0**  
Clock Start/From:  
Clock To:  
1st Value:  
2nd Value:  
Value Percent: **10.000**  
Continuous Index: **S01**  
Within 8" of Joint: **NO**  
Remarks:

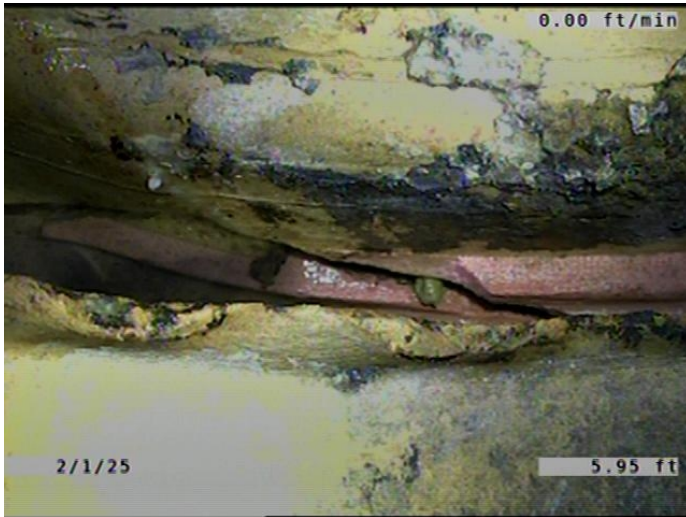
Code: **BSV**  
Description: **Broken Soil Visible**

Distance (ft): **5.9**  
Structural Grade: **5**  
O&M Grade: **0**  
Clock Start/From: **3**  
Clock To: **6**  
1st Value:  
2nd Value:  
Value Percent:  
Continuous Index:  
Within 8" of Joint: **YES**  
Remarks:

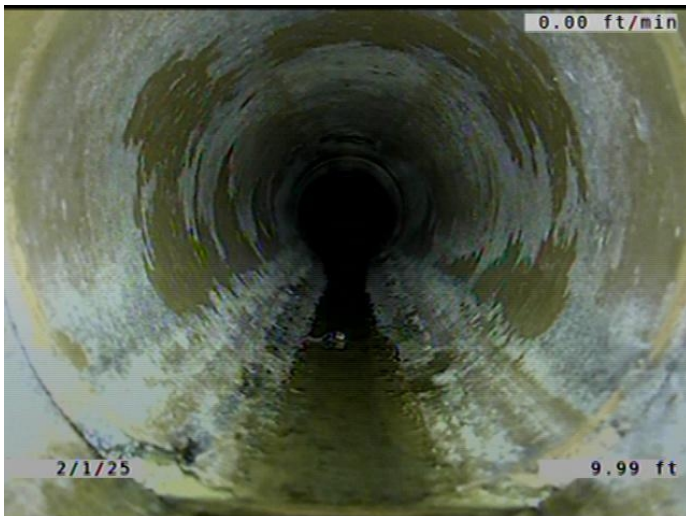
Code: **MWLS**  
Description: **Miscellaneous Water Level Sag**

Distance (ft): **10.0**  
Structural Grade: **2**  
O&M Grade: **0**  
Clock Start/From:  
Clock To:  
1st Value:  
2nd Value:  
Value Percent: **10.000**  
Continuous Index: **F01**  
Within 8" of Joint: **NO**  
Remarks:

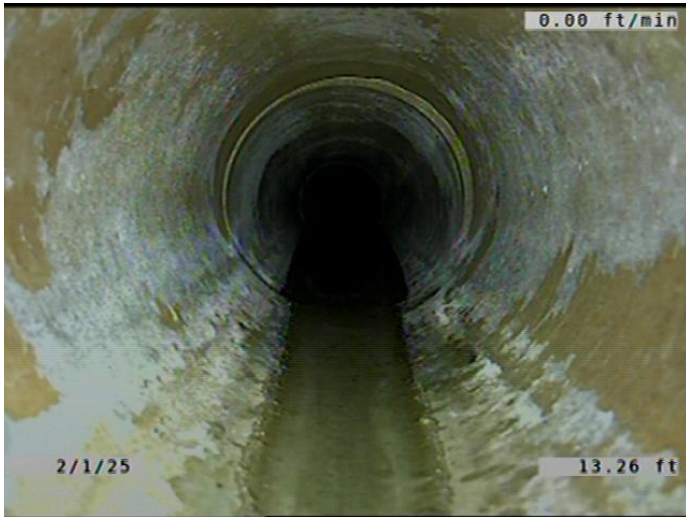
Code: **MWLS**  
Description: **Miscellaneous Water Level Sag**

Distance (ft): **13.3**  
Structural Grade: **2**  
O&M Grade: **0**  
Clock Start/From:  
Clock To:  
1st Value:  
2nd Value:  
Value Percent: **10.000**  
Continuous Index: **S02**  
Within 8" of Joint: **NO**  
Remarks:

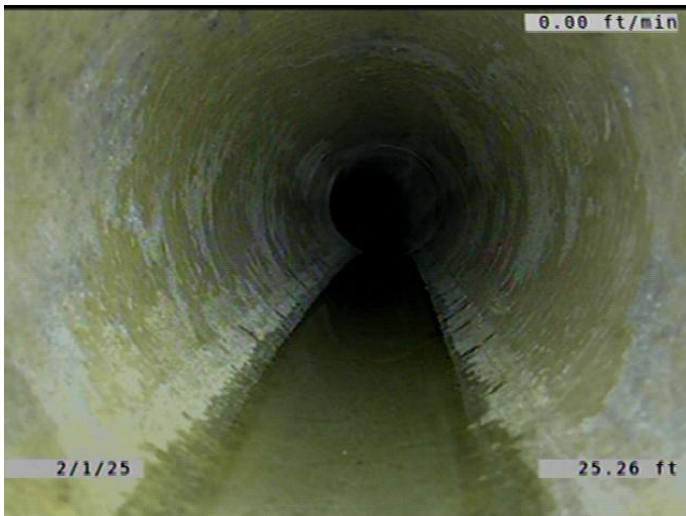
Code: **LR**  
Description: **Line Right**

Distance (ft): **25.3**  
Structural Grade: **0**  
O&M Grade: **1**  
Clock Start/From:  
Clock To:  
1st Value:  
2nd Value:  
Value Percent: **5.000**  
Continuous Index:  
Within 8" of Joint: **NO**  
Remarks:

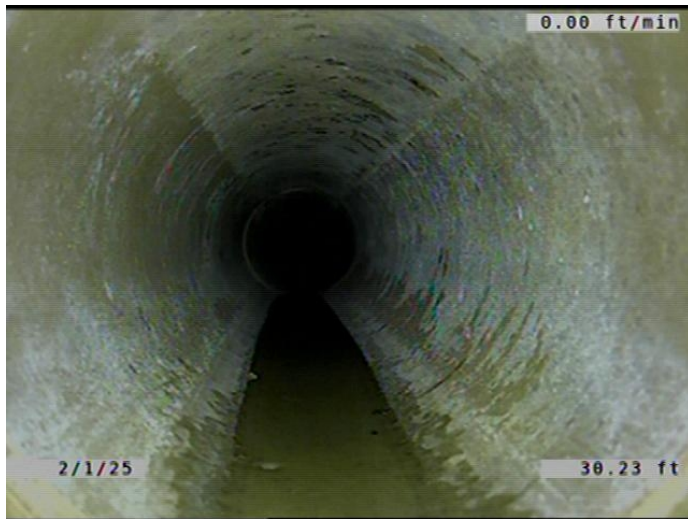
Code: **LL**  
Description: **Line Left**

Distance (ft): **30.2**  
Structural Grade: **0**  
O&M Grade: **1**  
Clock Start/From:  
Clock To:  
1st Value:  
2nd Value:  
Value Percent: **5.000**  
Continuous Index:  
Within 8" of Joint: **NO**  
Remarks:

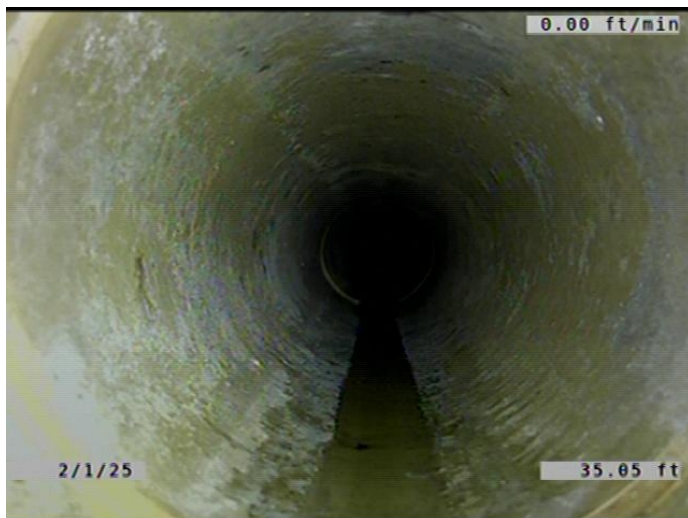
Code: **MWLS**  
Description: **Miscellaneous Water Level Sag**

Distance (ft): **35.0**  
Structural Grade: **2**  
O&M Grade: **0**  
Clock Start/From:  
Clock To:  
1st Value:  
2nd Value:  
Value Percent: **10.000**  
Continuous Index: **F02**  
Within 8" of Joint: **NO**  
Remarks:

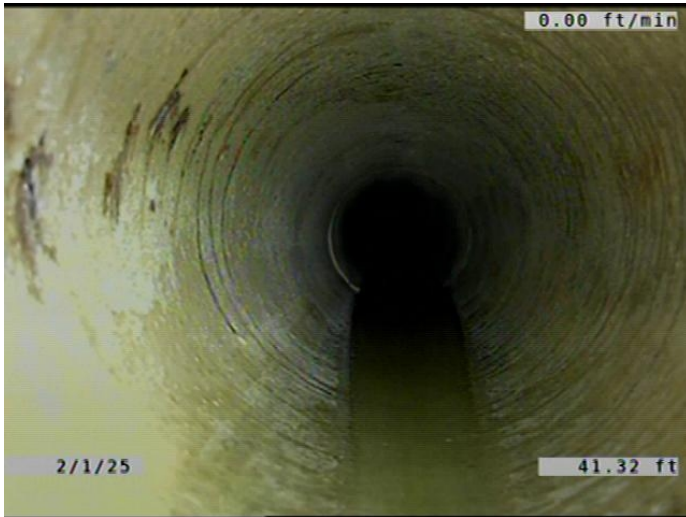
Code: **MWLS**  
Description: **Miscellaneous Water Level Sag**

Distance (ft): **41.3**  
Structural Grade: **2**  
O&M Grade: **0**  
Clock Start/From:  
Clock To:  
1st Value:  
2nd Value:  
Value Percent: **10.000**  
Continuous Index: **S03**  
Within 8" of Joint: **NO**  
Remarks:

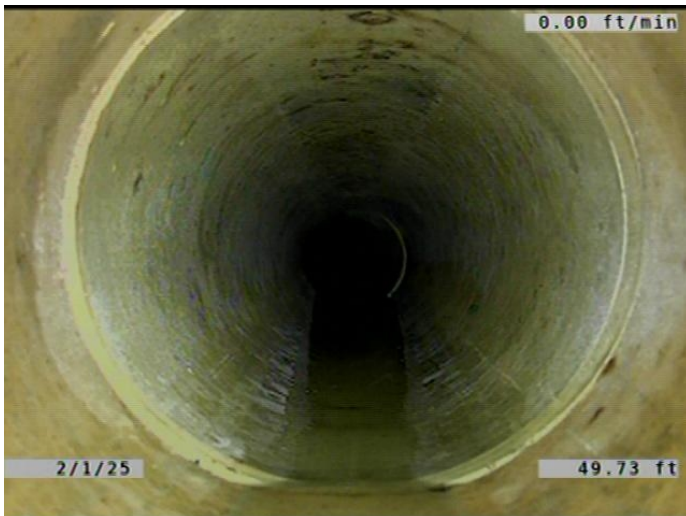
Code: **MWLS**  
Description: **Miscellaneous Water Level Sag**

Distance (ft): **49.7**  
Structural Grade: **2**  
O&M Grade: **0**  
Clock Start/From:  
Clock To:  
1st Value:  
2nd Value:  
Value Percent: **10.000**  
Continuous Index: **F03**  
Within 8" of Joint: **NO**  
Remarks:

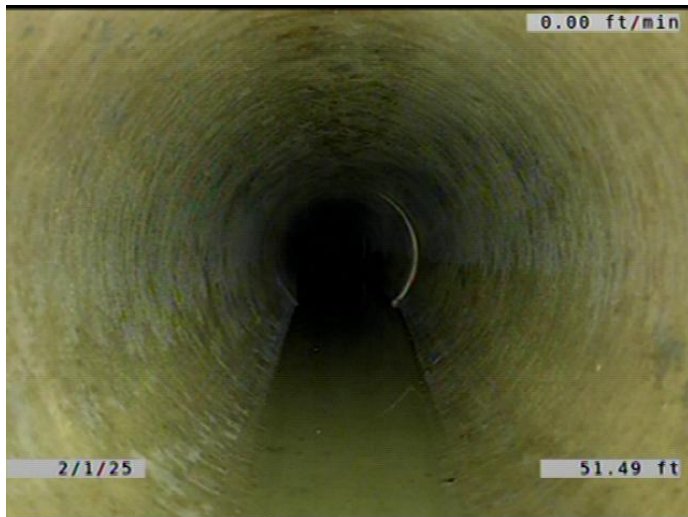
Code: **MWLS**  
Description: **Miscellaneous Water Level Sag**

Distance (ft): **51.5**  
Structural Grade: **2**  
O&M Grade: **0**  
Clock Start/From:  
Clock To:  
1st Value:  
2nd Value:  
Value Percent: **10.000**  
Continuous Index: **S04**  
Within 8" of Joint: **NO**  
Remarks:

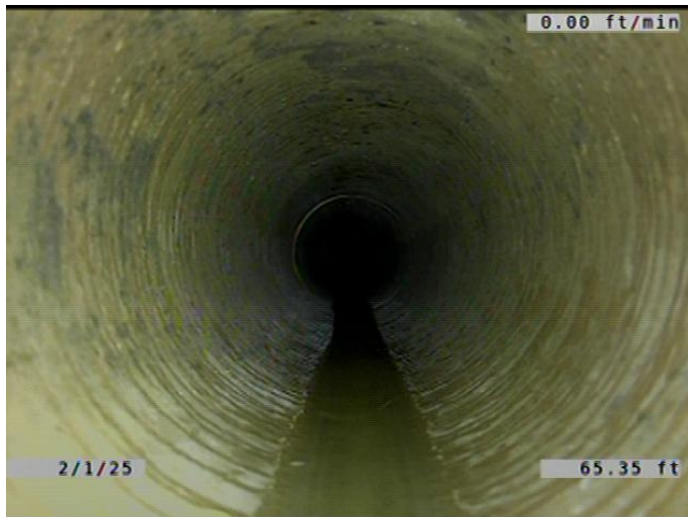
Code: **MWLS**  
Description: **Miscellaneous Water Level Sag**

Distance (ft): **65.4**  
Structural Grade: **2**  
O&M Grade: **0**  
Clock Start/From:  
Clock To:  
1st Value:  
2nd Value:  
Value Percent: **10.000**  
Continuous Index: **F04**  
Within 8" of Joint: **NO**  
Remarks:

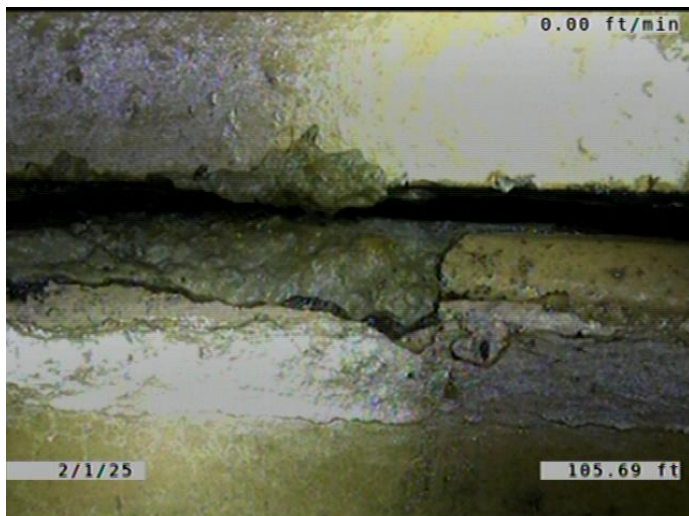
Code: **DAE**  
 Description: **Deposits Attached Encrustation**

Distance (ft): **105.7**  
 Structural Grade: **0**  
 O&M Grade: **2**  
 Clock Start/From: **7**  
 Clock To: **5**  
 1st Value:  
 2nd Value:  
 Value Percent: **5.000**  
 Continuous Index:  
 Within 8" of Joint: **YES**  
 Remarks:

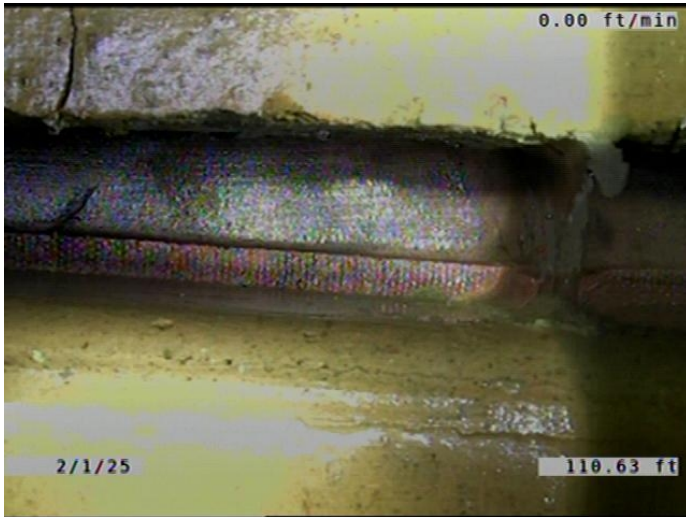
Code: **JAM**  
Description: **Joint Angular Medium**

Distance (ft): **110.6**  
Structural Grade: **3**  
O&M Grade: **0**  
Clock Start/From:  
Clock To:  
1st Value:  
2nd Value:  
Value Percent:  
Continuous Index:  
Within 8" of Joint: **NO**  
Remarks:

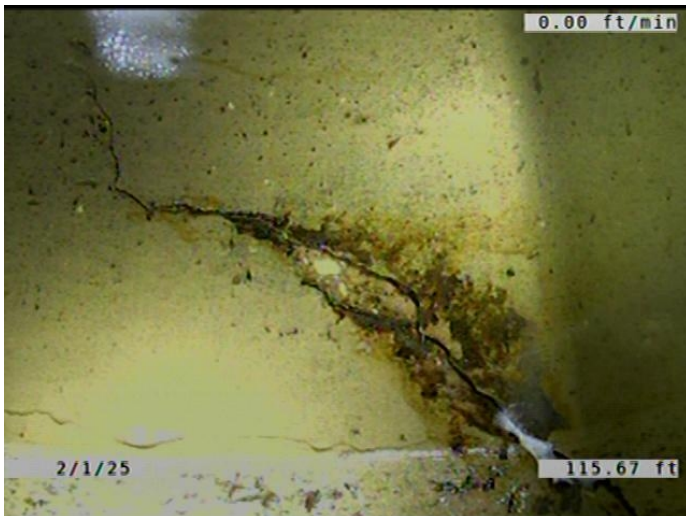
Code: **FM**  
Description: **Fracture Multiple**

Distance (ft): **115.7**  
Structural Grade: **4**  
O&M Grade: **0**  
Clock Start/From: **3**  
Clock To: **9**  
1st Value:  
2nd Value:  
Value Percent:  
Continuous Index:  
Within 8" of Joint: **YES**  
Remarks:

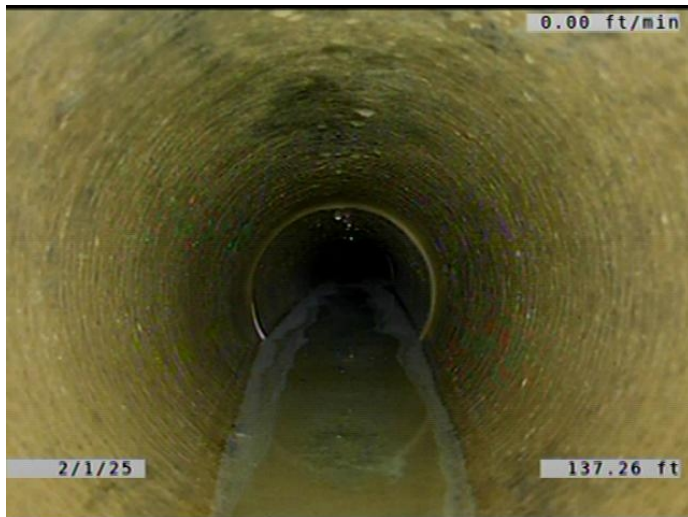
Code: **MWLS**  
 Description: **Miscellaneous Water Level Sag**

Distance (ft): **137.3**  
 Structural Grade: **2**  
 O&M Grade: **0**  
 Clock Start/From:  
 Clock To:  
 1st Value:  
 2nd Value:  
 Value Percent: **25.000**  
 Continuous Index: **S07**  
 Within 8" of Joint: **NO**  
 Remarks:

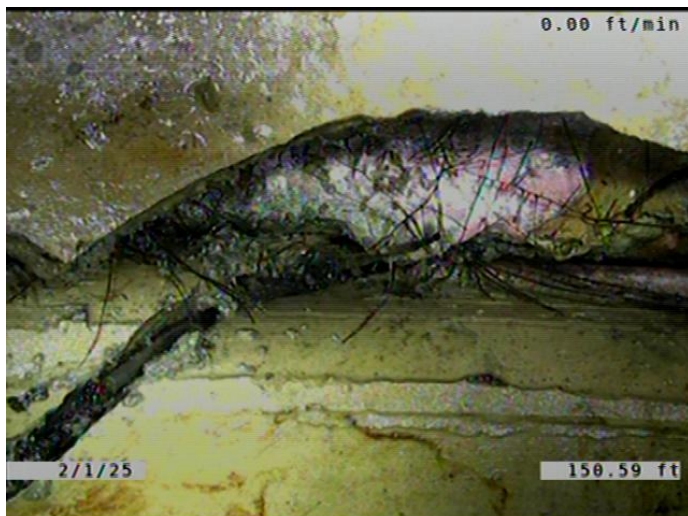
Code: **RFJ**  
 Description: **Roots Fine Joint**

Distance (ft): **150.6**  
 Structural Grade: **0**  
 O&M Grade: **1**  
 Clock Start/From: **8**  
 Clock To: **4**  
 1st Value:  
 2nd Value:  
 Value Percent:  
 Continuous Index:  
 Within 8" of Joint: **YES**  
 Remarks:

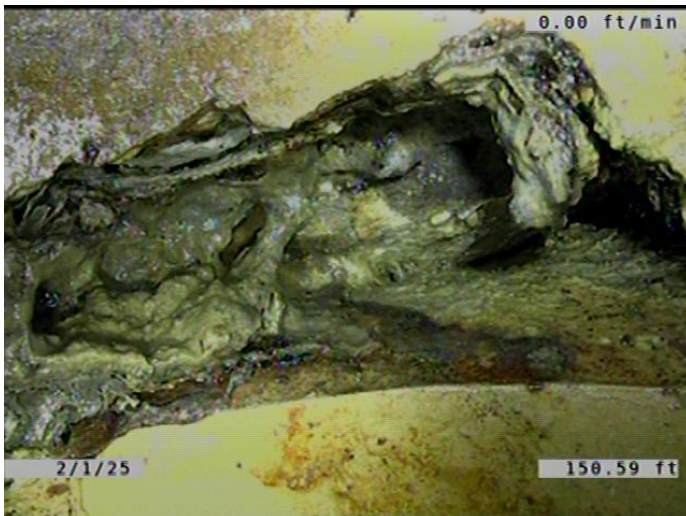
Code: **DAE**  
Description: **Deposits Attached Encrustation**

Distance (ft): **150.6**  
Structural Grade: **0**  
O&M Grade: **2**  
Clock Start/From: **8**  
Clock To: **4**  
1st Value:  
2nd Value:  
Value Percent: **5.000**  
Continuous Index:  
Within 8" of Joint: **YES**  
Remarks:

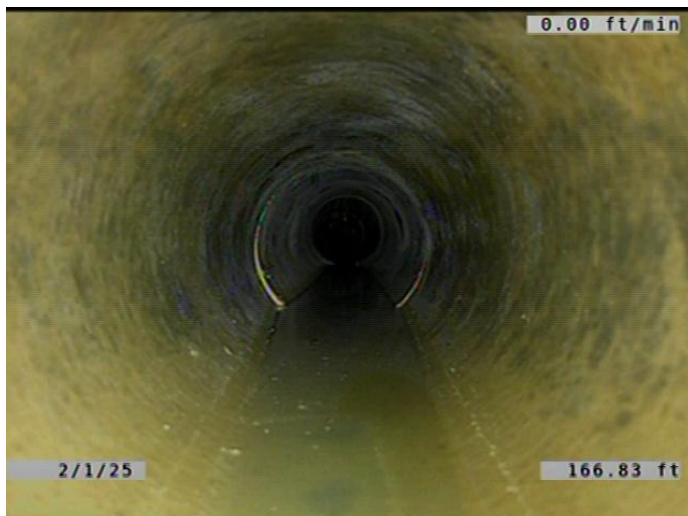
Code: **MWLS**  
Description: **Miscellaneous Water Level Sag**

Distance (ft): **166.8**  
Structural Grade: **2**  
O&M Grade: **0**  
Clock Start/From:  
Clock To:  
1st Value:  
2nd Value:  
Value Percent: **10.000**  
Continuous Index: **S08**  
Within 8" of Joint: **NO**  
Remarks:

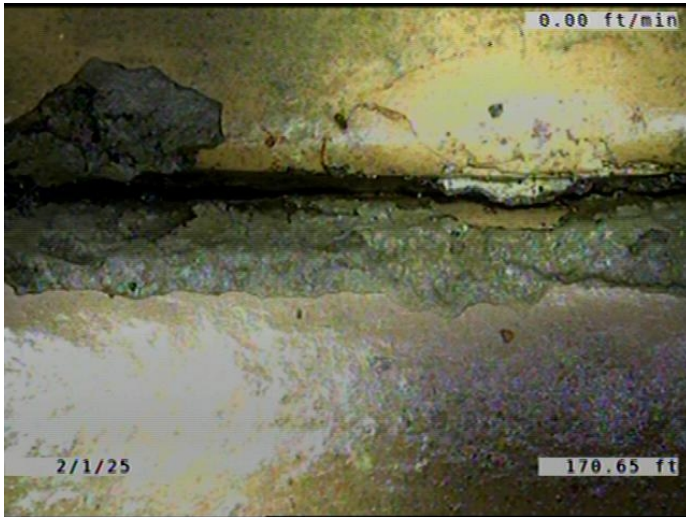
Code: **DAE**  
 Description: **Deposits Attached Encrustation**

Distance (ft): **170.6**  
 Structural Grade: **0**  
 O&M Grade: **2**  
 Clock Start/From: **7**  
 Clock To: **5**  
 1st Value:  
 2nd Value:  
 Value Percent: **5.000**  
 Continuous Index:  
 Within 8" of Joint: **YES**  
 Remarks:

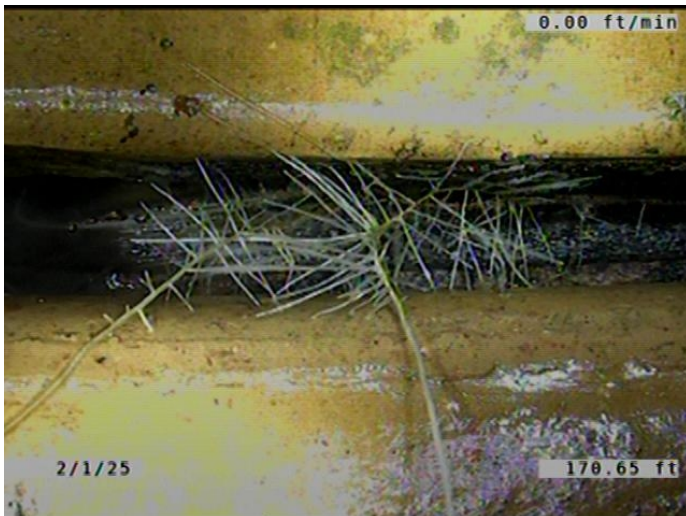
Code: **RFJ**  
 Description: **Roots Fine Joint**

Distance (ft): **170.6**  
 Structural Grade: **0**  
 O&M Grade: **1**  
 Clock Start/From: **8**  
 Clock To: **11**  
 1st Value:  
 2nd Value:  
 Value Percent:  
 Continuous Index:  
 Within 8" of Joint: **YES**  
 Remarks:

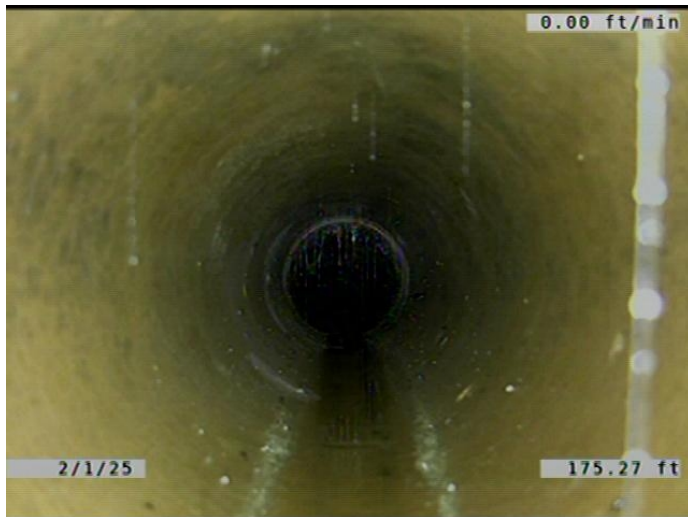
Code: **MWLS**  
Description: **Miscellaneous Water Level Sag**

Distance (ft): **175.3**  
Structural Grade: **2**  
O&M Grade: **0**  
Clock Start/From:  
Clock To:  
1st Value:  
2nd Value:  
Value Percent: **10.000**  
Continuous Index: **F08**  
Within 8" of Joint: **NO**  
Remarks:

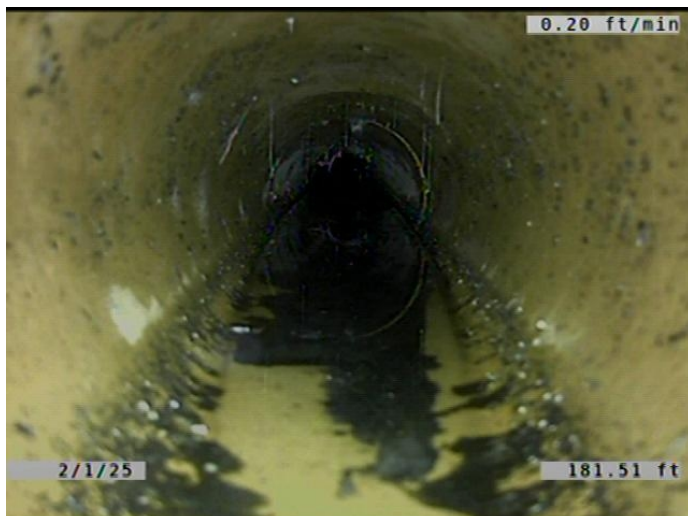
Code: **MWLS**  
Description: **Miscellaneous Water Level Sag**

Distance (ft): **181.5**  
Structural Grade: **2**  
O&M Grade: **0**  
Clock Start/From:  
Clock To:  
1st Value:  
2nd Value:  
Value Percent: **20.000**  
Continuous Index: **S09**  
Within 8" of Joint: **NO**  
Remarks:

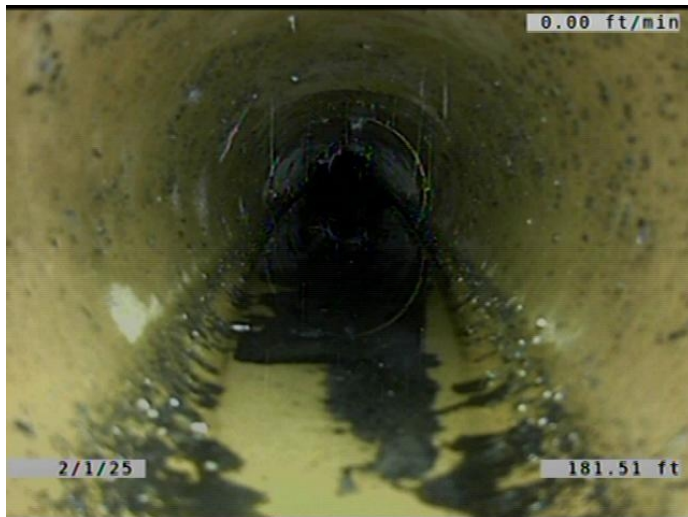
Code: **DSF**  
 Description: **Deposits Settled Fine**

Distance (ft): **181.5**  
 Structural Grade: **0**  
 O&M Grade: **2**  
 Clock Start/From: **5**  
 Clock To: **7**  
 1st Value:  
 2nd Value:  
 Value Percent: **5.000**  
 Continuous Index: **S10**  
 Within 8" of Joint: **YES**  
 Remarks:

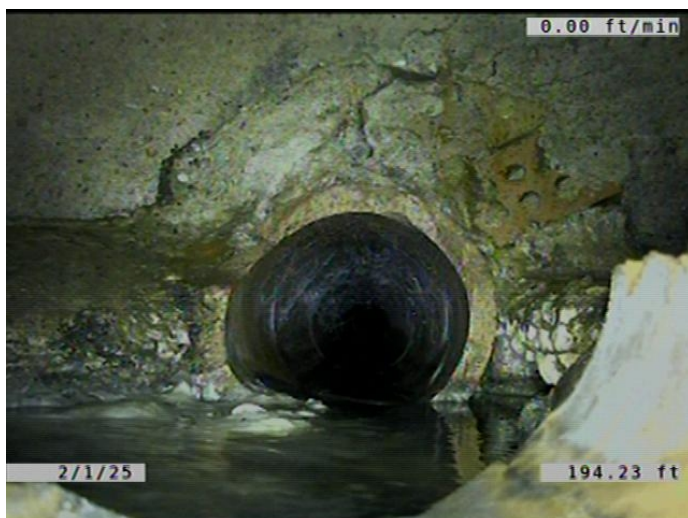
Code: **DSF**  
 Description: **Deposits Settled Fine**

Distance (ft): **194.2**  
 Structural Grade: **0**  
 O&M Grade: **2**  
 Clock Start/From: **5**  
 Clock To: **7**  
 1st Value:  
 2nd Value:  
 Value Percent: **5.000**  
 Continuous Index: **F10**  
 Within 8" of Joint: **YES**  
 Remarks:

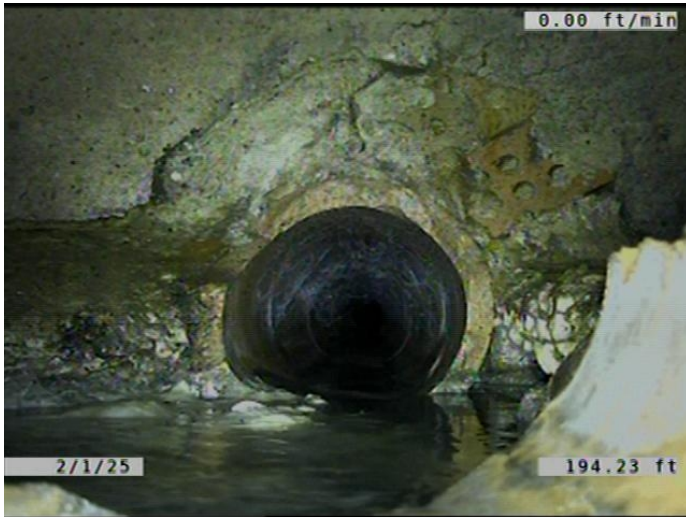
Code: **MWLS**  
 Description: **Miscellaneous Water Level Sag**

Distance (ft): **194.2**  
 Structural Grade: **2**  
 O&M Grade: **0**  
 Clock Start/From:  
 Clock To:  
 1st Value:  
 2nd Value:  
 Value Percent: **20.000**  
 Continuous Index: **F09**  
 Within 8" of Joint: **NO**  
 Remarks:
