Profile/Photo Observation Report

Street:	OFF W 39TH PL	Flow Control:	Not Controlled
City:	Hobart, IN	Year Renewed:	
Location:	Other	Tape/Media #:	
Purpose:	Not Known	Dia/Height:	8"
Use:	Sanitary	Material:	VCP
Drain Area:	NA	Lining:	
Category:	NA		
Comment:

Location Details:		Direction of Survey:	Upstream
US MH:	M-603-026	DS MH:	M-603-027
		Total Length Surveyed (ft):	65.5

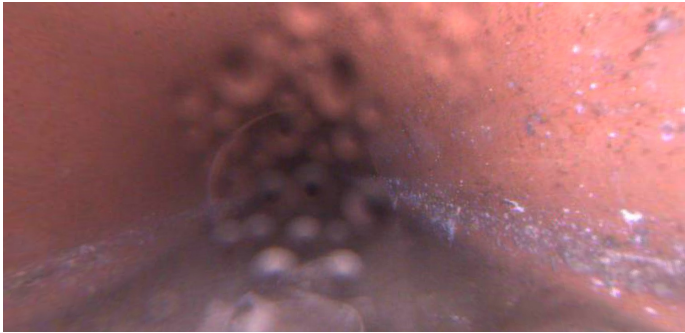
Code:	MWL
Description:	Water Level

Distance (ft):	.0
Structural Grade:	0
O&M Grade:	0
Clock Start/From:	
Clock To:	
1st Value:	
2nd Value:	
Value Percent:	40.000
Continuous Index:	
Within 8" of Joint:	NO
Remarks:

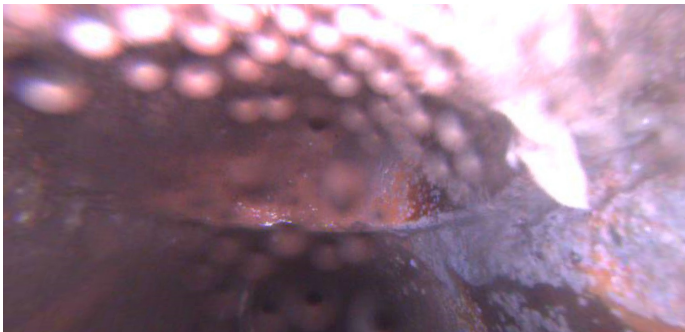
Code:	TBI
Description:	Tap Break-in Intruding

Distance (ft):	65.5
Structural Grade:	0
O&M Grade:	2
Clock Start/From:	12
Clock To:	
1st Value:	4.000
2nd Value:	2.000
Value Percent:	
Continuous Index:	
Within 8" of Joint:	
Remarks:

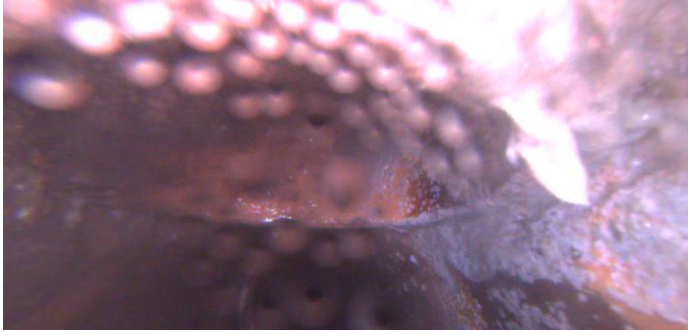
Code:	MSA
Description:	Abandoned Survey
Distance (ft):	65.5
Structural Grade:	0
O&M Grade:	0
Clock Start/From:	
Clock To:	
1st Value:	
2nd Value:	
Value Percent:	
Continuous Index:	
Within 8" of Joint:	NO
Remarks:	TBI
