## Profile/Photo Observation Report

Street:	<b>W 40th ave</b>	Flow Control:	<b>Not Controlled</b>
City:	<b>Hobart, IN</b>	Year Renewed:	
Location:	<b>Other</b>	Tape/Media #:	
Purpose:	<b>Not Known</b>	Dia/Height:	<b>8"</b>
Use:	<b>Sanitary</b>	Material:	<b>VCP</b>
Drain Area:	<b>NA</b>	Lining:	
Category:	<b>NA</b>		
Comment:

Location Details:		Direction of Survey:	<b>Upstream</b>
US MH:	<b>M-603-026</b>	DS MH:	<b>M-603-027</b>
		Total Length Surveyed (ft):	<b>65.5</b>

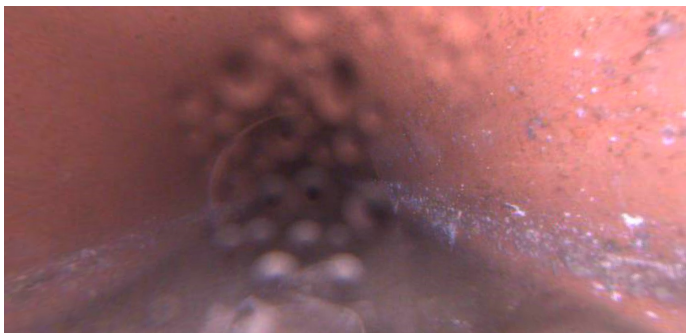
Code: **AMH**  
Description: **Manhole**

Distance (ft): **.0**  
Structural Grade: **0**  
O&M Grade: **0**  
Clock Start/From:  
Clock To:  
1st Value:  
2nd Value:  
Value Percent:  
Continuous Index:  
Within 8" of Joint: **NO**  
Remarks: **M-603-026**

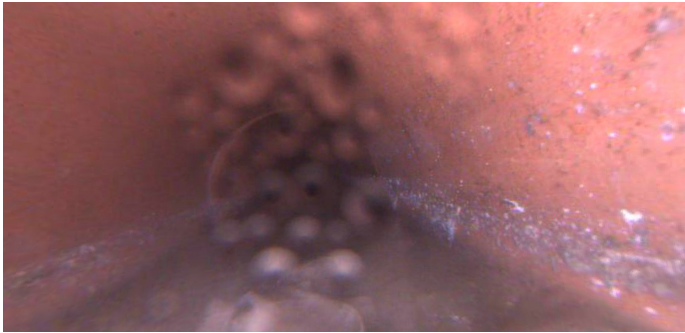
Code:	<b>MWL</b>
Description:	<b>Water Level</b>

Distance (ft):	<b>.0</b>
Structural Grade:	<b>0</b>
O&M Grade:	<b>0</b>
Clock Start/From:	
Clock To:	
1st Value:	
2nd Value:	
Value Percent:	<b>40.000</b>
Continuous Index:	
Within 8" of Joint:	<b>NO</b>
Remarks:

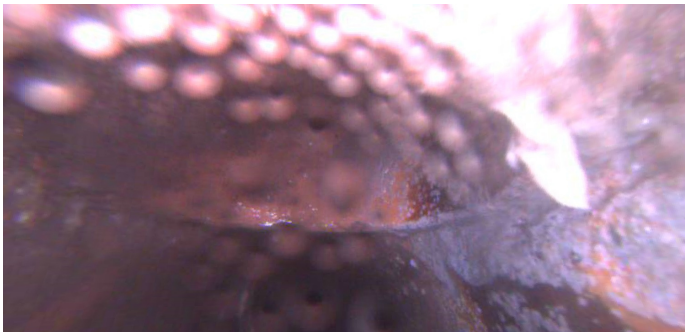
Code:	<b>TBI</b>
Description:	<b>Tap Break-in Intruding</b>

Distance (ft):	<b>65.5</b>
Structural Grade:	<b>0</b>
O&M Grade:	<b>2</b>
Clock Start/From:	<b>12</b>
Clock To:	
1st Value:	<b>4.000</b>
2nd Value:	<b>2.000</b>
Value Percent:	
Continuous Index:	
Within 8" of Joint:	
Remarks:

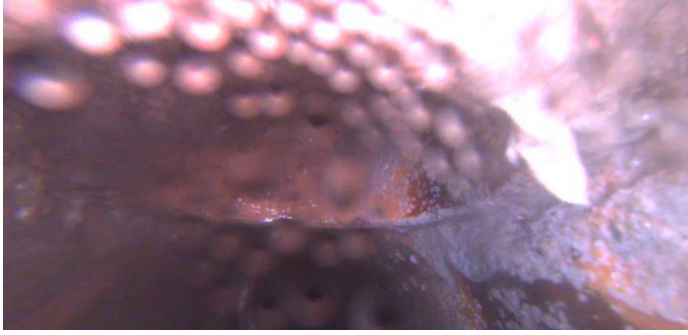
Code:	<b>MSA</b>
Description:	<b>Abandoned Survey</b>
Distance (ft):	<b>65.5</b>
Structural Grade:	<b>0</b>
O&M Grade:	<b>0</b>
Clock Start/From:	
Clock To:	
1st Value:	
2nd Value:	
Value Percent:	
Continuous Index:	
Within 8" of Joint:	<b>NO</b>
Remarks:	<b>TBI</b>
