Profile/Photo Observation Report

Date:	04/27/2018	Weather:		Coding:	PACP 6.0
Pipe Length (ft):		Owner:	City of Hobart	Pre Clean:	No Pre-Cleaning
P.O.#:	113	Surveyor:	M. Pielacha	PSR:	P-603-031-032
Customer:	City of Hobart	Clean Date:		Shape:	C

Street:	Cressmoor Park	Flow Control:	Not Controlled
City:	Hobart, IN	Year Renewed:	
Location:	Light Highway	Tape/Media #:	DEP 113
Purpose:	Routine Assessment	Dia/Height:	6"
Use:	Sanitary	Material:	VCP
Drain Area:		Lining:	
Category:	NA		
Comment:	YES501824 Submittal 2		
Location Details:		Direction of Survey:	Downstream
US MH:	M-603-031	DS MH:	M-603-032
		Total Length Surveyed (ft):	25.1

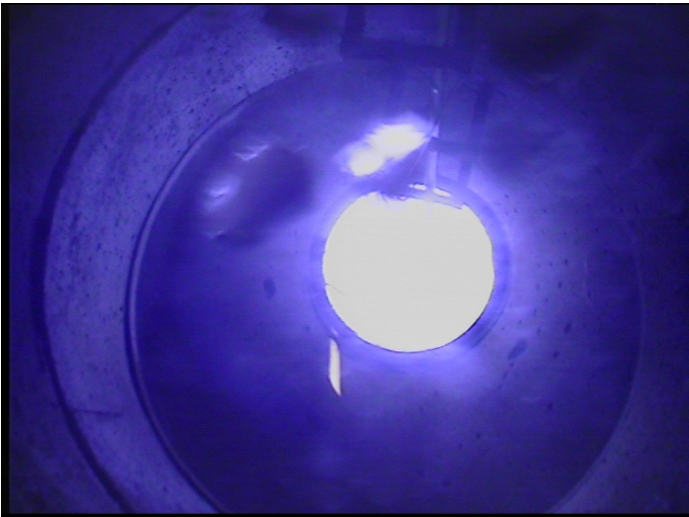
AMH

Manhole

.0

M-603-031

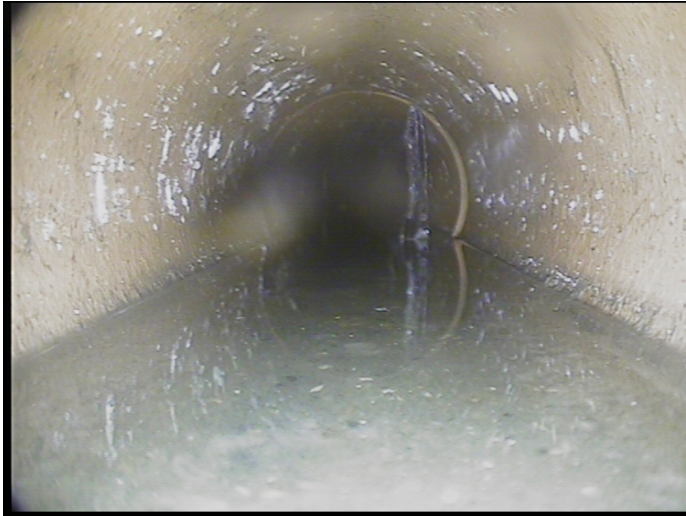
Code: **MWL**
Description: **Water Level**

Distance (ft): **.0**
Structural Grade: **0**
O&M Grade: **0**
Clock Start/From:
Clock To:
1st Value:
2nd Value:
Value Percent: **10.000**
Continuous Index:
Within 8" of Joint: **NO**
Remarks:

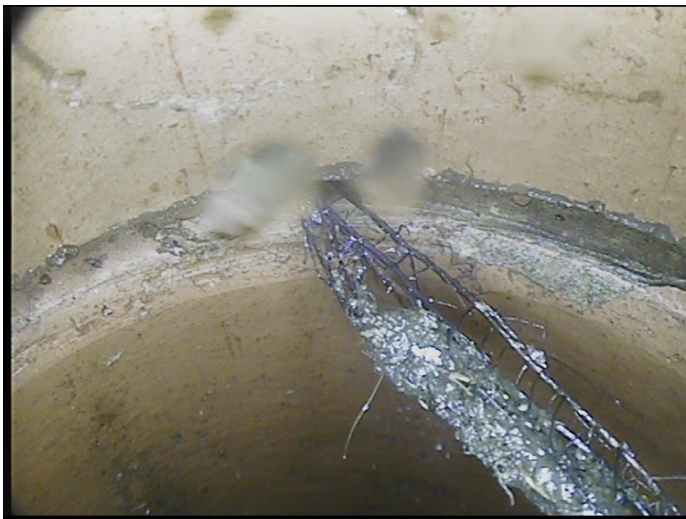
Code: **RFJ**
Description: **Roots Fine Joint**

Distance (ft): **3.0**
Structural Grade: **0**
O&M Grade: **1**
Clock Start/From: **1**
Clock To:
1st Value:
2nd Value:
Value Percent:
Continuous Index: **S01**
Within 8" of Joint: **YES**
Remarks:

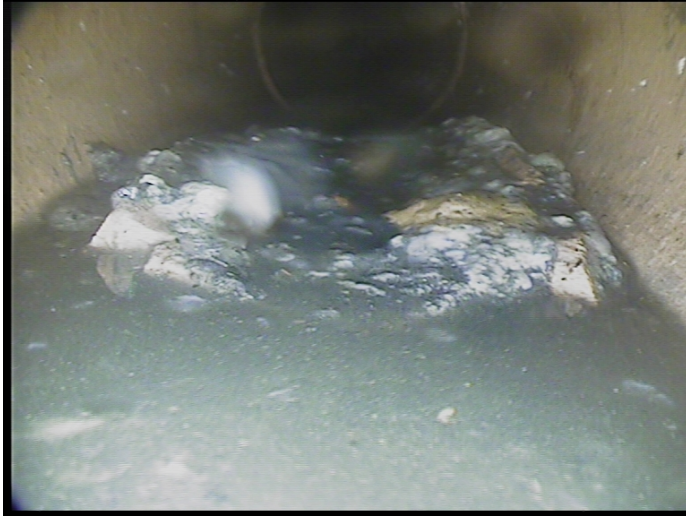
Code: **OBR**
Description: **Obstacle Rocks**

Distance (ft): **9.3**
Structural Grade: **0**
O&M Grade: **2**
Clock Start/From: **5**
Clock To: **7**
1st Value:
2nd Value:
Value Percent: **10.000**
Continuous Index:
Within 8" of Joint: **NO**
Remarks:

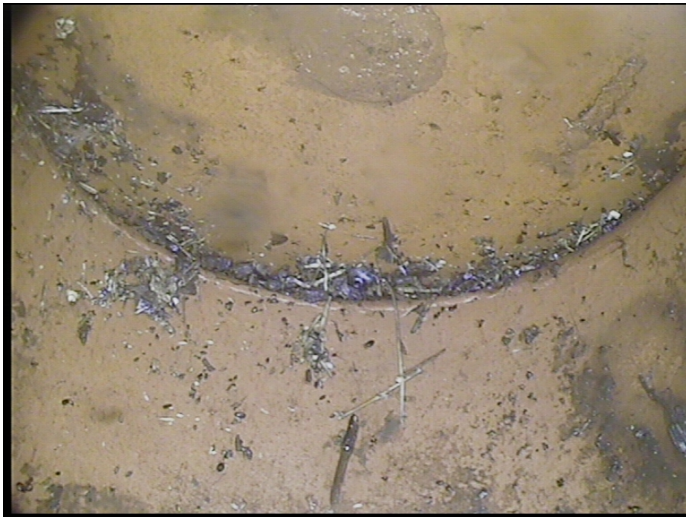
Code: **TFC**
Description: **Tap Factory Capped**

Distance (ft): **25.1**
Structural Grade: **0**
O&M Grade: **0**
Clock Start/From: **12**
Clock To:
1st Value: **6.000**
2nd Value:
Value Percent:
Continuous Index:
Within 8" of Joint: **NO**
Remarks:

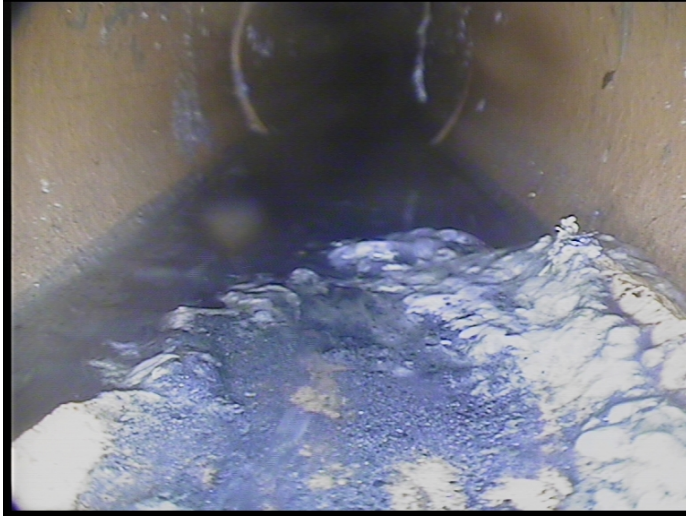
Code: **RFJ**
Description: **Roots Fine Joint**

Distance (ft): **25.1**
Structural Grade: **0**
O&M Grade: **1**
Clock Start/From: **1**
Clock To:
1st Value:
2nd Value:
Value Percent:
Continuous Index: **F01**
Within 8" of Joint: **YES**
Remarks:

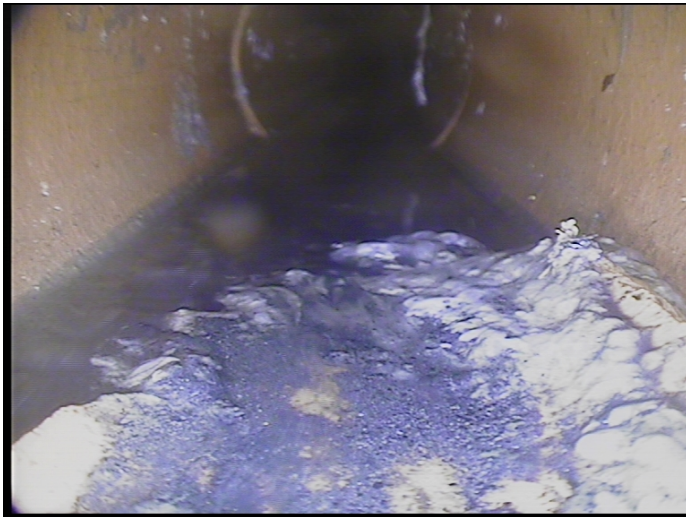
Code: **MSA**
Description: **Abandoned Survey**

Distance (ft): **25.1**
Structural Grade: **0**
O&M Grade: **0**
Clock Start/From:
Clock To:
1st Value:
2nd Value:
Value Percent:
Continuous Index:
Within 8" of Joint: **NO**
Remarks: **debris**
