## Profile/Photo Observation Report

Street:	<b>Cressmoor Park</b>	Flow Control:	<b>Not Controlled</b>
City:	<b>Hobart, IN</b>	Year Renewed:	
Location:	<b>Light Highway</b>	Tape/Media #:	<b>DEP 116</b>
Purpose:	<b>Routine Assessment</b>	Dia/Height:	<b>6"</b>
Use:	<b>Sanitary</b>	Material:	<b>VCP</b>
Drain Area:		Lining:	
Category:	<b>NA</b>		
Comment:	<b>YES501824 Submittal 2</b>		
Location Details:		Direction of Survey:	<b>Downstream</b>
US MH:	<b>M-603-031</b>	DS MH:	<b>M-603-032</b>
		Total Length Surveyed (ft):	<b>193.6</b>

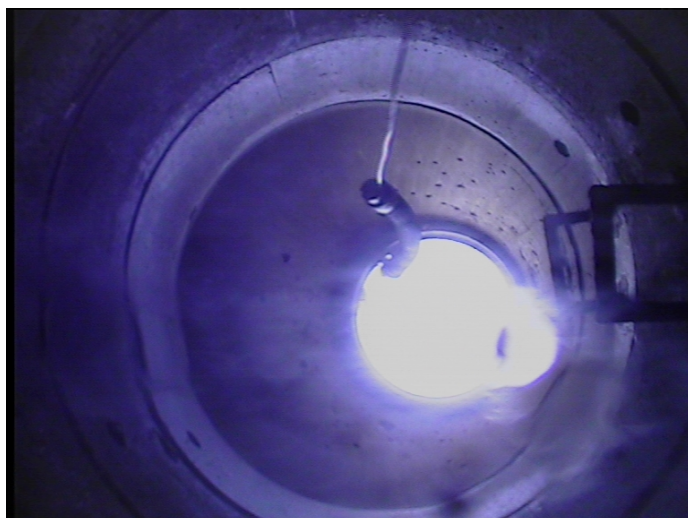
Code: **AMH**  
 Description: **Manhole**

Distance (ft): **.0**  
 Structural Grade: **0**  
 O&M Grade: **0**  
 Clock Start/From:  
 Clock To:  
 1st Value:  
 2nd Value:  
 Value Percent:  
 Continuous Index:  
 Within 8" of Joint: **NO**  
 Remarks: **M-603-031**

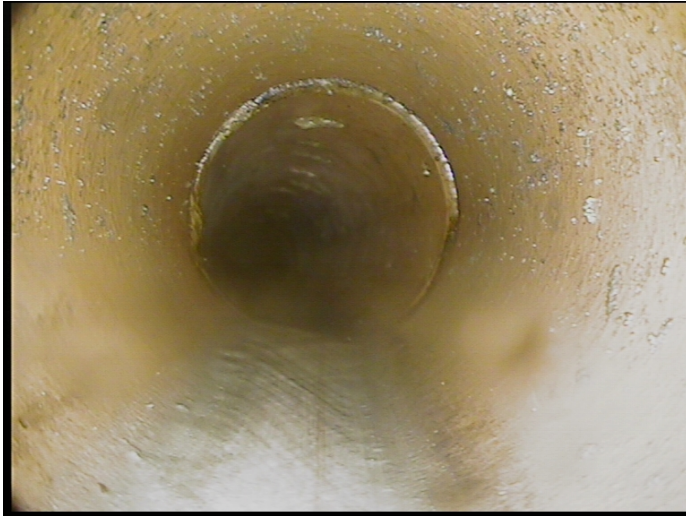
Code: **MWL**  
Description: **Water Level**

Distance (ft): **.0**  
Structural Grade: **0**  
O&M Grade: **0**  
Clock Start/From:  
Clock To:  
1st Value:  
2nd Value:  
Value Percent: **5.000**  
Continuous Index:  
Within 8" of Joint: **NO**  
Remarks:

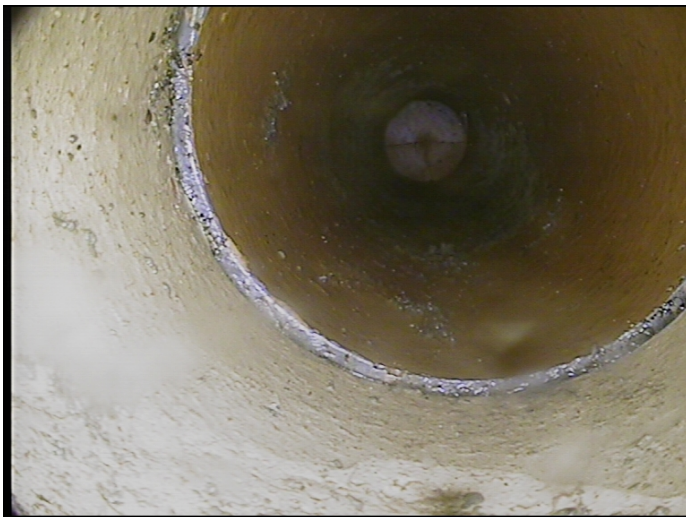
Code: **TFC**  
Description: **Tap Factory Capped**

Distance (ft): **15.1**  
Structural Grade: **0**  
O&M Grade: **0**  
Clock Start/From: **1**  
Clock To:  
1st Value: **6.000**  
2nd Value:  
Value Percent:  
Continuous Index:  
Within 8" of Joint: **NO**  
Remarks:

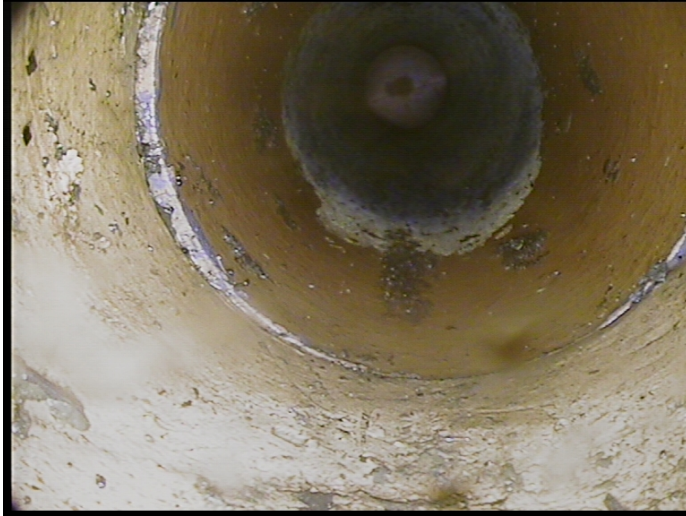
Code: **TFC**  
Description: **Tap Factory Capped**

Distance (ft): **25.1**  
Structural Grade: **0**  
O&M Grade: **0**  
Clock Start/From: **12**  
Clock To:  
1st Value: **4.000**  
2nd Value:  
Value Percent:  
Continuous Index:  
Within 8" of Joint: **NO**  
Remarks:

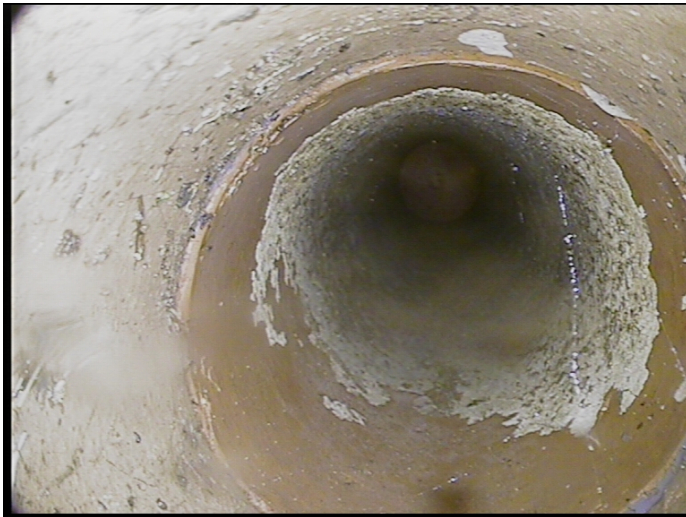
Code: **TFC**  
Description: **Tap Factory Capped**

Distance (ft): **54.8**  
Structural Grade: **0**  
O&M Grade: **0**  
Clock Start/From: **12**  
Clock To:  
1st Value: **4.000**  
2nd Value:  
Value Percent:  
Continuous Index:  
Within 8" of Joint: **NO**  
Remarks:

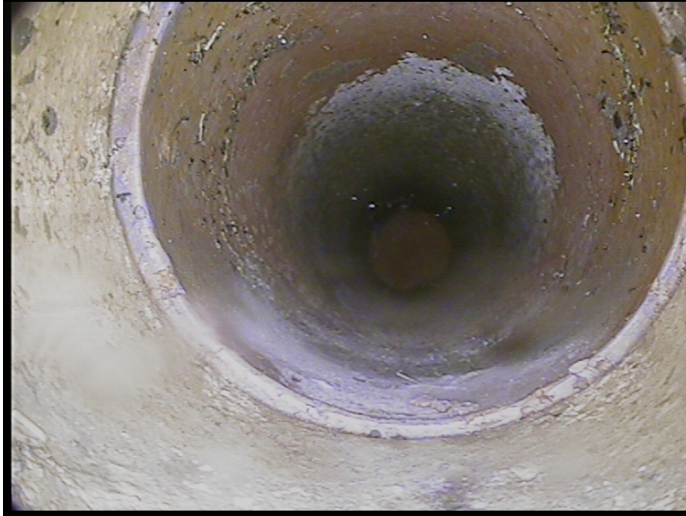
Code:	<b>TFC</b>
Description:	<b>Tap Factory Capped</b>
Distance (ft):	<b>65.0</b>
Structural Grade:	<b>0</b>
O&M Grade:	<b>0</b>
Clock Start/From:	<b>12</b>
Clock To:	
1st Value:	<b>4.000</b>
2nd Value:	
Value Percent:	
Continuous Index:	
Within 8" of Joint:	<b>NO</b>
Remarks:

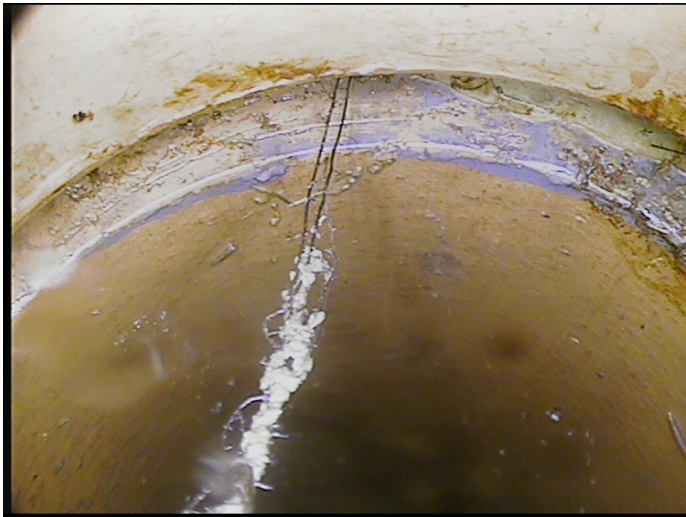
Code:	<b>RFJ</b>
Description:	<b>Roots Fine Joint</b>
Distance (ft):	<b>69.3</b>
Structural Grade:	<b>0</b>
O&M Grade:	<b>1</b>
Clock Start/From:	<b>11</b>
Clock To:	
1st Value:	
2nd Value:	
Value Percent:	
Continuous Index:	
Within 8" of Joint:	<b>YES</b>
Remarks:

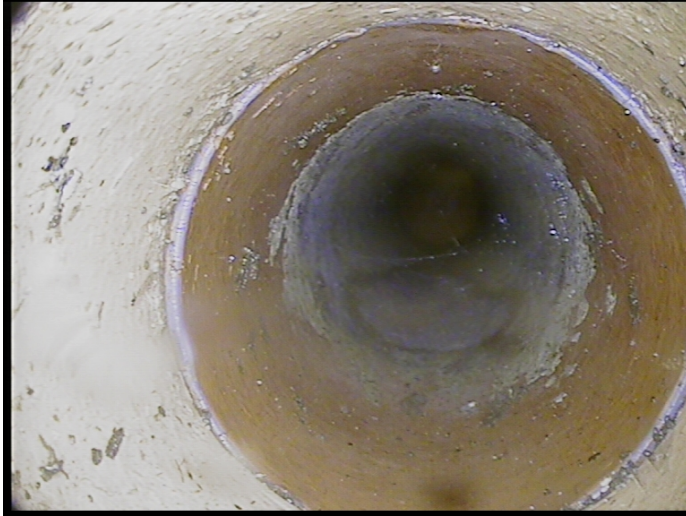
Code: **TFC**  
Description: **Tap Factory Capped**

Distance (ft): **94.4**  
Structural Grade: **0**  
O&M Grade: **0**  
Clock Start/From: **12**  
Clock To:  
1st Value: **4.000**  
2nd Value:  
Value Percent:  
Continuous Index:  
Within 8" of Joint: **NO**  
Remarks:

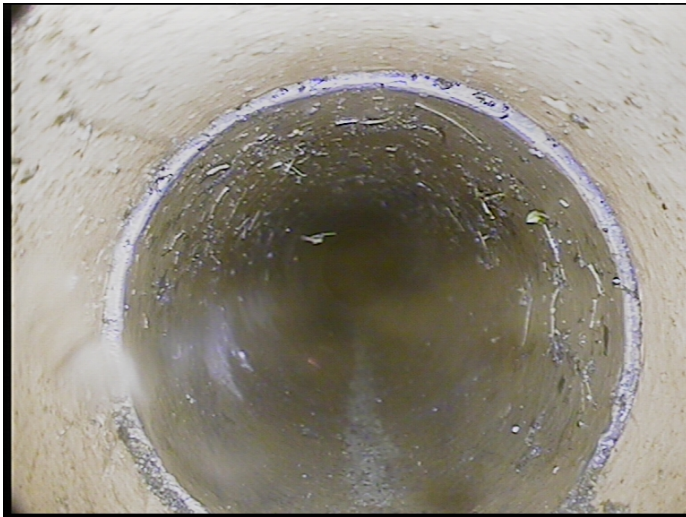
Code: **TF**  
Description: **Tap Factory**

Distance (ft): **104.1**  
Structural Grade: **0**  
O&M Grade: **0**  
Clock Start/From: **12**  
Clock To:  
1st Value: **4.000**  
2nd Value:  
Value Percent:  
Continuous Index:  
Within 8" of Joint: **NO**  
Remarks:

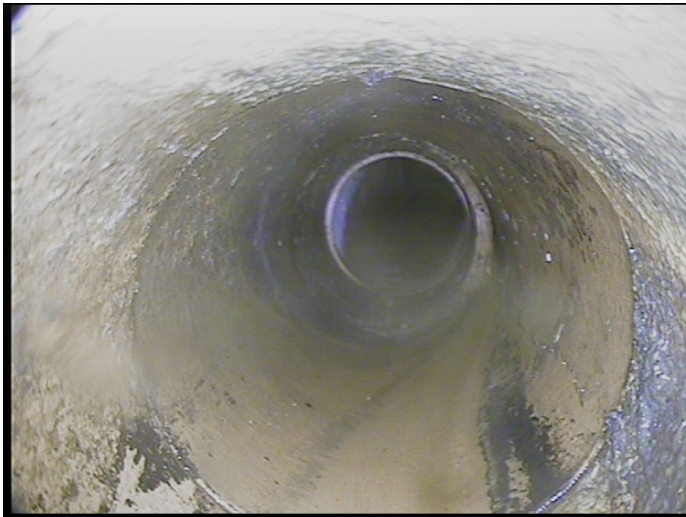
Code: **TFA**  
Description: **Tap Factory Active**

Distance (ft): **134.4**  
Structural Grade: **0**  
O&M Grade: **0**  
Clock Start/From: **12**  
Clock To:  
1st Value: **4.000**  
2nd Value:  
Value Percent:  
Continuous Index:  
Within 8" of Joint: **NO**  
Remarks:

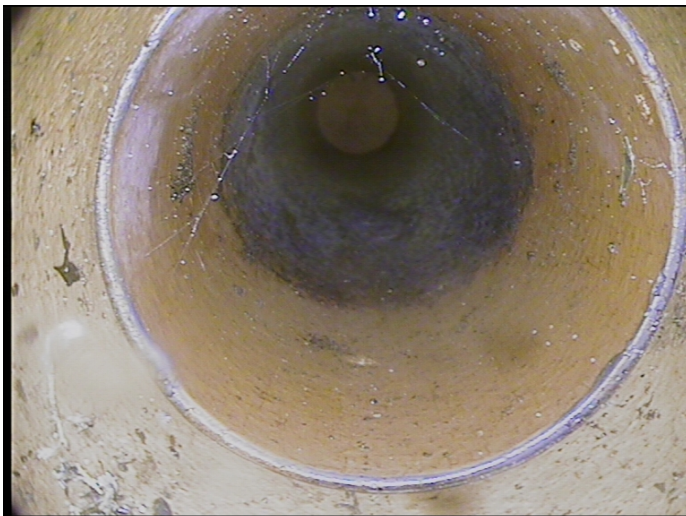
Code: **TFC**  
Description: **Tap Factory Capped**

Distance (ft): **143.8**  
Structural Grade: **0**  
O&M Grade: **0**  
Clock Start/From: **12**  
Clock To:  
1st Value: **4.000**  
2nd Value:  
Value Percent:  
Continuous Index:  
Within 8" of Joint: **NO**  
Remarks:

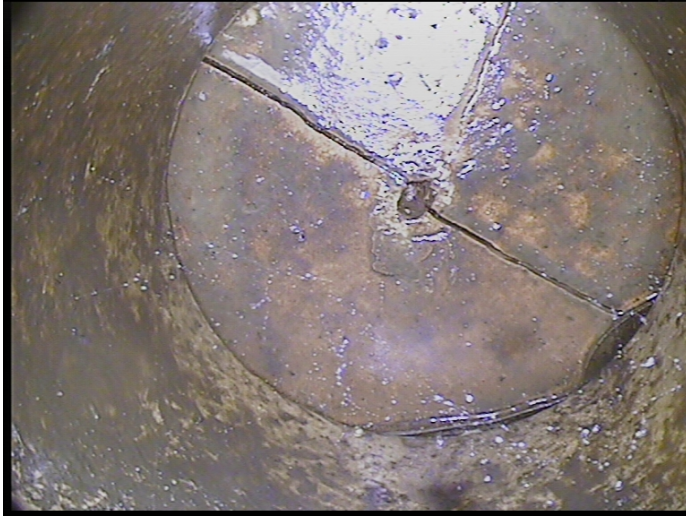
Code: **TFC**  
Description: **Tap Factory Capped**

Distance (ft): **173.4**  
Structural Grade: **0**  
O&M Grade: **0**  
Clock Start/From: **12**  
Clock To:  
1st Value: **4.000**  
2nd Value:  
Value Percent:  
Continuous Index:  
Within 8" of Joint: **NO**  
Remarks:

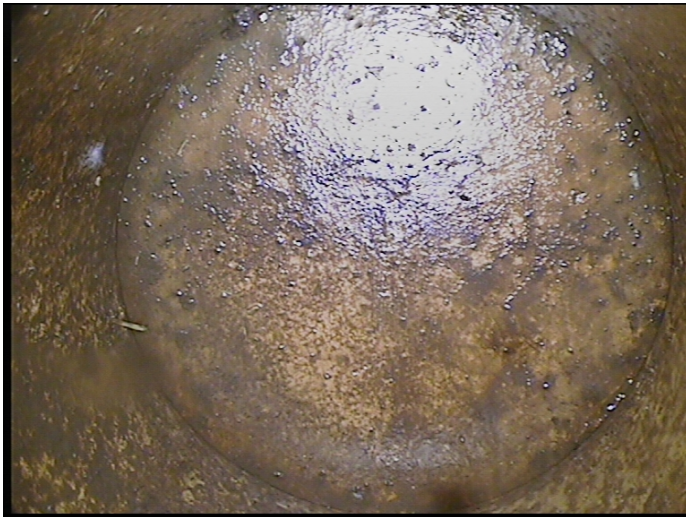
Code: **TFC**  
Description: **Tap Factory Capped**

Distance (ft): **184.0**  
Structural Grade: **0**  
O&M Grade: **0**  
Clock Start/From: **12**  
Clock To:  
1st Value: **4.000**  
2nd Value:  
Value Percent:  
Continuous Index:  
Within 8" of Joint: **NO**  
Remarks:

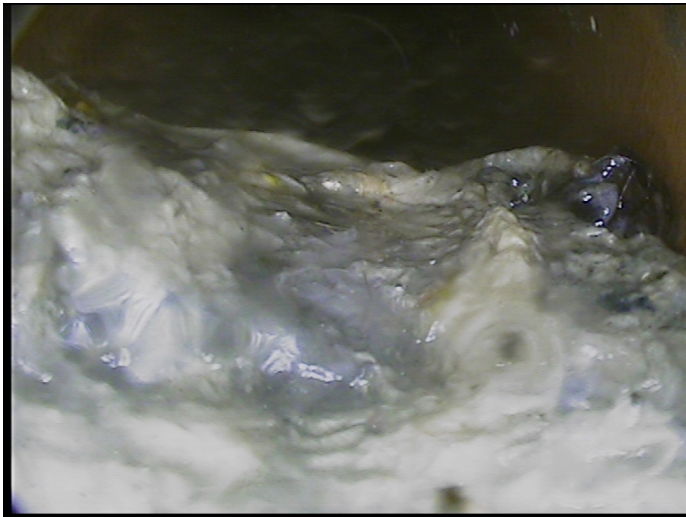
Code:	<b>MSA</b>
Description:	<b>Abandoned Survey</b>
Distance (ft):	<b>193.6</b>
Structural Grade:	<b>0</b>
O&M Grade:	<b>0</b>
Clock Start/From:	
Clock To:	
1st Value:	
2nd Value:	
Value Percent:	
Continuous Index:	
Within 8" of Joint:	<b>NO</b>
Remarks:	<b>debris</b>
