Profile/Photo Observation Report

Date:	04/12/2018	Weather:		Coding:	PACP 6.0
Pipe Length (ft):		Owner:	City of Hobart	Pre Clean:	No Pre-Cleaning
P.O.#:	36-1	Surveyor:	M. Pielacha	PSR:	M-603-037-M-603-036
Customer:	City of Hobart	Clean Date:		Shape:	C

Street:	Off 37th Avenue	Flow Control:	Not Controlled
City:	Hobart, IN	Year Renewed:	
Location:	Light Highway	Tape/Media #:	DEP 36
Purpose:	Routine Assessment	Dia/Height:	6"
Use:	Sanitary	Material:	VCP
Drain Area:		Lining:	
Category:	NA		
Comment:			
Location Details:		Direction of Survey:	Upstream
US MH:	M-603-037	DS MH:	M-603-036
		Total Length Surveyed (ft):	2.1

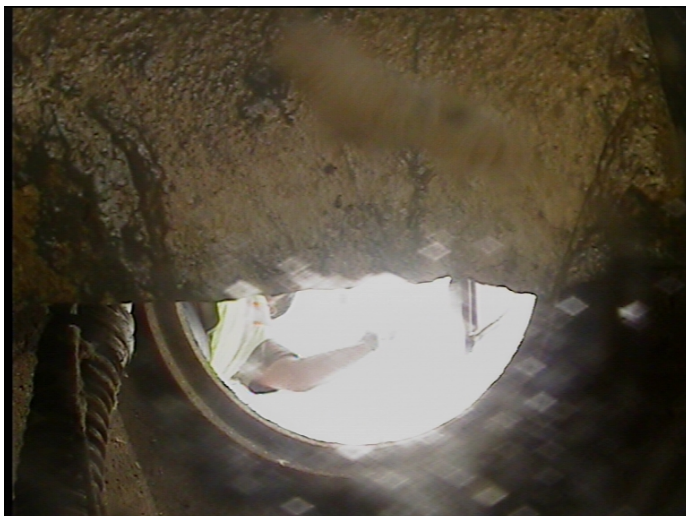
Code: **AMH**
Description: **Manhole**

Distance (ft): **.0**
Structural Grade: **0**
O&M Grade: **0**
Clock Start/From:
Clock To:
1st Value:
2nd Value:
Value Percent:
Continuous Index:
Within 8" of Joint: **NO**
Remarks: **M-603-036**

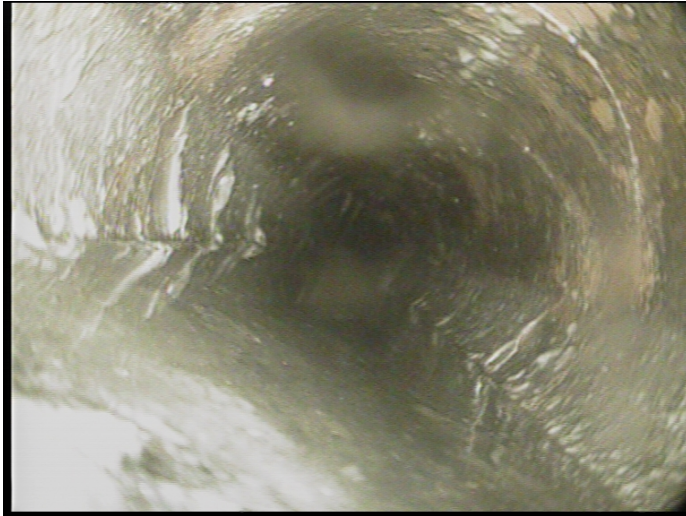
Code: **MWL**
Description: **Water Level**

Distance (ft): **.0**
Structural Grade: **0**
O&M Grade: **0**
Clock Start/From:
Clock To:
1st Value:
2nd Value:
Value Percent: **10.000**
Continuous Index:
Within 8" of Joint: **NO**
Remarks:

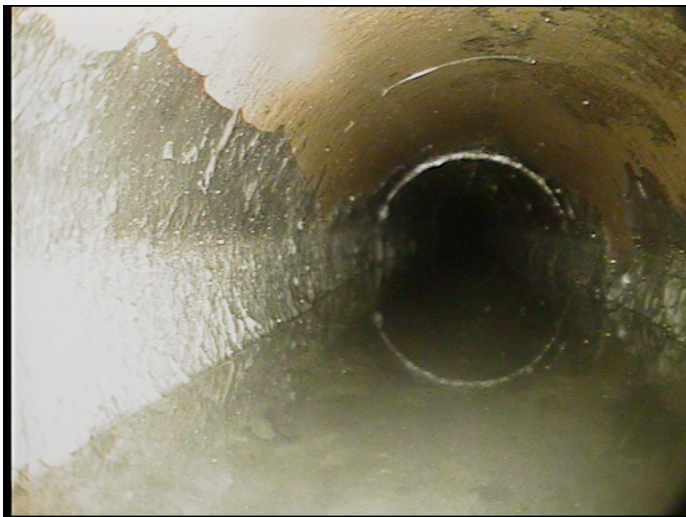
Code: **MSA**
Description: **Abandoned Survey**

Distance (ft): **2.1**
Structural Grade: **0**
O&M Grade: **0**
Clock Start/From:
Clock To:
1st Value:
2nd Value:
Value Percent:
Continuous Index:
Within 8" of Joint: **NO**
Remarks: **sediment**
