Profile/Photo Observation Report

Street:	W Cleveland Ave.	Flow Control:	Not Controlled
City:	Hobart, IN	Year Renewed:	
Location:	Other	Tape/Media #:	
Purpose:	Not Known	Dia/Height:	10"
Use:	Sanitary	Material:	CP
Drain Area:	NA	Lining:	
Category:	NA		
Comment:

Location Details:		Direction of Survey:	Upstream
US MH:	M-604-002	DS MH:	M-604-001
		Total Length Surveyed (ft):	6.2

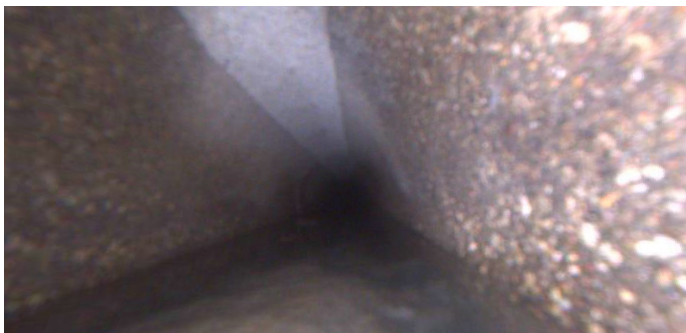
Code: **AMH**
Description: **Manhole**

Distance (ft): **.0**
Structural Grade: **0**
O&M Grade: **0**
Clock Start/From:
Clock To:
1st Value:
2nd Value:
Value Percent:
Continuous Index:
Within 8" of Joint: **NO**
Remarks: **M-604-001**

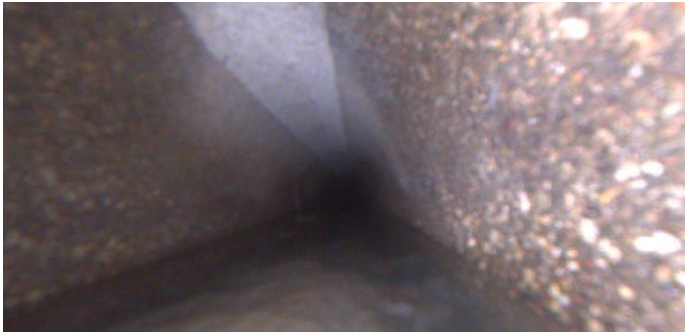
Code:	MWL
Description:	Water Level

Distance (ft):	.0
Structural Grade:	0
O&M Grade:	0
Clock Start/From:	
Clock To:	
1st Value:	
2nd Value:	
Value Percent:	30.000
Continuous Index:	
Within 8" of Joint:	NO
Remarks:

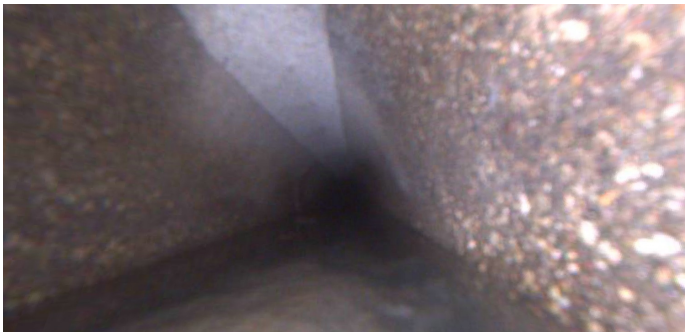
Code:	SAP
Description:	Surface Aggregate Projecting

Distance (ft):	.0
Structural Grade:	3
O&M Grade:	0
Clock Start/From:	8
Clock To:	4
1st Value:	
2nd Value:	
Value Percent:	
Continuous Index:	S01
Within 8" of Joint:	
Remarks:

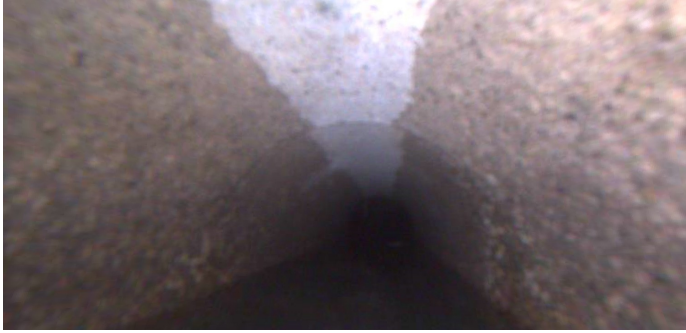
Code: **MSA**
Description: **Abandoned Survey**

Distance (ft): **6.2**
Structural Grade: **0**
O&M Grade: **0**
Clock Start/From:
Clock To:
1st Value:
2nd Value:
Value Percent:
Continuous Index:
Within 8" of Joint: **NO**
Remarks: **debris under water**

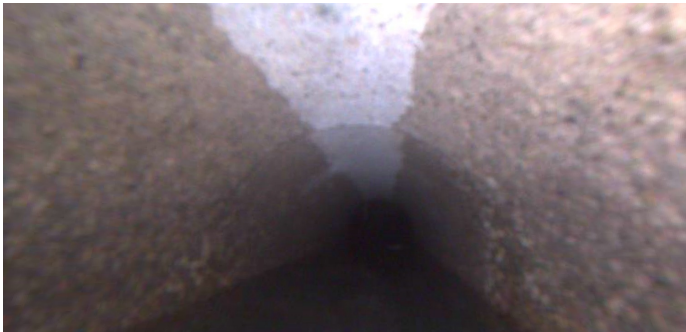
Code: **SAP**
Description: **Surface Aggregate Projecting**

Distance (ft): **6.2**
Structural Grade: **3**
O&M Grade: **0**
Clock Start/From: **8**
Clock To: **4**
1st Value:
2nd Value:
Value Percent:
Continuous Index: **F01**
Within 8" of Joint:
Remarks:
