Profile/Photo Observation Report

Street:	W CLEVELAND AVE & BEVERLY LN	Flow Control:	Not Controlled
City:	Hobart, IN	Year Renewed:	
Location:	Other	Tape/Media #:	
Purpose:	Not Known	Dia/Height:	10"
Use:	Sanitary	Material:	VCP
Drain Area:	NA	Lining:	
Category:	NA		
Comment:

Location Details:		Direction of Survey:	Downstream
US MH:	M-604-003	DS MH:	M-604-002
		Total Length Surveyed (ft):	8.1

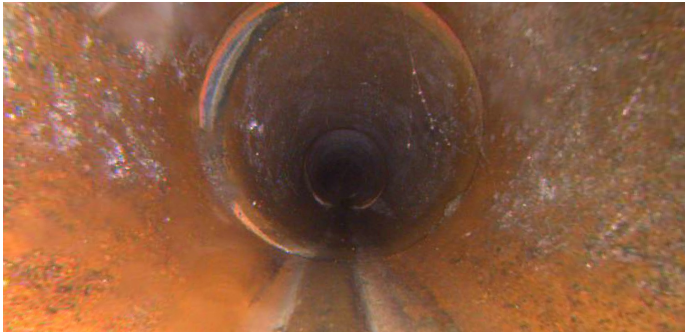
Code:	MWL
Description:	Water Level

Distance (ft):	.0
Structural Grade:	0
O&M Grade:	0
Clock Start/From:	
Clock To:	
1st Value:	
2nd Value:	
Value Percent:	5.000
Continuous Index:	
Within 8" of Joint:	NO
Remarks:

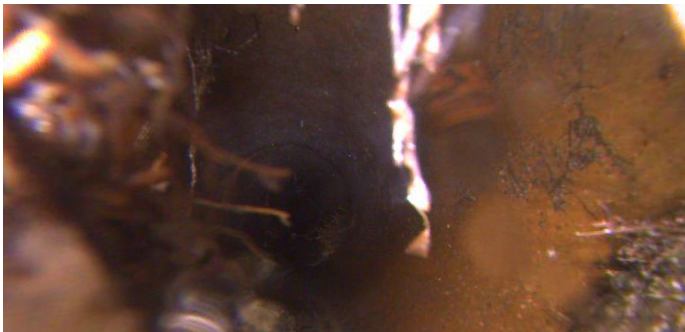
Code:	RMJ
Description:	Roots Medium Joint

Distance (ft):	8.1
Structural Grade:	0
O&M Grade:	3
Clock Start/From:	8
Clock To:	4
1st Value:	
2nd Value:	
Value Percent:	40.000
Continuous Index:	
Within 8" of Joint:	YES
Remarks:

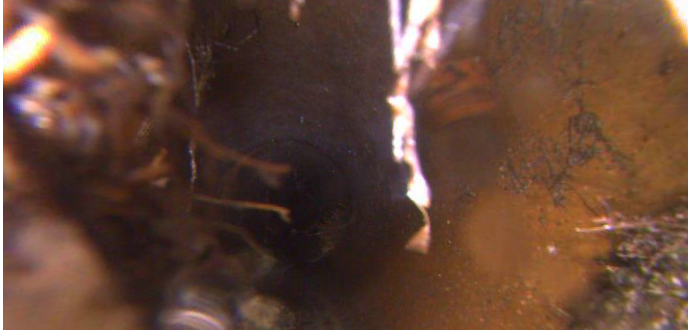
Code:	MSA
Description:	Abandoned Survey
Distance (ft):	8.1
Structural Grade:	0
O&M Grade:	0
Clock Start/From:	
Clock To:	
1st Value:	
2nd Value:	
Value Percent:	
Continuous Index:	
Within 8" of Joint:	NO
Remarks:	roots
