## Profile/Photo Observation Report

Street:	<b>W Cleveland Ave.</b>	Flow Control:	<b>Not Controlled</b>
City:	<b>Hobart, IN</b>	Year Renewed:	
Location:	<b>Other</b>	Tape/Media #:	
Purpose:	<b>Not Known</b>	Dia/Height:	<b>10"</b>
Use:	<b>Sanitary</b>	Material:	<b>VCP</b>
Drain Area:	<b>NA</b>	Lining:	
Category:	<b>NA</b>		
Comment:

Location Details:		Direction of Survey:	<b>Downstream</b>
US MH:	<b>M-604-003</b>	DS MH:	<b>M-604-002</b>
		Total Length Surveyed (ft):	<b>8.1</b>

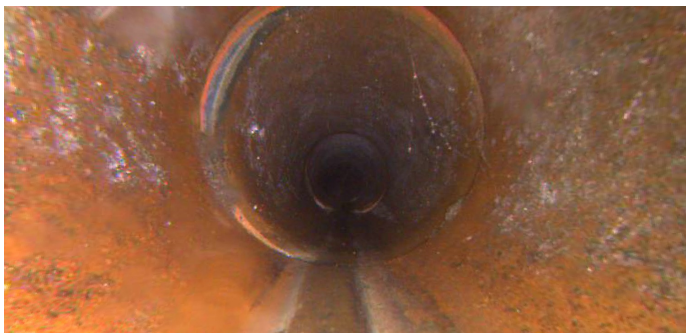
Code: **AMH**  
Description: **Manhole**

Distance (ft): **.0**  
Structural Grade: **0**  
O&M Grade: **0**  
Clock Start/From:  
Clock To:  
1st Value:  
2nd Value:  
Value Percent:  
Continuous Index:  
Within 8" of Joint: **NO**  
Remarks: **M-604-003**

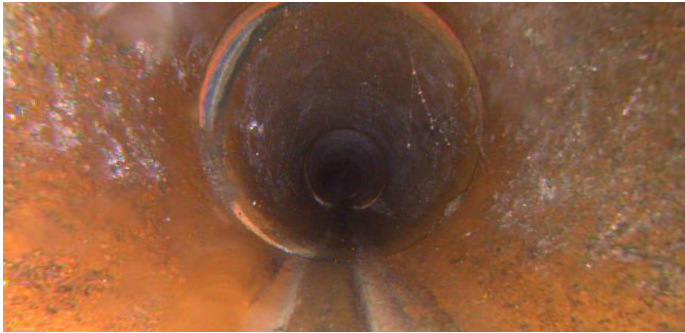
Code:	<b>MWL</b>
Description:	<b>Water Level</b>

Distance (ft):	<b>.0</b>
Structural Grade:	<b>0</b>
O&M Grade:	<b>0</b>
Clock Start/From:	
Clock To:	
1st Value:	
2nd Value:	
Value Percent:	<b>5.000</b>
Continuous Index:	
Within 8" of Joint:	<b>NO</b>
Remarks:

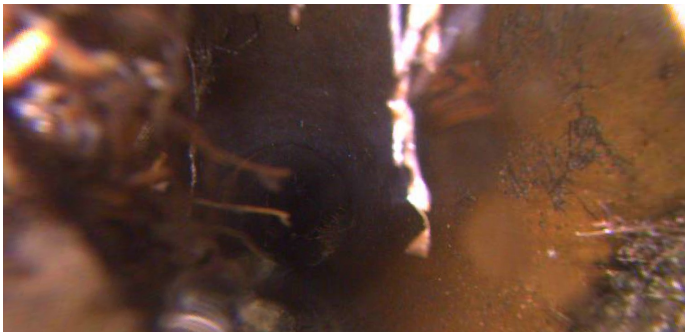
Code:	<b>RMJ</b>
Description:	<b>Roots Medium Joint</b>

Distance (ft):	<b>8.1</b>
Structural Grade:	<b>0</b>
O&M Grade:	<b>3</b>
Clock Start/From:	<b>8</b>
Clock To:	<b>4</b>
1st Value:	
2nd Value:	
Value Percent:	<b>40.000</b>
Continuous Index:	
Within 8" of Joint:	<b>YES</b>
Remarks:

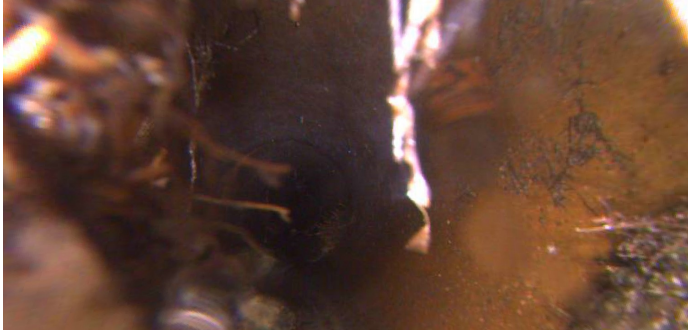
Code:	<b>MSA</b>
Description:	<b>Abandoned Survey</b>
Distance (ft):	<b>8.1</b>
Structural Grade:	<b>0</b>
O&M Grade:	<b>0</b>
Clock Start/From:	
Clock To:	
1st Value:	
2nd Value:	
Value Percent:	
Continuous Index:	
Within 8" of Joint:	<b>NO</b>
Remarks:	<b>roots</b>
