Profile/Photo Observation Report

Street:	W CLEVELAND AVE & WILLOW PL	Flow Control:	Not Controlled
City:	Hobart, IN	Year Renewed:	
Location:	Other	Tape/Media #:	
Purpose:	Not Known	Dia/Height:	8"
Use:	Sanitary	Material:	CP
Drain Area:	NA	Lining:	
Category:	NA		
Comment:

Location Details:		Direction of Survey:	Downstream
US MH:	M-604-004	DS MH:	M-604-005
		Total Length Surveyed (ft):	5.2

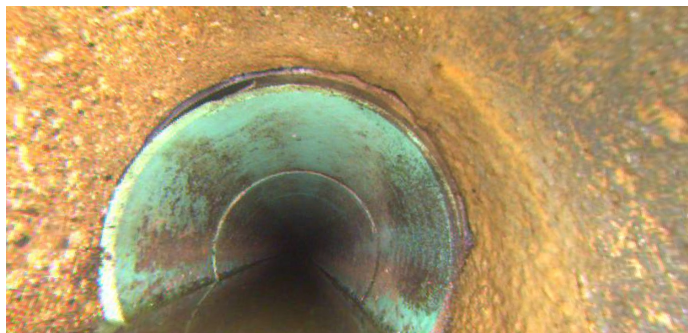
Code: **AMH**
Description: **Manhole**

Distance (ft): **.0**
Structural Grade: **0**
O&M Grade: **0**
Clock Start/From:
Clock To:
1st Value:
2nd Value:
Value Percent:
Continuous Index:
Within 8" of Joint: **NO**
Remarks: **M-604-004**

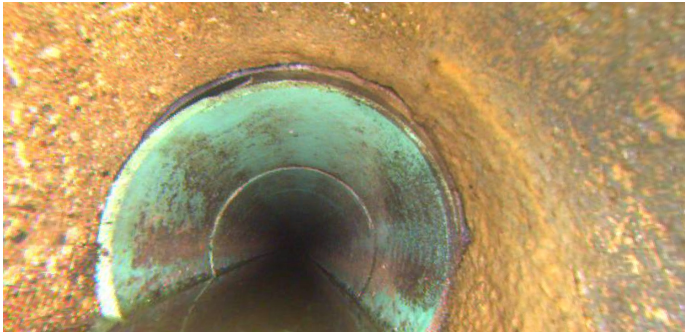
Code:	MWL
Description:	Water Level

Distance (ft):	.0
Structural Grade:	0
O&M Grade:	0
Clock Start/From:	
Clock To:	
1st Value:	
2nd Value:	
Value Percent:	10.000
Continuous Index:	
Within 8" of Joint:	NO
Remarks:

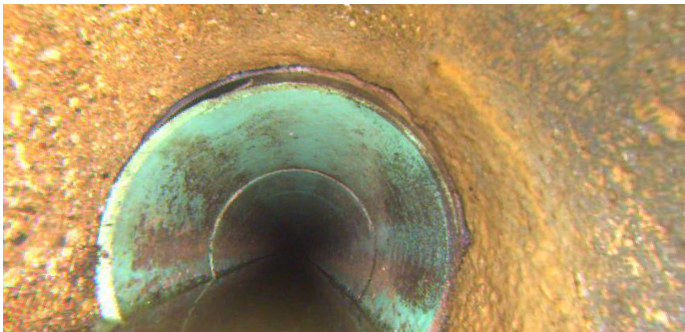
Code:	SAV
Description:	Surface Aggregate Visible

Distance (ft):	.0
Structural Grade:	3
O&M Grade:	0
Clock Start/From:	8
Clock To:	4
1st Value:	
2nd Value:	
Value Percent:	
Continuous Index:	
Within 8" of Joint:	
Remarks:

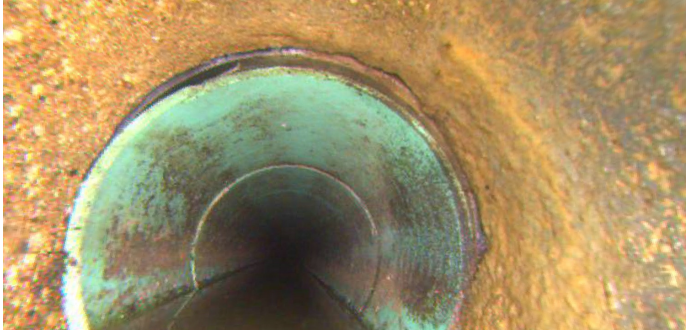
Code: **MMC**
Description: **Material Change**

Distance (ft): **.0**
Structural Grade: **0**
O&M Grade: **0**
Clock Start/From:
Clock To:
1st Value:
2nd Value:
Value Percent:
Continuous Index:
Within 8" of Joint: **NO**
Remarks: **PVC**

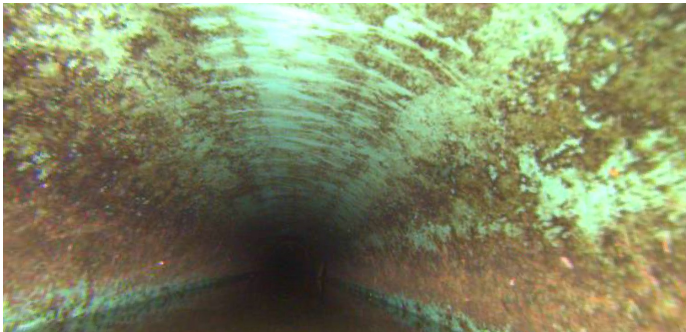
Code: **MSA**
Description: **Abandoned Survey**

Distance (ft): **5.2**
Structural Grade: **0**
O&M Grade: **0**
Clock Start/From:
Clock To:
1st Value:
2nd Value:
Value Percent:
Continuous Index:
Within 8" of Joint: **NO**
Remarks: **PVC**
