## Profile/Photo Observation Report

Street:	<b>Willow Pl.</b>	Flow Control:	<b>Not Controlled</b>
City:	<b>Hobart, IN</b>	Year Renewed:	
Location:	<b>Other</b>	Tape/Media #:	
Purpose:	<b>Not Known</b>	Dia/Height:	<b>8"</b>
Use:	<b>Sanitary</b>	Material:	<b>PVC</b>
Drain Area:	<b>NA</b>	Lining:	
Category:	<b>NA</b>		
Comment:

Location Details:		Direction of Survey:	<b>Upstream</b>
US MH:	<b>M-604-004</b>	DS MH:	<b>M-604-005</b>
		Total Length Surveyed (ft):	<b>5.2</b>

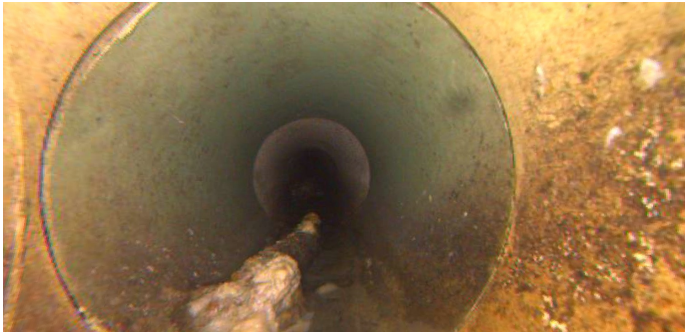
Code:	<b>MWL</b>
Description:	<b>Water Level</b>

Distance (ft):	<b>.0</b>
Structural Grade:	<b>0</b>
O&M Grade:	<b>0</b>
Clock Start/From:	
Clock To:	
1st Value:	
2nd Value:	
Value Percent:	<b>5.000</b>
Continuous Index:	
Within 8" of Joint:	<b>NO</b>
Remarks:

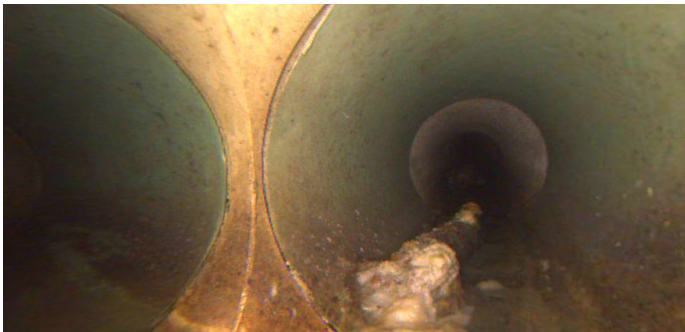
Code:	<b>TFA</b>
Description:	<b>Tap Factory Active</b>

Distance (ft):	<b>.0</b>
Structural Grade:	<b>0</b>
O&M Grade:	<b>0</b>
Clock Start/From:	<b>9</b>
Clock To:	
1st Value:	<b>4.000</b>
2nd Value:	
Value Percent:	
Continuous Index:	
Within 8" of Joint:	
Remarks:

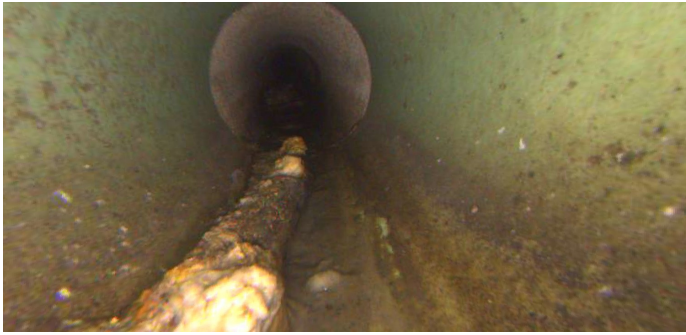
Code: **OBZ**  
Description: **Obstacle Other**

Distance (ft): **1.4**  
Structural Grade: **0**  
O&M Grade: **2**  
Clock Start/From: **6**  
Clock To:  
1st Value:  
2nd Value:  
Value Percent: **5.000**  
Continuous Index:  
Within 8" of Joint: **NO**  
Remarks: **stick**

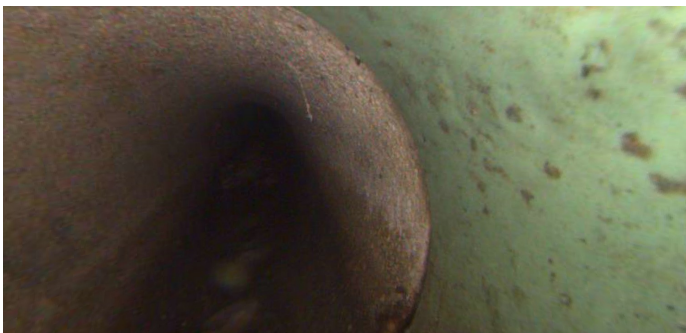
Code: **MSA**  
Description: **Abandoned Survey**

Distance (ft): **4.9**  
Structural Grade: **0**  
O&M Grade: **0**  
Clock Start/From:  
Clock To:  
1st Value:  
2nd Value:  
Value Percent:  
Continuous Index:  
Within 8" of Joint: **NO**  
Remarks: **stick**
