RedZone  
ROBOTICS

Total Length Surveyed (ft):      **306.5**

**M-604-006**

**M-604-004**

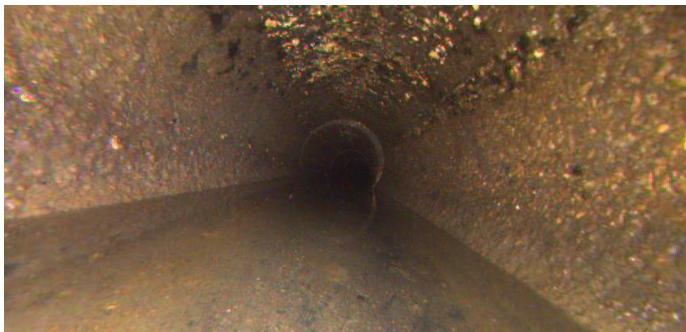
Code: **AMH**  
Description: **Manhole**

Distance (ft): **.0**  
Structural Grade: **0**  
O&M Grade: **0**  
Clock Start/From:  
Clock To:  
1st Value:  
2nd Value:  
Value Percent:  
Continuous Index:  
Within 8" of Joint: **NO**  
Remarks: **M-604-006**

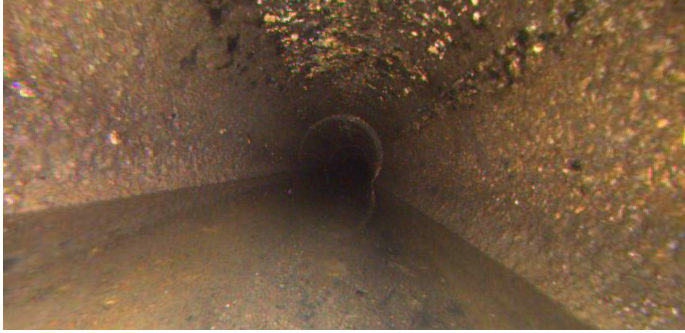
Code: **MWL**  
Description: **Water Level**

Distance (ft): **.0**  
Structural Grade: **0**  
O&M Grade: **0**  
Clock Start/From:  
Clock To:  
1st Value:  
2nd Value:  
Value Percent: **30.000**  
Continuous Index:  
Within 8" of Joint: **NO**  
Remarks:

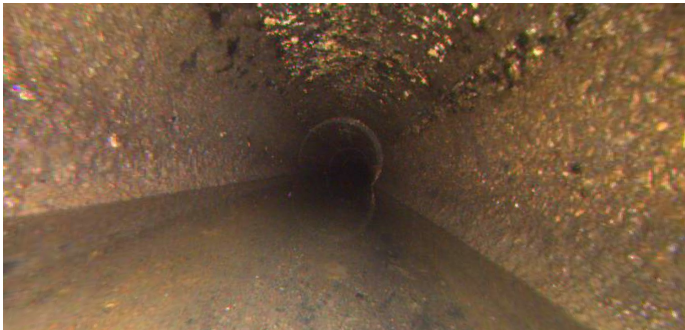
Code: **SAP**  
Description: **Surface Aggregate Projecting**

Distance (ft): **.0**  
Structural Grade: **3**  
O&M Grade: **0**  
Clock Start/From: **8**  
Clock To: **4**  
1st Value:  
2nd Value:  
Value Percent:  
Continuous Index: **S01**  
Within 8" of Joint:  
Remarks:

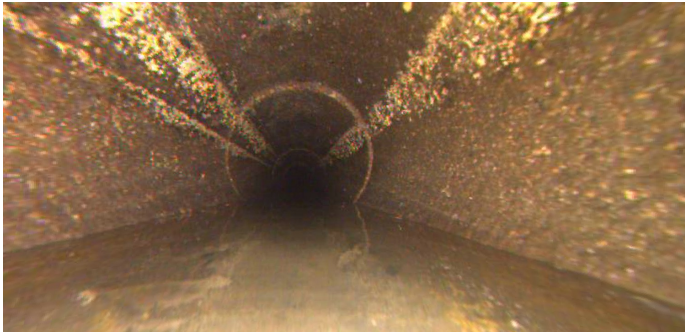
Code: **DAGS**  
Description: **Deposits Attached Grease**

Distance (ft): **14.1**  
Structural Grade: **0**  
O&M Grade: **2**  
Clock Start/From: **8**  
Clock To: **4**  
1st Value:  
2nd Value:  
Value Percent: **5.000**  
Continuous Index: **S02**  
Within 8" of Joint: **NO**  
Remarks:

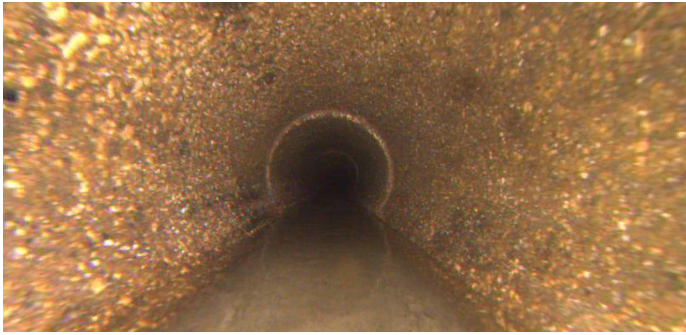
Code: **DAGS**  
Description: **Deposits Attached Grease**

Distance (ft): **52.9**  
Structural Grade: **0**  
O&M Grade: **2**  
Clock Start/From: **8**  
Clock To: **4**  
1st Value:  
2nd Value:  
Value Percent: **5.000**  
Continuous Index: **F02**  
Within 8" of Joint: **NO**  
Remarks:

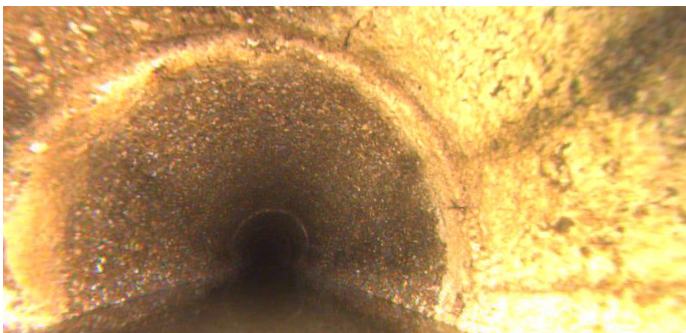
Code: **FM**  
Description: **Fracture Multiple**

Distance (ft): **75.3**  
Structural Grade: **4**  
O&M Grade: **0**  
Clock Start/From: **1**  
Clock To: **4**  
1st Value:  
2nd Value:  
Value Percent:  
Continuous Index:  
Within 8" of Joint: **YES**  
Remarks:

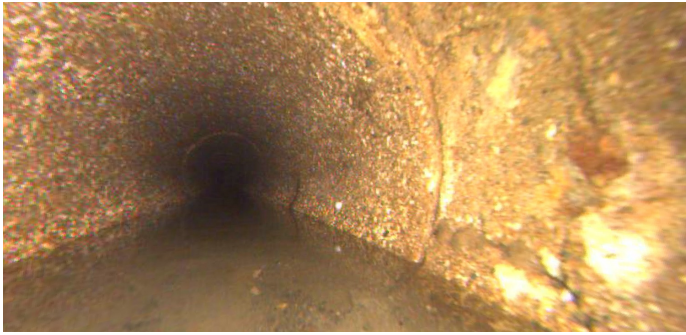
Code: **FM**  
Description: **Fracture Multiple**

Distance (ft): **84.4**  
Structural Grade: **4**  
O&M Grade: **0**  
Clock Start/From: **2**  
Clock To: **4**  
1st Value:  
2nd Value:  
Value Percent:  
Continuous Index:  
Within 8" of Joint: **YES**  
Remarks:

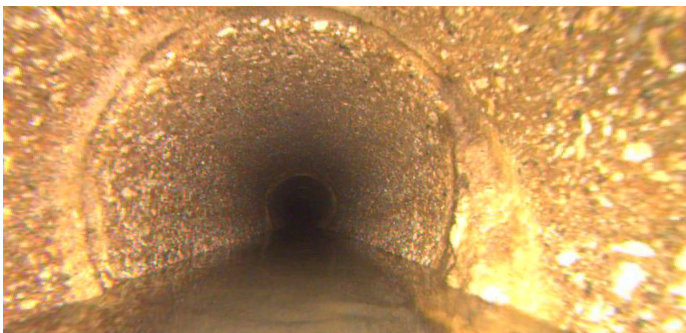
Code: **DAE**  
Description: **Deposits Attached Encrustation**

Distance (ft): **99.3**  
Structural Grade: **0**  
O&M Grade: **2**  
Clock Start/From: **8**  
Clock To: **4**  
1st Value:  
2nd Value:  
Value Percent: **5.000**  
Continuous Index:  
Within 8" of Joint: **YES**  
Remarks:

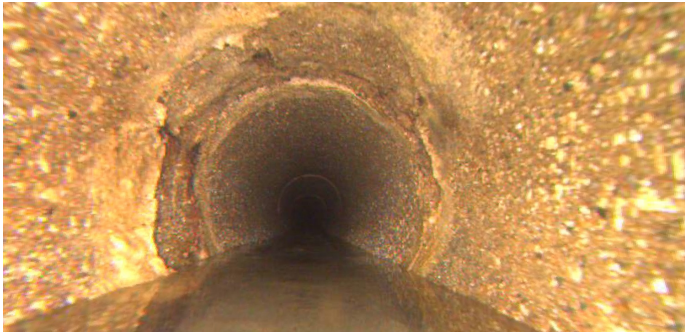
Code: **DAE**  
Description: **Deposits Attached Encrustation**

Distance (ft): **101.9**  
Structural Grade: **0**  
O&M Grade: **2**  
Clock Start/From: **8**  
Clock To: **4**  
1st Value:  
2nd Value:  
Value Percent: **5.000**  
Continuous Index:  
Within 8" of Joint: **YES**  
Remarks:

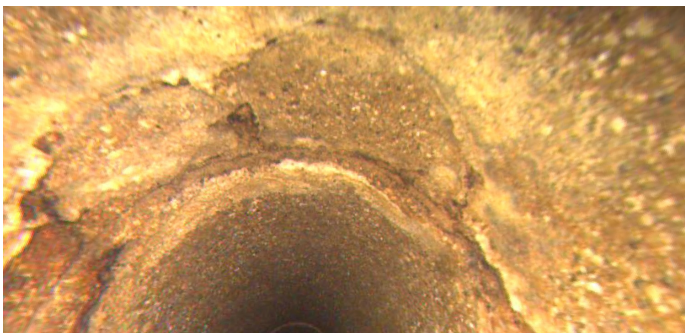
Code: **FM**  
Description: **Fracture Multiple**

Distance (ft): **102.4**  
Structural Grade: **4**  
O&M Grade: **0**  
Clock Start/From: **8**  
Clock To: **4**  
1st Value:  
2nd Value:  
Value Percent:  
Continuous Index:  
Within 8" of Joint: **YES**  
Remarks:

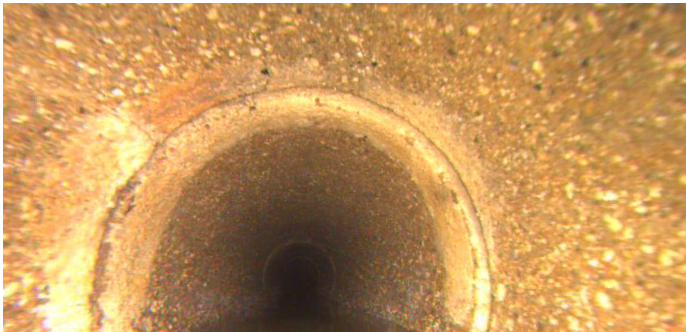
Code: **FL**  
Description: **Fracture Longitudinal**

Distance (ft): **117.3**  
Structural Grade: **3**  
O&M Grade: **0**  
Clock Start/From: **10**  
Clock To:  
1st Value:  
2nd Value:  
Value Percent:  
Continuous Index:  
Within 8" of Joint: **YES**  
Remarks:

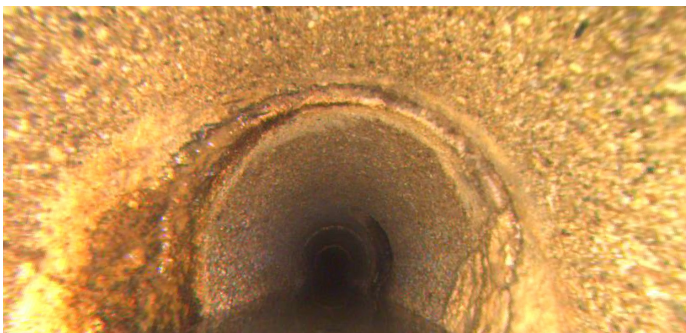
Code: **IW**  
Description: **Infil Weeper**

Distance (ft): **126.5**  
Structural Grade: **0**  
O&M Grade: **2**  
Clock Start/From: **8**  
Clock To: **4**  
1st Value:  
2nd Value:  
Value Percent:  
Continuous Index:  
Within 8" of Joint: **YES**  
Remarks:

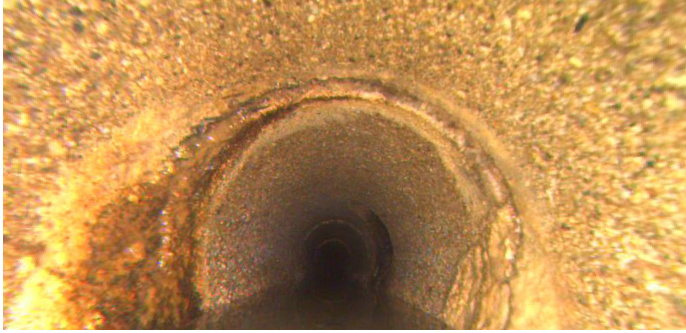
Code: **DAE**  
Description: **Deposits Attached Encrustation**

Distance (ft): **126.5**  
Structural Grade: **0**  
O&M Grade: **2**  
Clock Start/From: **8**  
Clock To: **4**  
1st Value:  
2nd Value:  
Value Percent: **5.000**  
Continuous Index:  
Within 8" of Joint: **YES**  
Remarks:

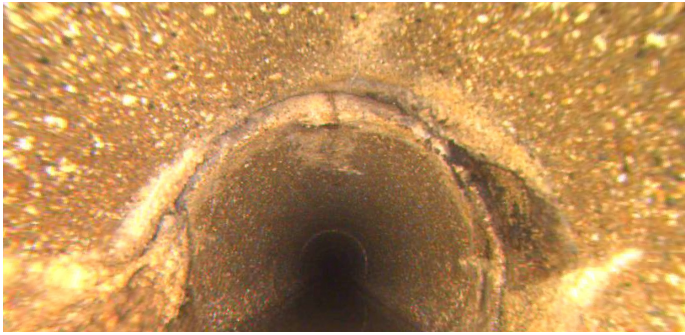
Code: **DAE**  
Description: **Deposits Attached Encrustation**

Distance (ft): **156.4**  
Structural Grade: **0**  
O&M Grade: **2**  
Clock Start/From: **8**  
Clock To: **4**  
1st Value:  
2nd Value:  
Value Percent: **5.000**  
Continuous Index:  
Within 8" of Joint: **YES**  
Remarks:

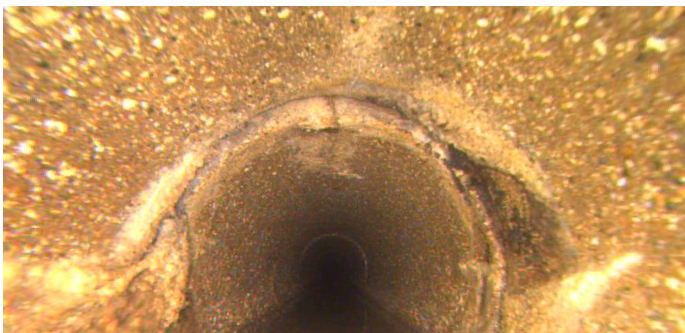
Code: **FL**  
Description: **Fracture Longitudinal**

Distance (ft): **156.4**  
Structural Grade: **3**  
O&M Grade: **0**  
Clock Start/From: **12**  
Clock To:  
1st Value:  
2nd Value:  
Value Percent:  
Continuous Index:  
Within 8" of Joint: **YES**  
Remarks:

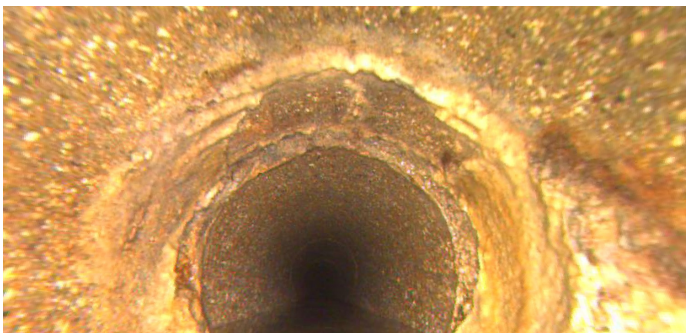
Code: **DAE**  
Description: **Deposits Attached Encrustation**

Distance (ft): **177.5**  
Structural Grade: **0**  
O&M Grade: **2**  
Clock Start/From: **8**  
Clock To: **4**  
1st Value:  
2nd Value:  
Value Percent: **5.000**  
Continuous Index:  
Within 8" of Joint: **YES**  
Remarks:

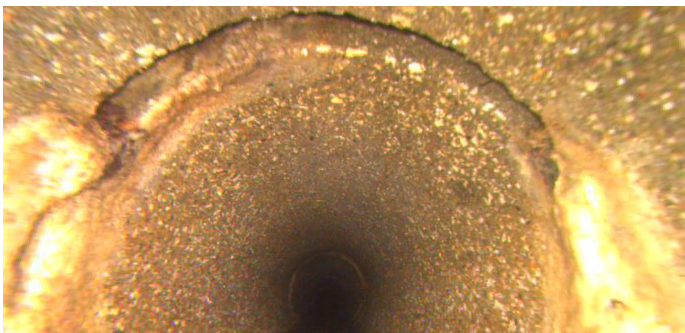
Code: **DAE**  
Description: **Deposits Attached Encrustation**

Distance (ft): **187.0**  
Structural Grade: **0**  
O&M Grade: **2**  
Clock Start/From: **8**  
Clock To: **4**  
1st Value:  
2nd Value:  
Value Percent: **5.000**  
Continuous Index: **S03**  
Within 8" of Joint: **YES**  
Remarks:

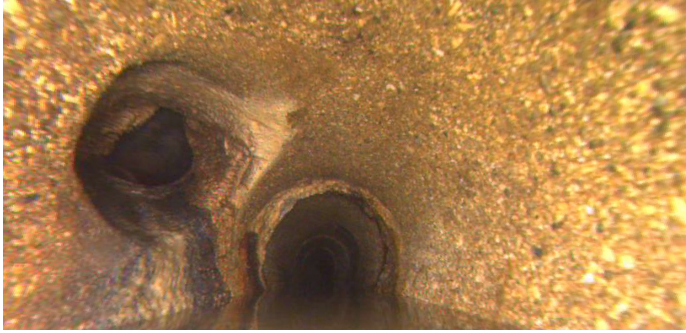
Code: **TF**  
Description: **Tap Factory**

Distance (ft): **200.6**  
Structural Grade: **0**  
O&M Grade: **0**  
Clock Start/From: **10**  
Clock To:  
1st Value: **4.000**  
2nd Value:  
Value Percent:  
Continuous Index:  
Within 8" of Joint:  
Remarks:

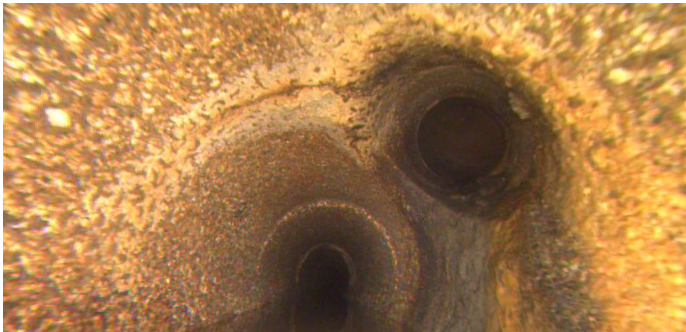
Code: **TF**  
Description: **Tap Factory**

Distance (ft): **203.6**  
Structural Grade: **0**  
O&M Grade: **0**  
Clock Start/From: **2**  
Clock To:  
1st Value: **4.000**  
2nd Value:  
Value Percent:  
Continuous Index:  
Within 8" of Joint:  
Remarks:

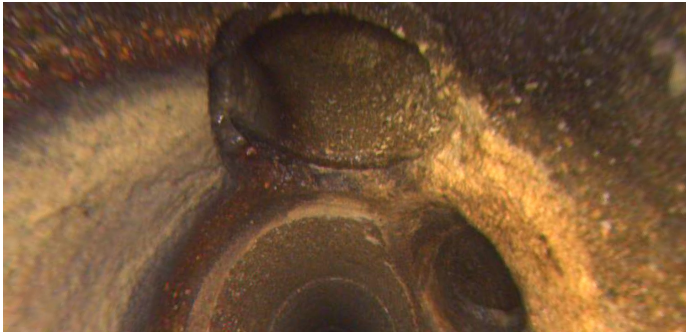
Code: **TB**  
Description: **Tap Break-in**

Distance (ft): **266.4**  
Structural Grade: **0**  
O&M Grade: **0**  
Clock Start/From: **12**  
Clock To:  
1st Value: **4.000**  
2nd Value:  
Value Percent:  
Continuous Index:  
Within 8" of Joint:  
Remarks:

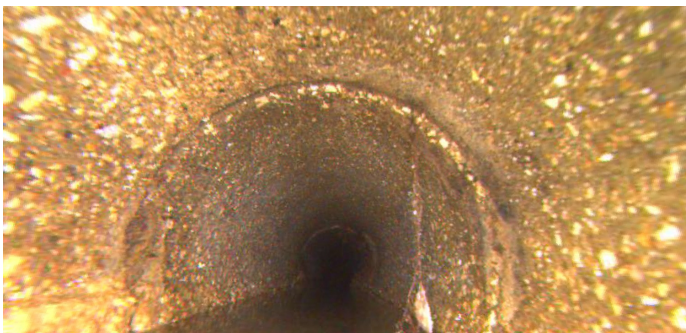
Code: **RFJ**  
Description: **Roots Fine Joint**

Distance (ft): **280.0**  
Structural Grade: **0**  
O&M Grade: **1**  
Clock Start/From: **8**  
Clock To: **4**  
1st Value:  
2nd Value:  
Value Percent:  
Continuous Index:  
Within 8" of Joint: **YES**  
Remarks:

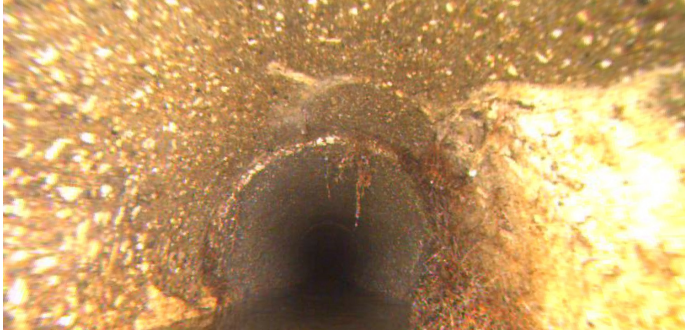
Code: **FM**  
Description: **Fracture Multiple**

Distance (ft): **282.6**  
Structural Grade: **4**  
O&M Grade: **0**  
Clock Start/From: **8**  
Clock To: **12**  
1st Value:  
2nd Value:  
Value Percent:  
Continuous Index:  
Within 8" of Joint: **YES**  
Remarks:

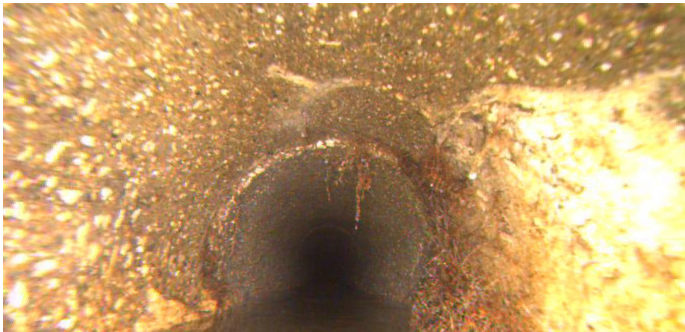
Code: **RMJ**  
Description: **Roots Medium Joint**

Distance (ft): **282.6**  
Structural Grade: **0**  
O&M Grade: **3**  
Clock Start/From: **8**  
Clock To: **4**  
1st Value:  
2nd Value:  
Value Percent: **5.000**  
Continuous Index:  
Within 8" of Joint: **YES**  
Remarks:

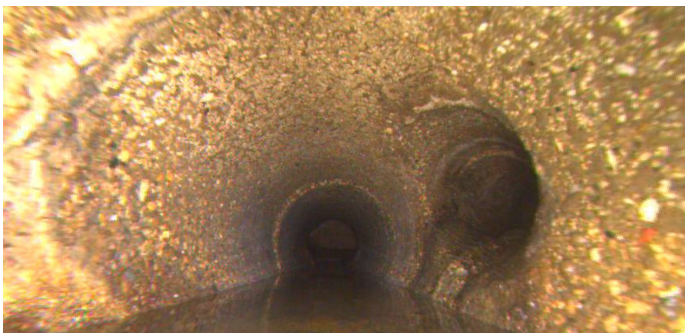
Code: **TF**  
Description: **Tap Factory**

Distance (ft): **299.7**  
Structural Grade: **0**  
O&M Grade: **0**  
Clock Start/From: **3**  
Clock To:  
1st Value: **4.000**  
2nd Value:  
Value Percent:  
Continuous Index:  
Within 8" of Joint:  
Remarks:

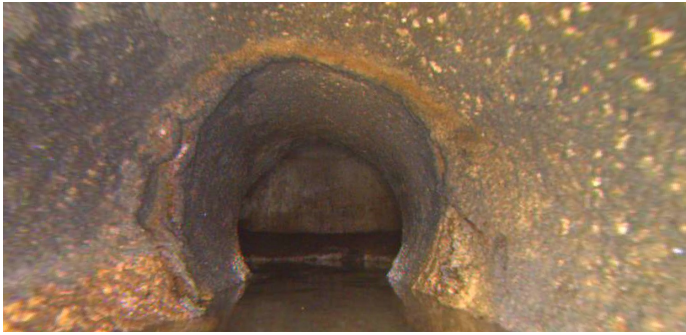
Code: **FC**  
Description: **Fracture Circumferential**

Distance (ft): **303.1**  
Structural Grade: **2**  
O&M Grade: **0**  
Clock Start/From: **8**  
Clock To: **4**  
1st Value:  
2nd Value:  
Value Percent:  
Continuous Index:  
Within 8" of Joint:  
Remarks:

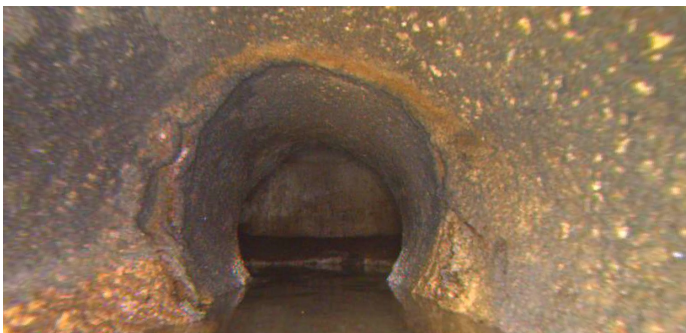
Code: **DAE**  
Description: **Deposits Attached Encrustation**

Distance (ft): **303.1**  
Structural Grade: **0**  
O&M Grade: **2**  
Clock Start/From: **8**  
Clock To: **4**  
1st Value:  
2nd Value:  
Value Percent: **5.000**  
Continuous Index: **F03**  
Within 8" of Joint: **YES**  
Remarks:

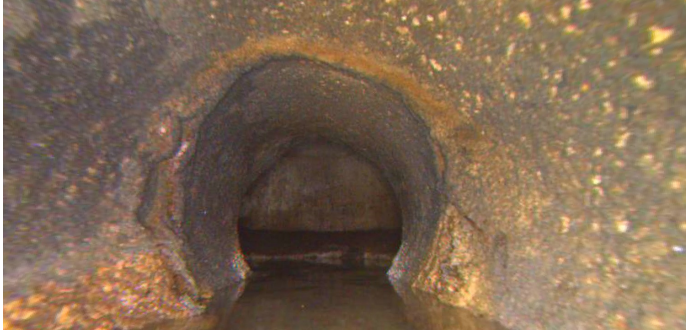
Code: **SAP**  
Description: **Surface Aggregate Projecting**

Distance (ft): **303.1**  
Structural Grade: **3**  
O&M Grade: **0**  
Clock Start/From: **8**  
Clock To: **4**  
1st Value:  
2nd Value:  
Value Percent:  
Continuous Index: **F01**  
Within 8" of Joint:  
Remarks:

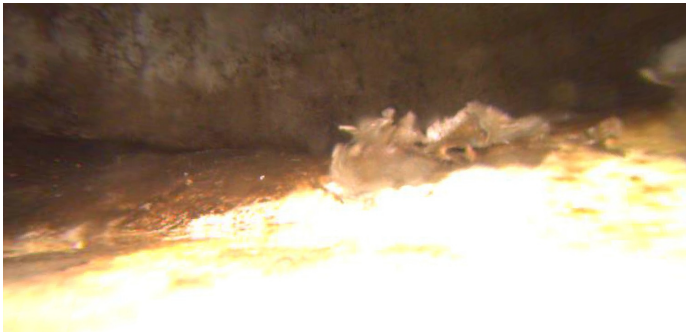
Code: **AMH**  
Description: **Manhole**

Distance (ft): **306.5**  
Structural Grade: **0**  
O&M Grade: **0**  
Clock Start/From:  
Clock To:  
1st Value:  
2nd Value:  
Value Percent:  
Continuous Index:  
Within 8" of Joint: **NO**  
Remarks: **M-604-004**
